# Confidential Inspection Report

1234 Main Cir Avon  
Lake OH 44012

November 15, 2019

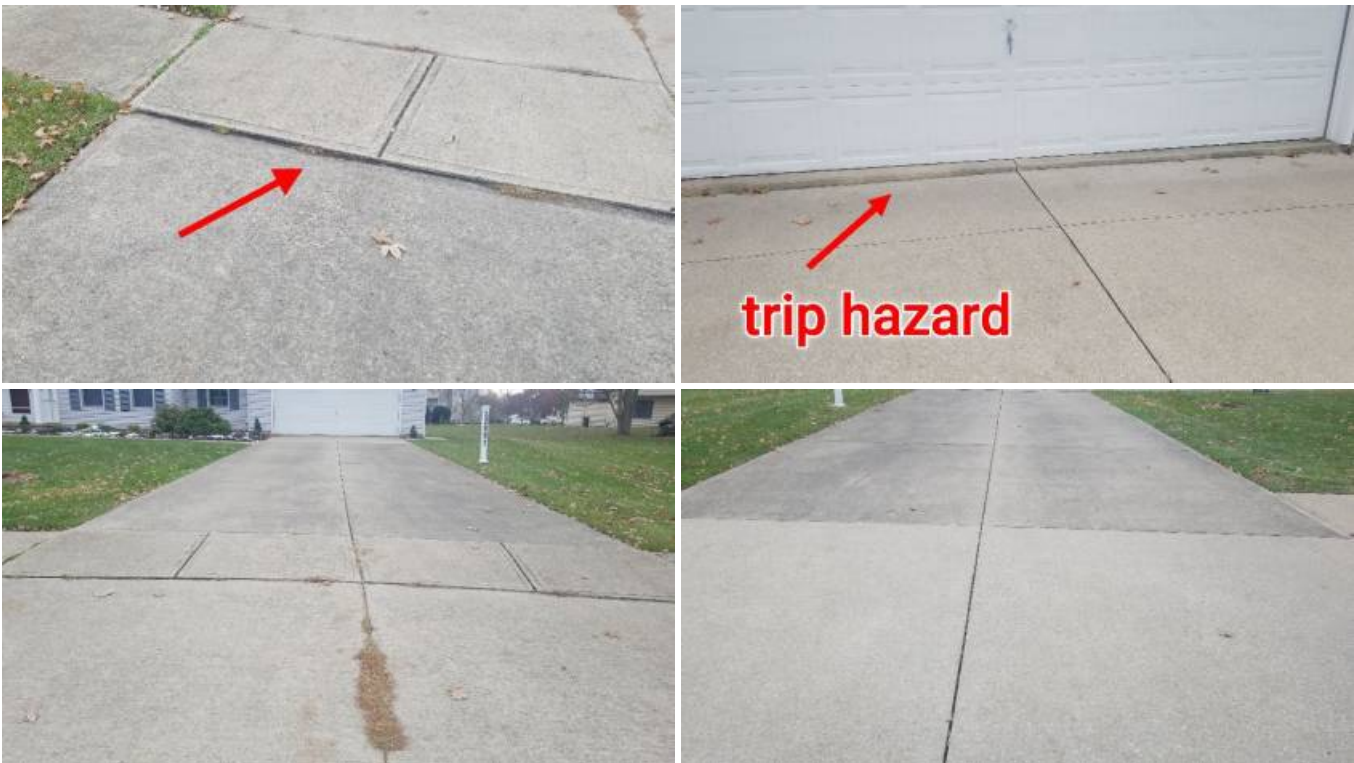
The driveway surface material is in functional condition with only normal deterioration noted. Common cracks observed; primarily a cosmetic concern. Suggest sealing all concrete slab joints as well as any cracks in concrete/asphalt/brick surfaces to prevent water penetration as a routine maintenance effort.

Possible trip hazard noted at various locations. This is a safety concern. Suggest repair/replacement as needed to ensure safety.

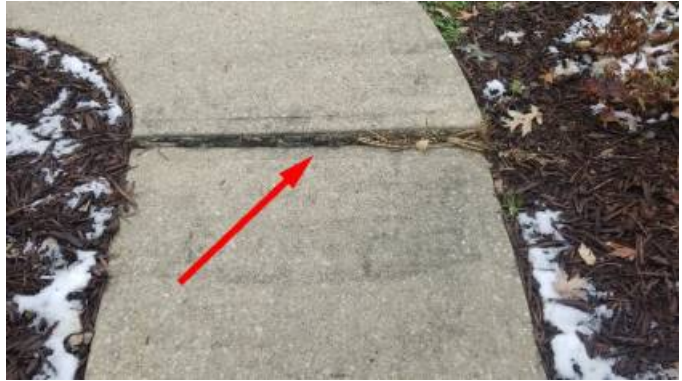
Possible trip hazard noted at various locations. This is a safety concern. Suggest repair/replacement as needed to ensure safety.

Settling observed recommend review by a qualified contractor for repair or replacement as needed.

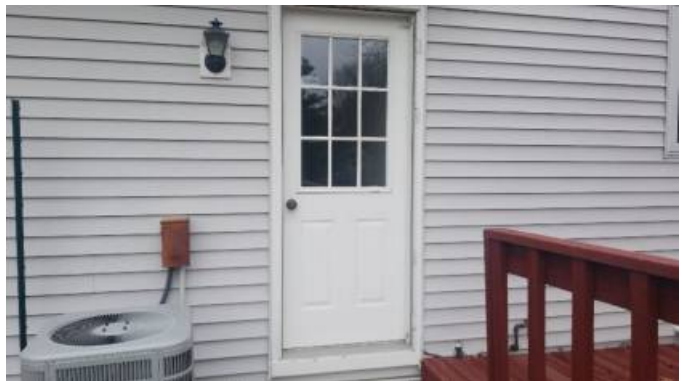
**Peeling paint observed at doors, suggest scraping and painting as needed as part of normal maintenance.**

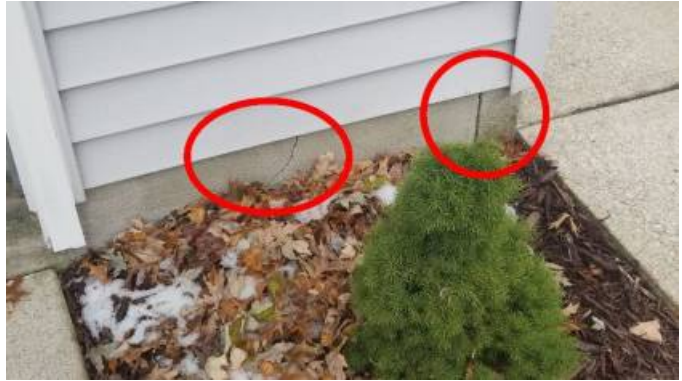
Common cracks observed, primarily a cosmetic concern. Suggest sealing any cracks in concrete/brick/block surfaces to prevent water penetration as a routine maintenance effort.

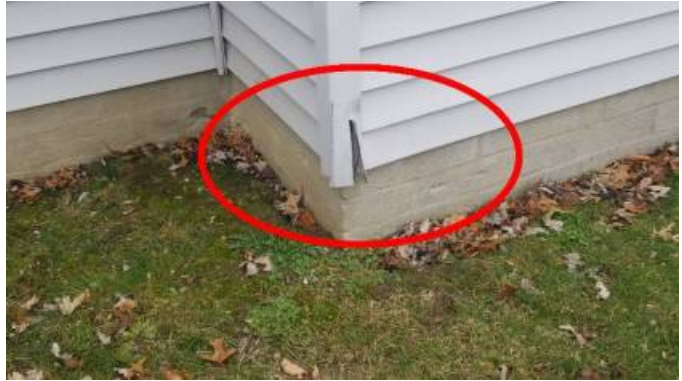
**Loose/damaged trim observed at various areas; suggest repair or replacement as needed.**

**Peeling paint observed at various areas; suggest scraping and painting as needed as part of normal maintenance.**

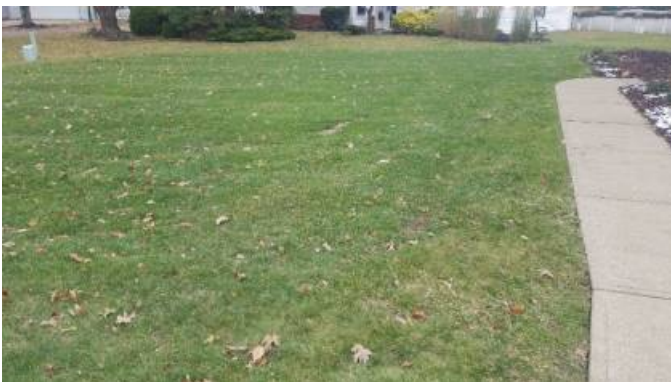
Flat lot. Grading and/or adding dirt backfill to any low lying areas located around the foundation is recommended to ensure proper drainage away from the foundation at all times. The ground immediately adjacent to the foundation should slope away from the house a minimum of 6" in the first 6'.

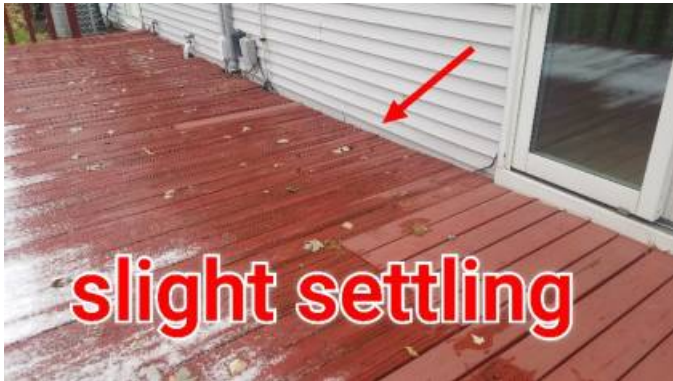
**Deck is weathered: suggest cleaning, staining or sealing as needed to preserve the remaining life of the deck.**

**Peeling paint observed at various areas, suggest scraping and painting as needed as part of normal maintenance.**

**Deck appears to be leaning slightly due to support posts settling over time. If concerned, recommend review by a qualified contractor for repair or correction as needed.**

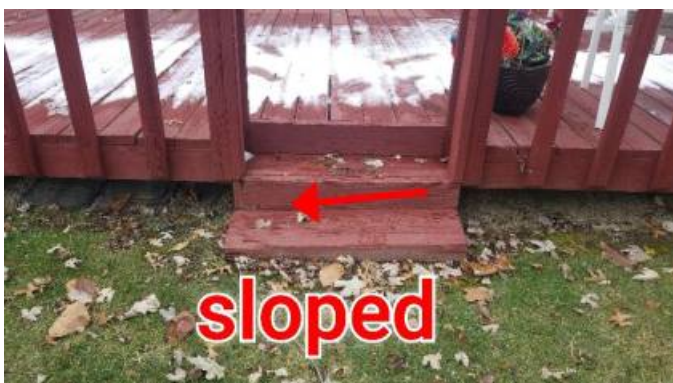
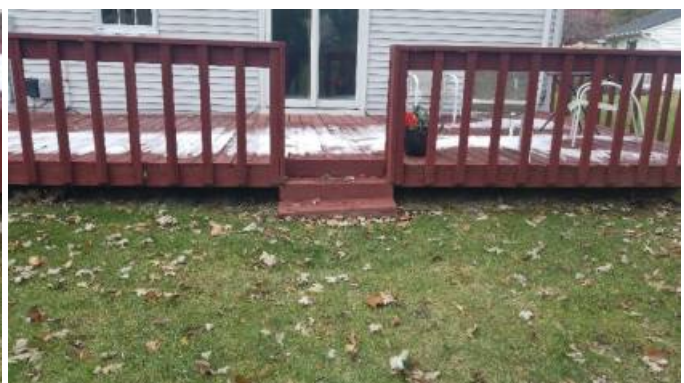
Stair or landing is sloped/uneven. Unable to determine cause. This condition is possibly related to localized minor settlement, which is common in homes built on a conventional foundation. No further signs of settlement were observed in general area. Corrections are needed to ensure safety.

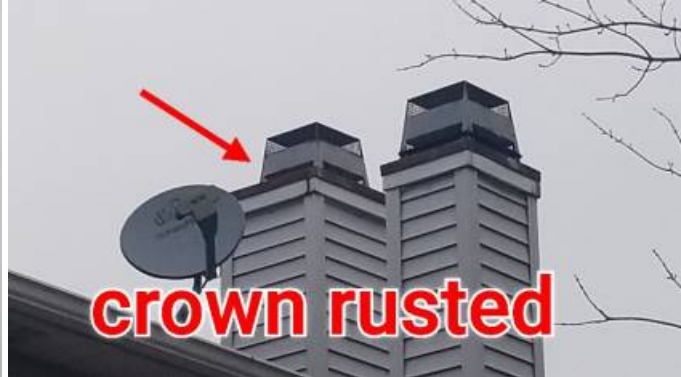
**Metal chimney crown is rusted. Chimney crown is the metal that seals the top of the chimney. This is a neglected maintenance item in most homes. Recommend repair or replacement as needed.**

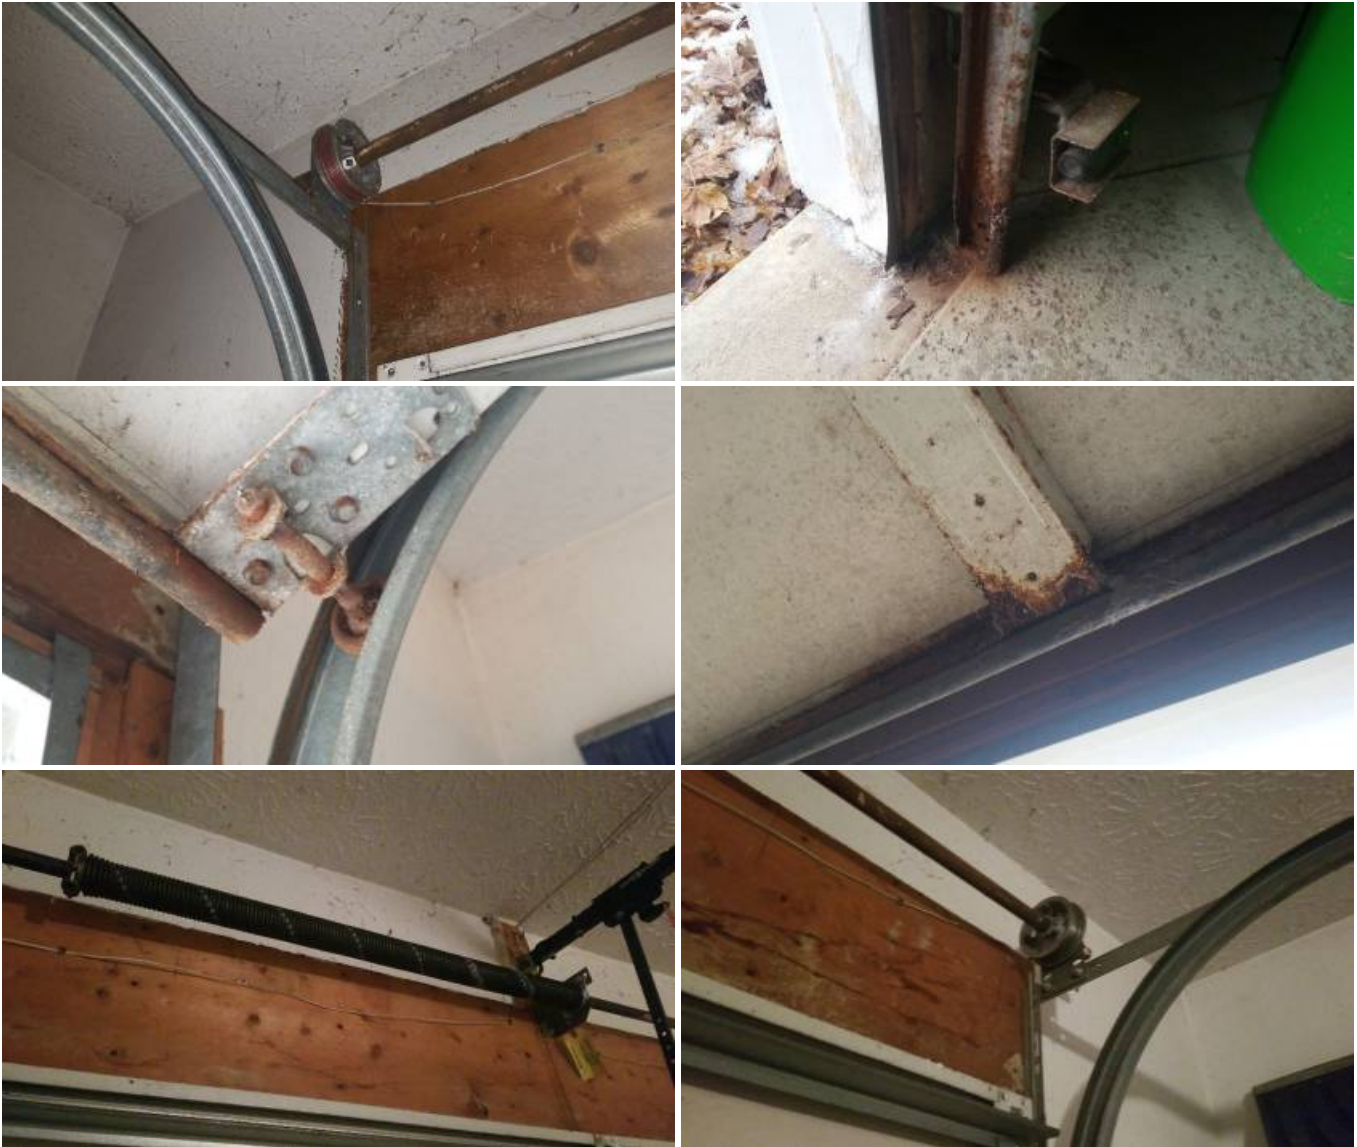
**Garage door brackets and track wheels are rusted, damaged, or appear to need adjustment. Due to safety concerns, client is advised to consult with a door specialist prior to closing to ensure working order and safety.**

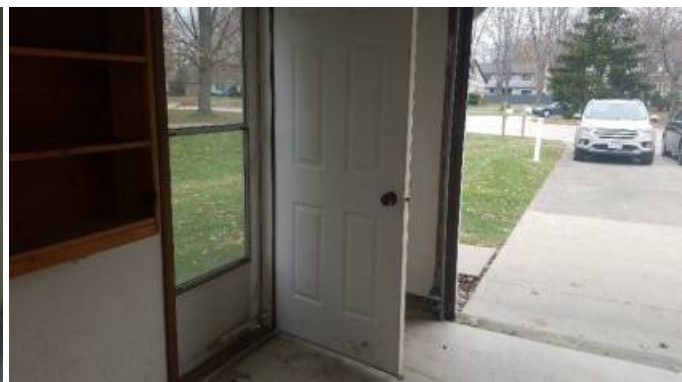
**Peeling paint observed at doors, suggest scraping and painting as needed as part of normal maintenance.**

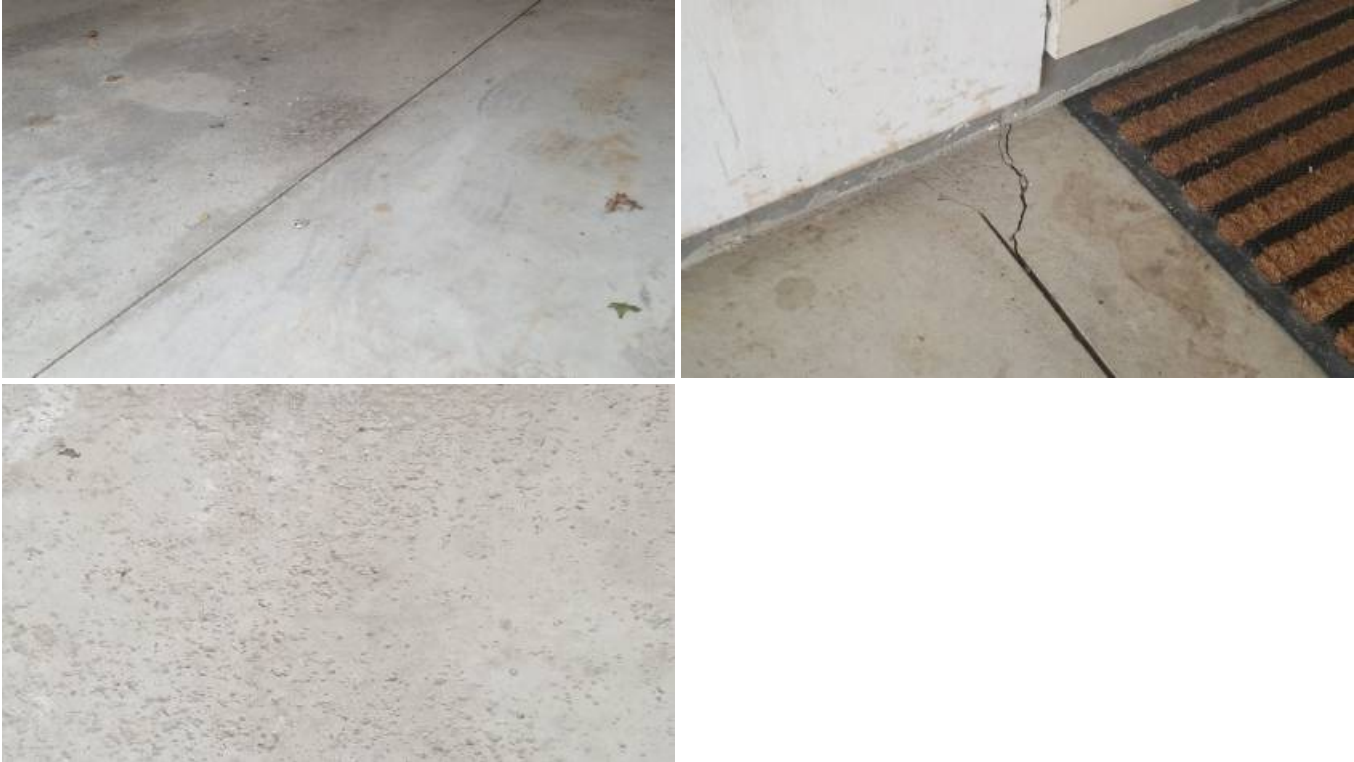
**Surface of concrete is deteriorated; this is mostly a cosmetic concern.**

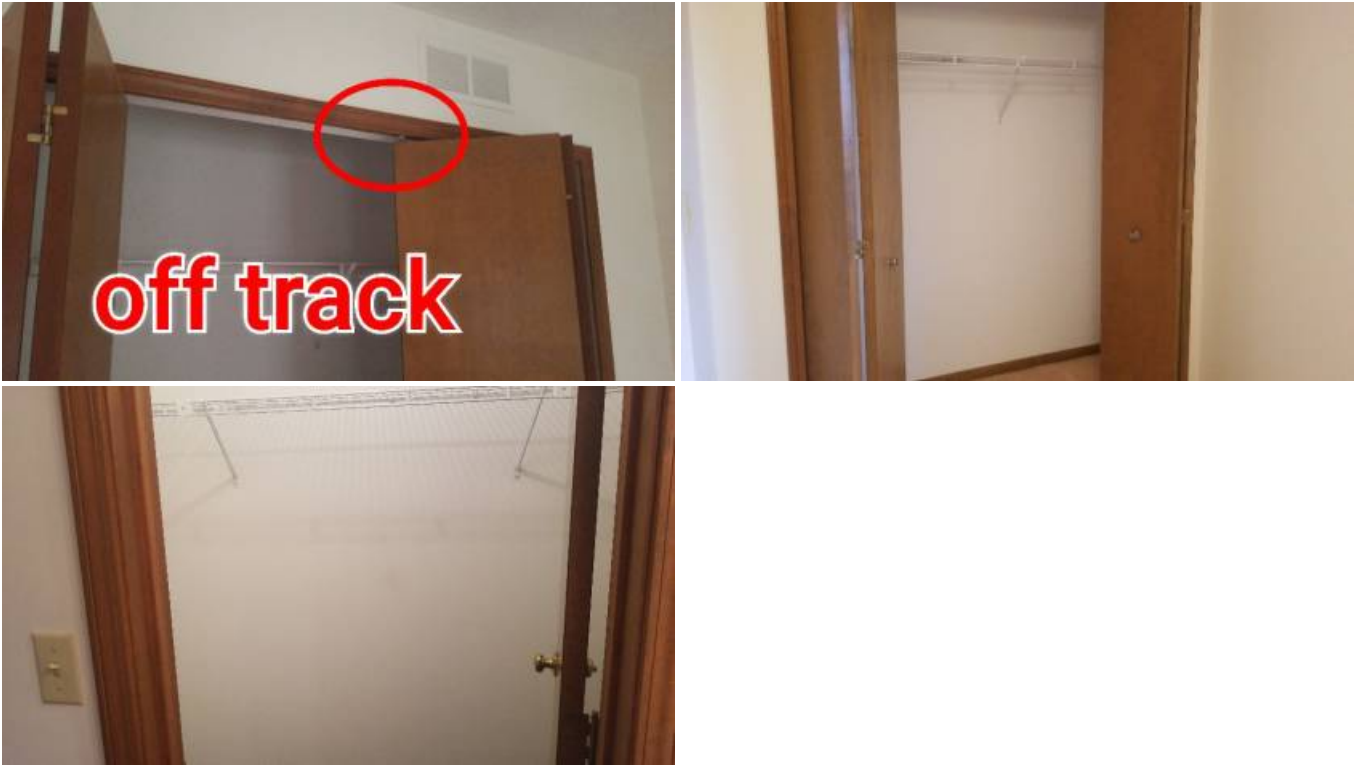
Door rubs jamb and will not close properly, adjustments are needed. This condition is possibly related to minor settlement, which is common in homes built on a conventional foundation. No further signs of settlement were observed in general area of door.

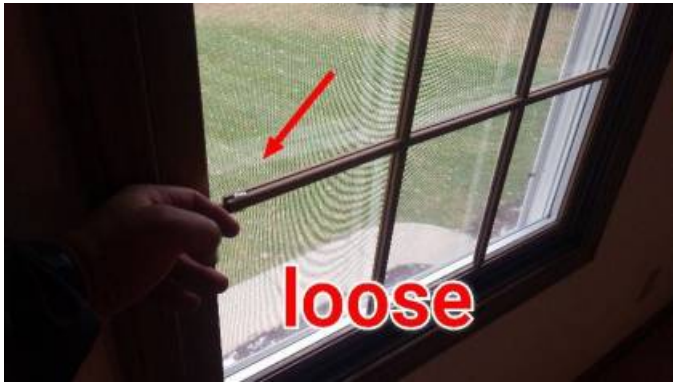
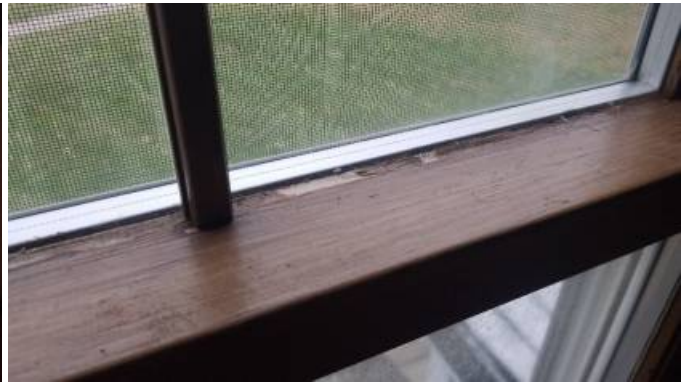
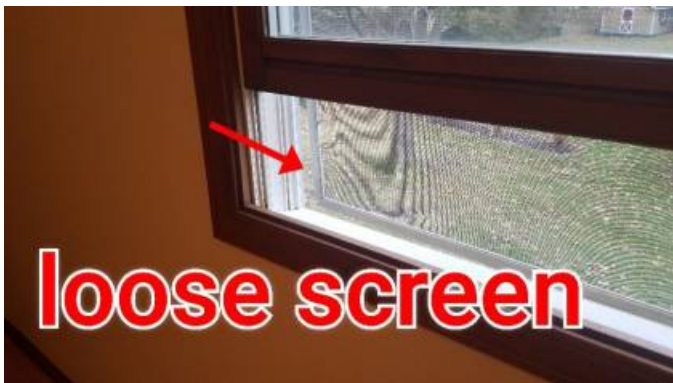
Damaged/missing screens observed at various locations, suggest corrections for proper use and operation of windows.

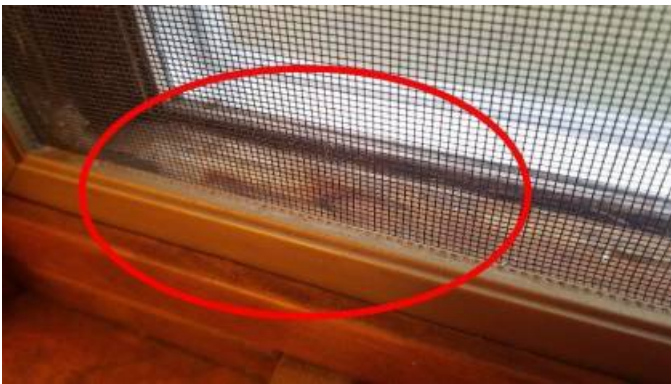
**Moisture damaged trim and/or sill observed. The extent of damage could not be determined without destructive analysis. Maintenance and/or repairs should be performed. Whenever there is water damage, there is the possibility of hidden mold growth and pest infestation.**

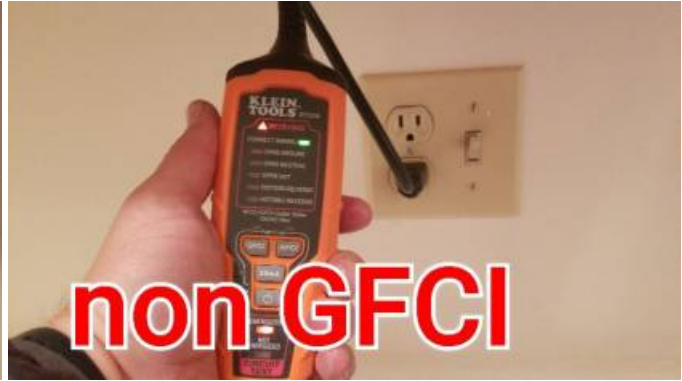
**Ground Fault Circuit Interrupters (GFCI) may not have been required when the home was built. GFCI's should be at all receptacles that service a counter in the kitchen, the bathrooms, the garage, the laundry room and exterior receptacles as an upgrade to safety. Upgrades should be performed by a qualified electrician.**

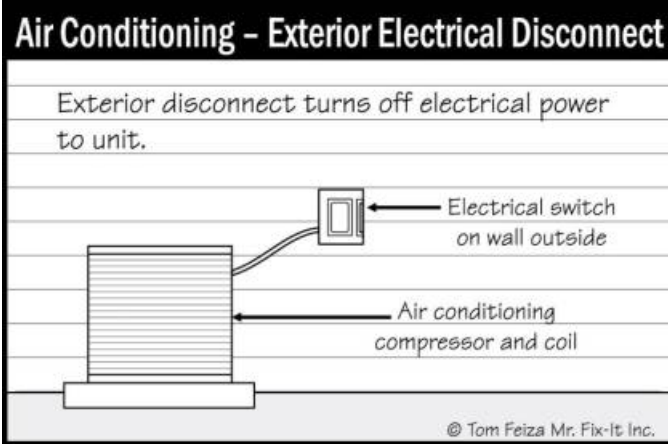
A004

**Inspector observed disconnect box was rusted, recommend review for replacement as needed by a qualified electrician.**

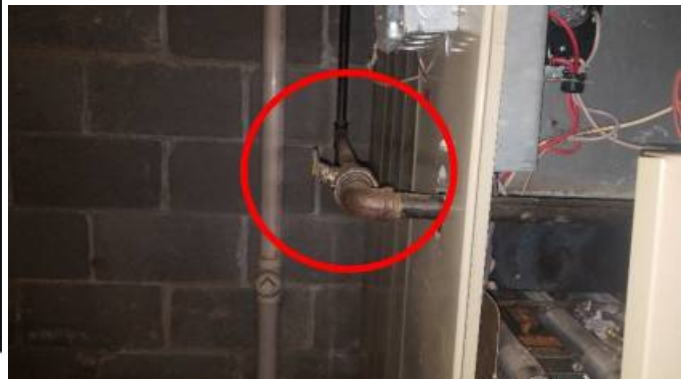
**Rust, scale, and some debris was observed in this appliance. Recommend review by a**

**qualified HVAC contractor ensure proper and safe operation of this unit prior to close. Dismantling to inspect for holes and/or cracks in heat exchanger is not within the scope of this inspection.**

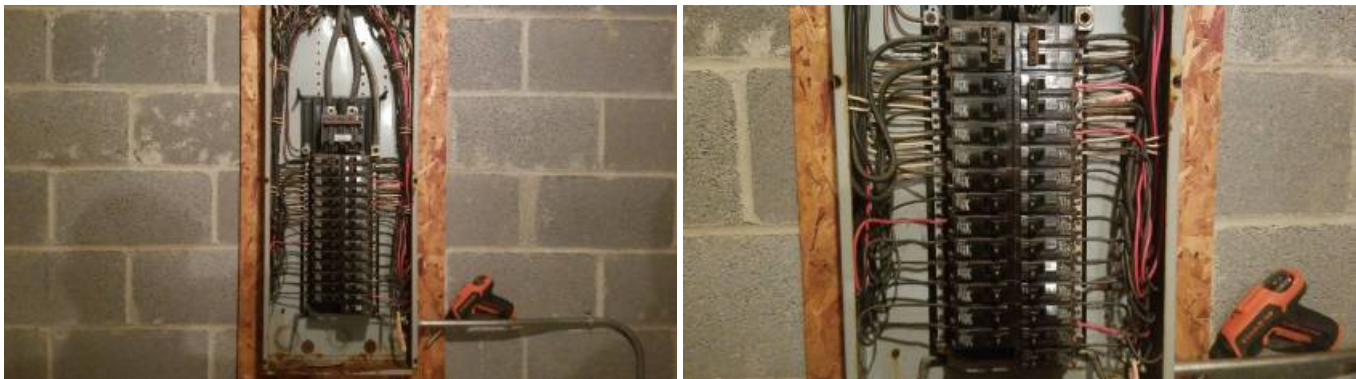
8. **Double tapping observed in panel at neutral bus bars. Double tapping (i.e. 2 wires under a single screw), can cause possible overheating of the wire and is a safety concern. Recommend review by a qualified electrician for repair as needed.**

**Excessive rust or water was observed in the panel, this is a possible safety hazard. Recommend review by a qualified electrician for repair or replacement as needed.**

**In the inspector's opinion, the electrical panel has exceeded its designed life expectancies and may be a safety concern due to all the corrosion and moisture in the panel. We make no warranty, guarantee or estimation as to the remaining useful life of this panel. Recommend replacing the electrical panel with a licensed electrical contractor.**

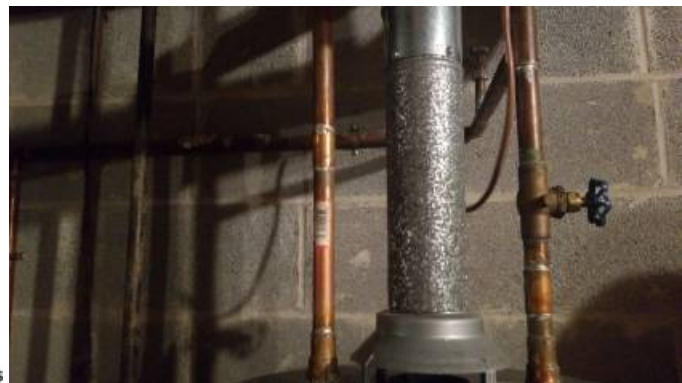
**Ground jumper cable not observed between hot and cold water lines, recommend qualified electrician install jumper cable to insure proper grounding and safety.**

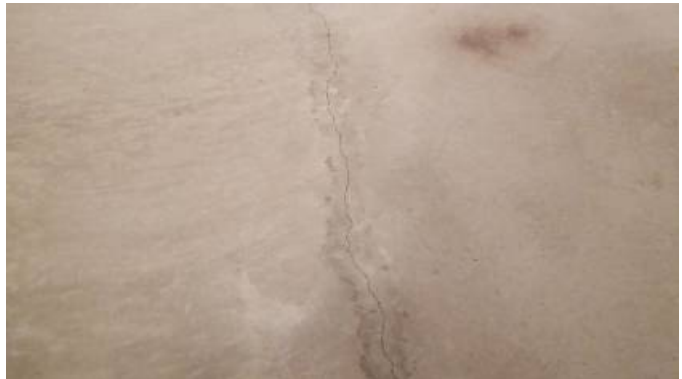
**Common cracks observed, primarily a cosmetic concern. Suggest sealing all joints as well as any cracks in surfaces to prevent water penetration as a routine maintenance effort.**
