**Confidential Inspection Report**  
**3542 W 44th St**  
**Cleveland OH 44109**

**August 27, 2021**

Prepared for:  
**John Doe**  
**3542 W 44th St**  
**Cleveland OH 44109**

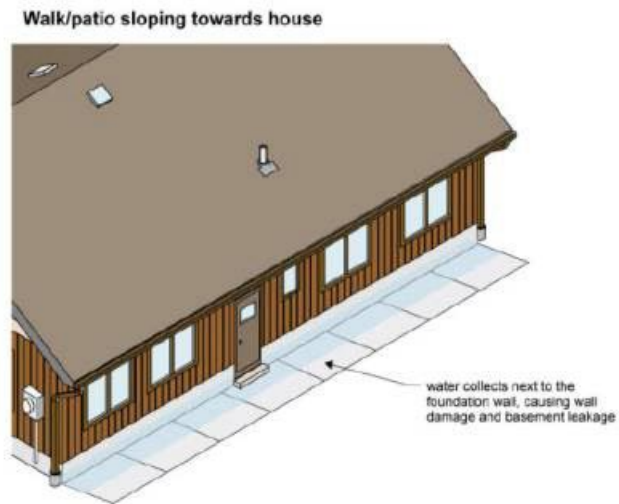
Evidence of ponding observed. Grade improvements, landscape alterations, or the installation of surface drains may be needed if water ponding is an ongoing concern. Ponding near foundation may result in basement/crawlspace seepage or foundation damage. This inspection does not include determining if the property is above the 100 year flood plain. For further information regarding elevation of the lot, check with your survey and appraiser.

Walkway shows an unusual amount of cracking. Due to conditions observed, driveway may require some level of maintenance, repair or replacement in the foreseeable future. You should plan or budget for additional expenses on this component.

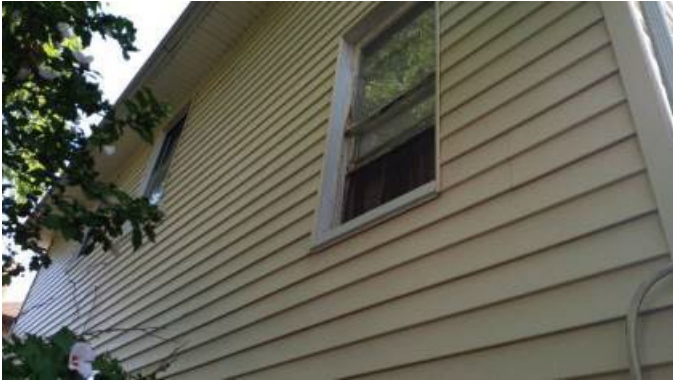
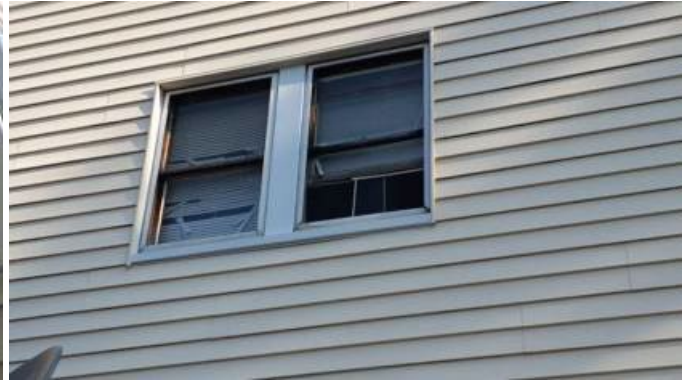
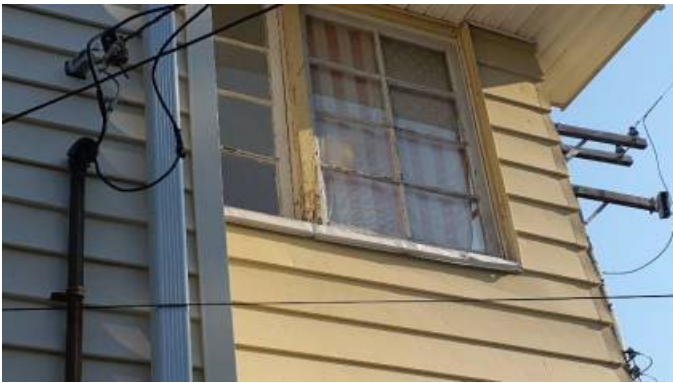
In the inspectors opinion many of the windows/frames are near the end of their useful life due to age and poor condition. Recommend review by a qualified professional for repair or replacement, as needed, prior to close.

Suggest windows and frames be kept caulked, sealed/painted to prevent moisture penetration. Failure to keep windows and frames sealed can cause deterioration and extensive moisture damage to the interior walls and surrounding sub-flooring. This damage is not always visible or accessible to the inspector at the time of inspection.

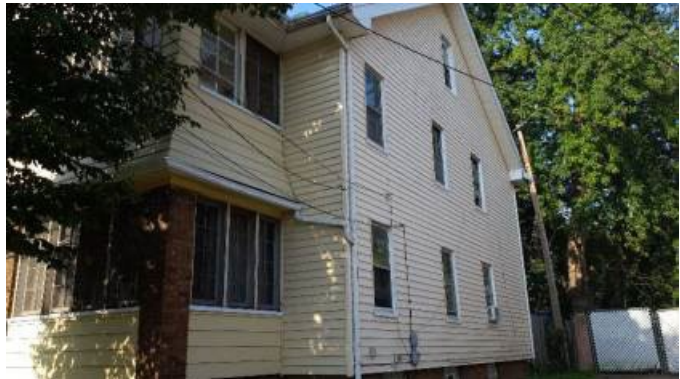
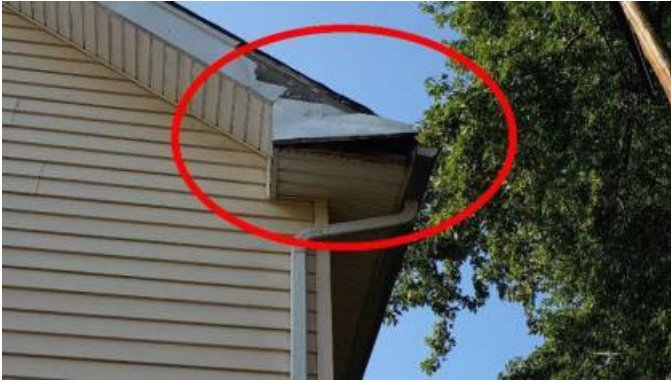
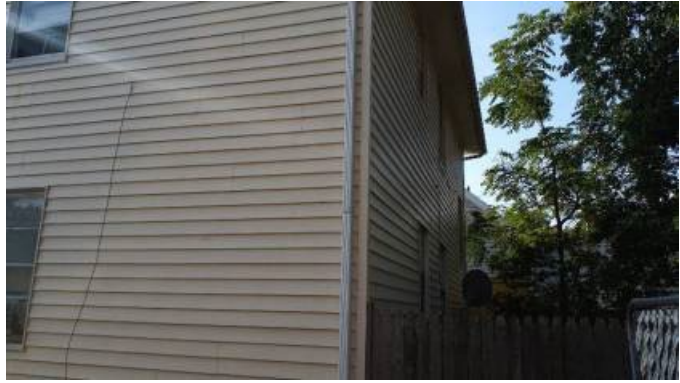
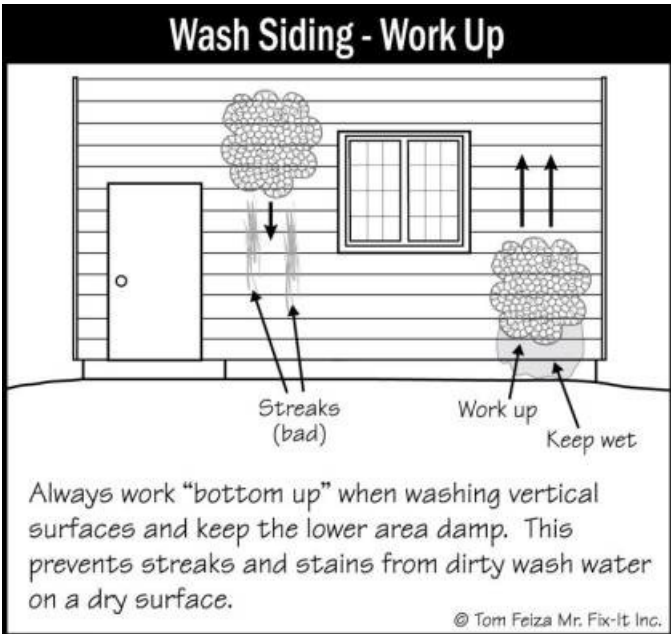
**Loose/missing siding observed at various areas. Recommend review for repair or replacement as needed.**

**Suggest keeping wood/vinyl/aluminum siding, sealed/painted to prevent moisture penetration. Failure to keep wood siding sealed can cause deterioration and extensive moisture damage to the sheathing and walls. This damage is not always visible or accessible to the inspector at the time of inspection.**

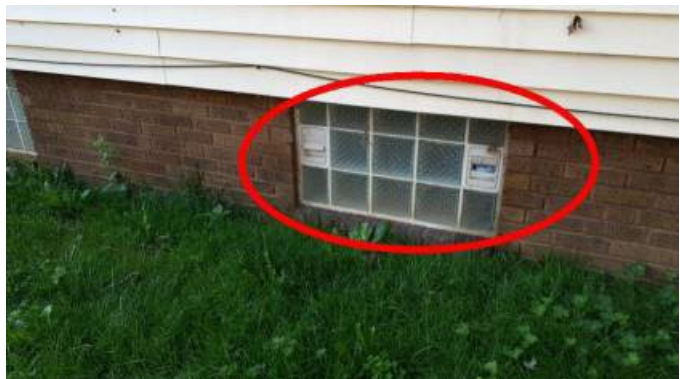
**Observed damaged vent. Recommend repairing or replacing vent cover to keep out birds and vermin.**

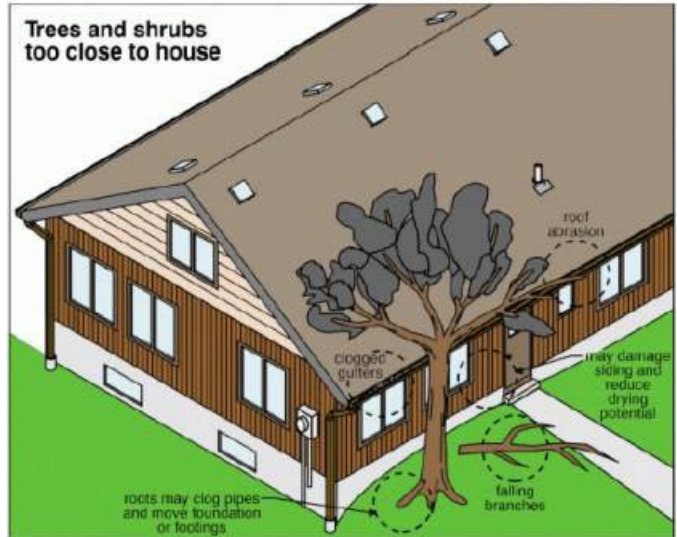
**Trees overhanging the structure need to be trimmed so that limbs, leaves, and rain will not drop off the tree onto the roof covering and clog the gutters, damage the roof, or promote moss growth. Trees that rub against the roof can cause severe damage and can drastically reduce the life of the roofing material. If concerned recommend contractor review for corrections as needed.**

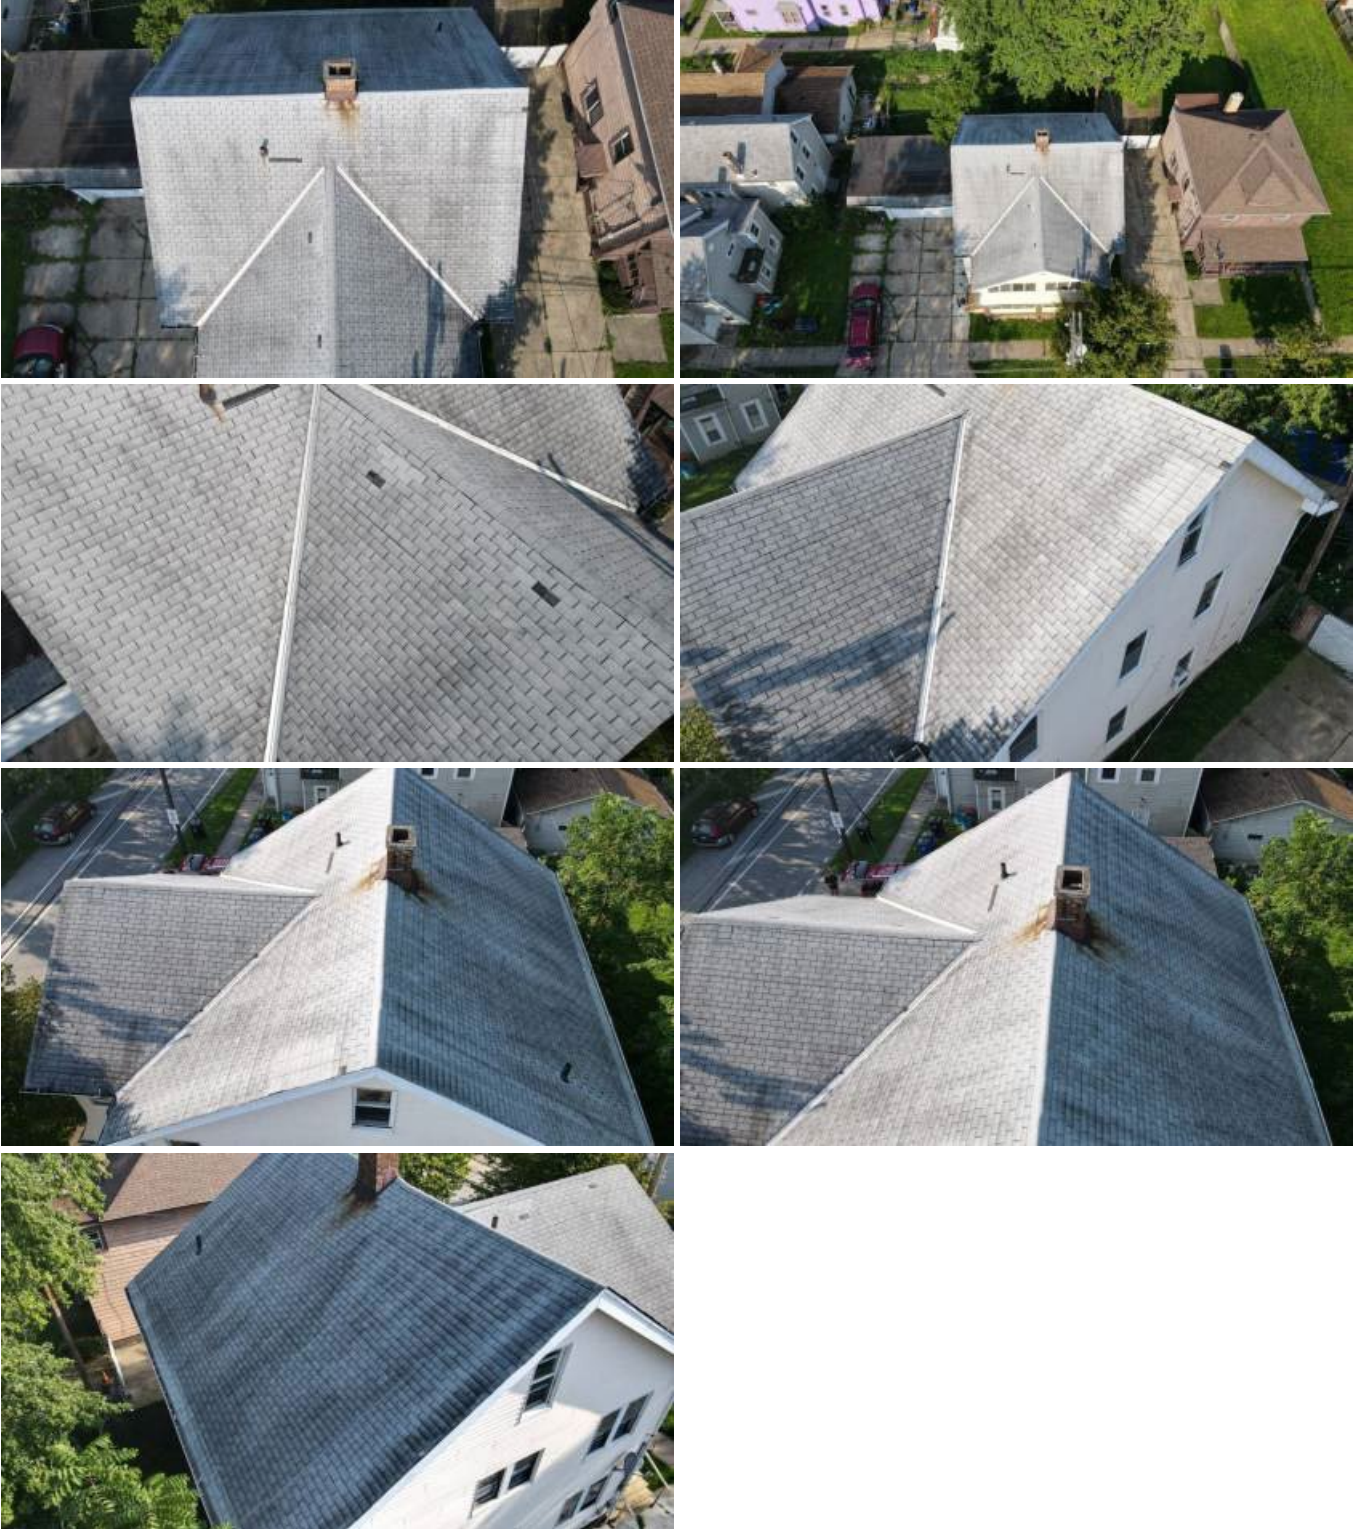
**Missing shingles observed. Recommend review by a qualified roofer for repair or replacement as needed prior to close.**

**Multiple layers of roofing observed on all or some parts of the roof. Typically two layers are considered the maximum in most jurisdictions.**

**Recommend a roof "tune-up" by a qualified roofing contractor to reseal any loose shingles, caulk around flashings and nail heads and review for any other issues.**

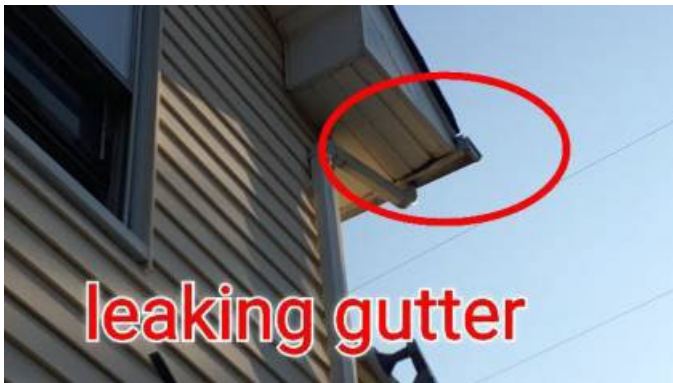
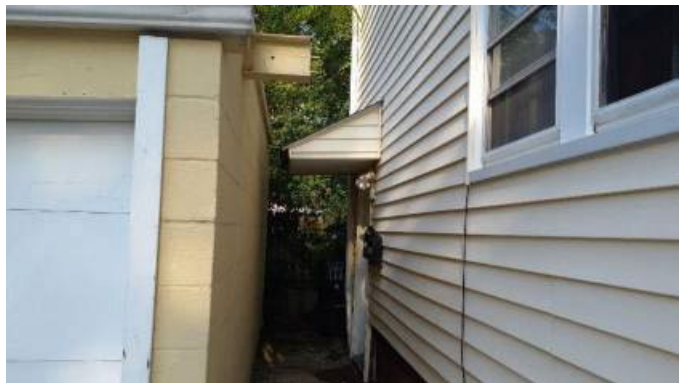
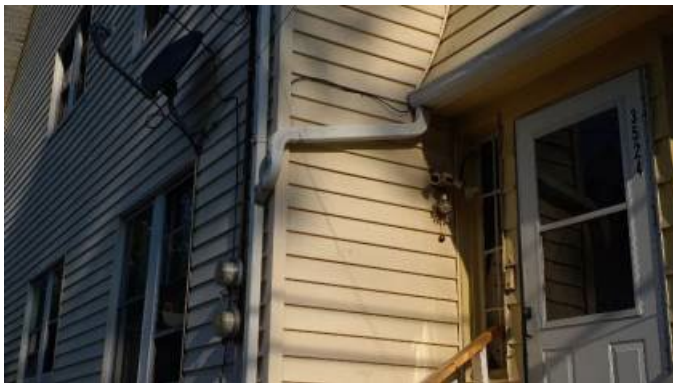
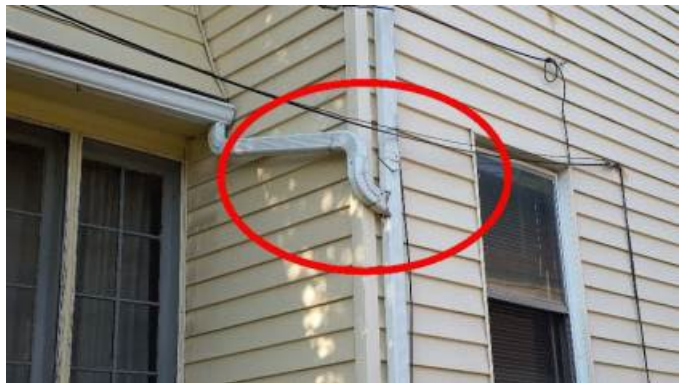
The flashings or seal around the flashing is deteriorated. Recommend review by qualified roofer for repair or replacement as needed.

Fasteners are loose at one or more areas; suggest securing as needed for proper operation. Loose nails in fascia board may indicate that fascia board is deteriorated. Unable to view behind gutter. Recommend review by qualified contractor for repair or replacement as needed.

No gutter system is present on all or part of the roof, suggest client consider installing a full gutter system to more effectively divert roof runoff.

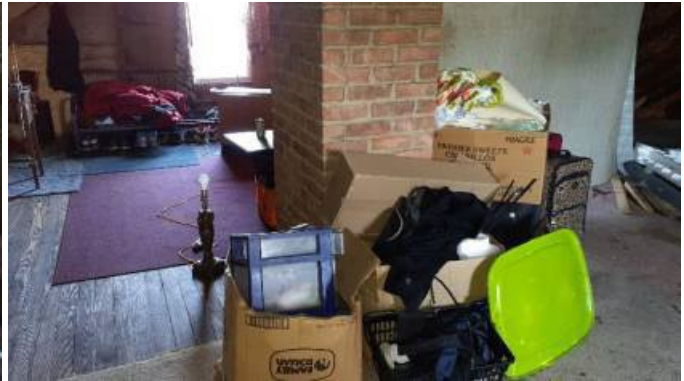
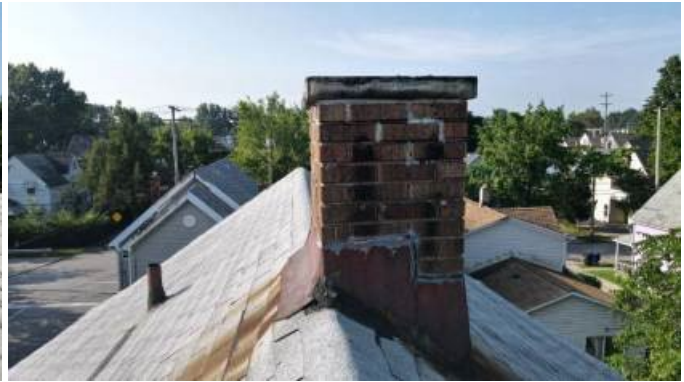
**Deteriorated mortar observed, suggest tuckpointing as needed to prevent further damage.**

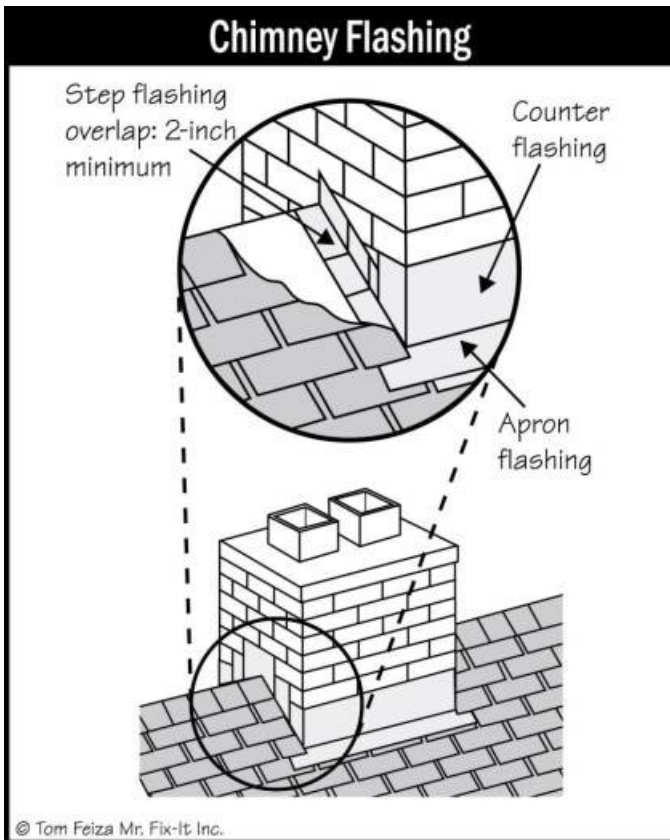
R028

Flashings are covered with roofing cement, which may indicate previous water penetration into the structure at this location. Suggest client consult with sellers for additional information or review by qualified roofer for repair as needed.

All nails used to secure flashing should be secured and sealed as part of a routine maintenance effort to prevent roof damage.

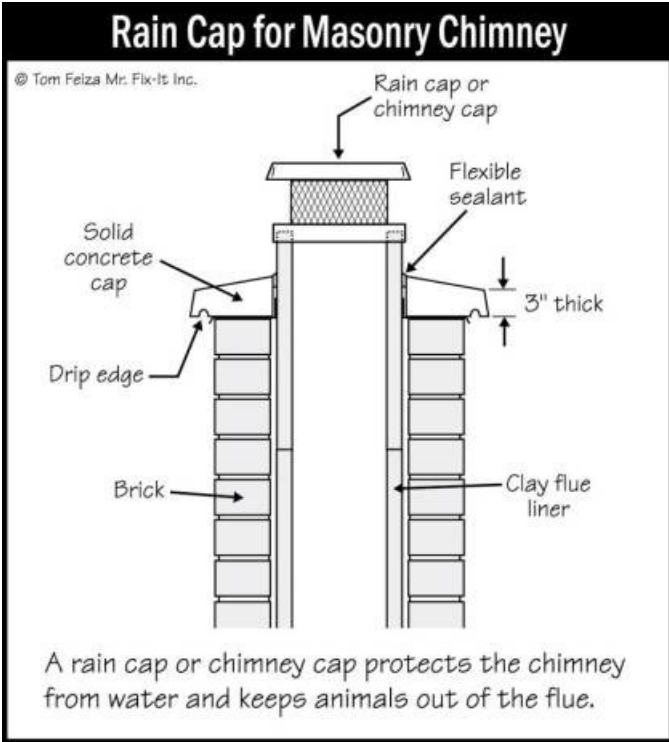
F030

No chimney rain cap observed, suggest installing a screened chimney raincap to prevent the entrance of the elements, local wildlife, and to preserve the life of the chimney as well as minimize maintenance.

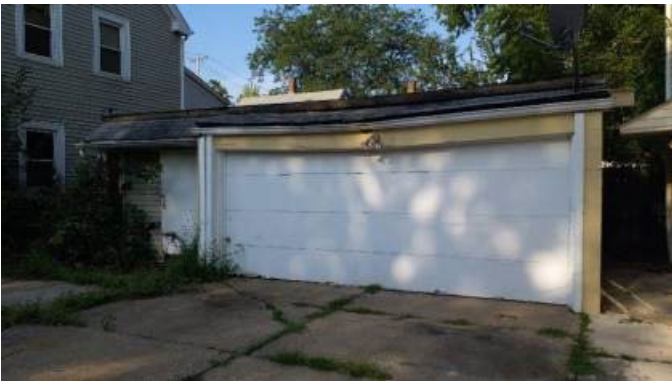
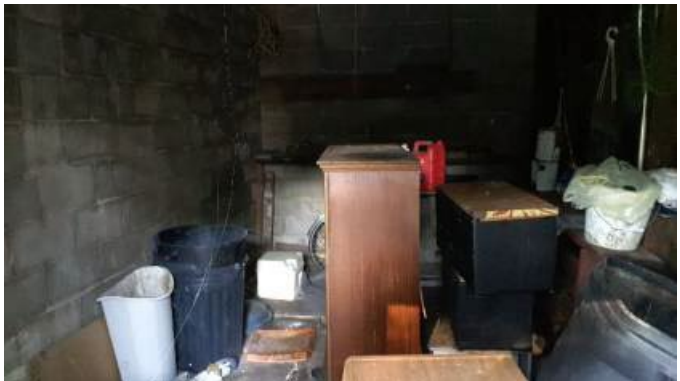
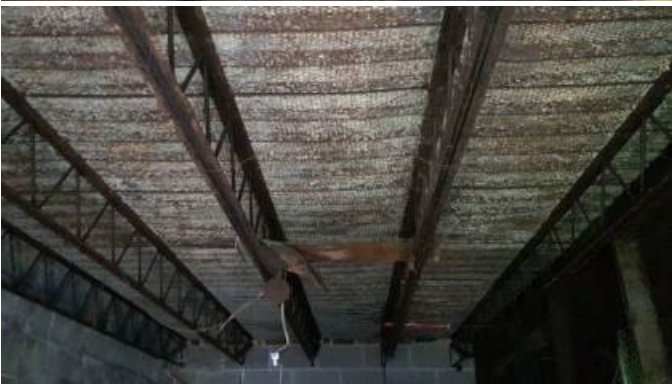
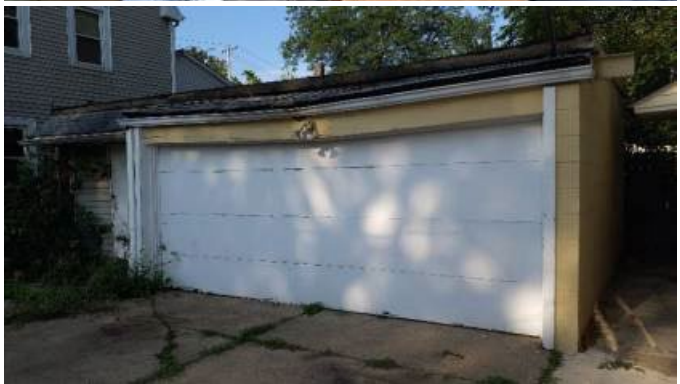
The garage exhibited severe general deterioration and appeared to be at or near the end of its long-term service life. The Inspector recommends that you consult with a qualified contractor to discuss options and costs for replacement or repair of garage.

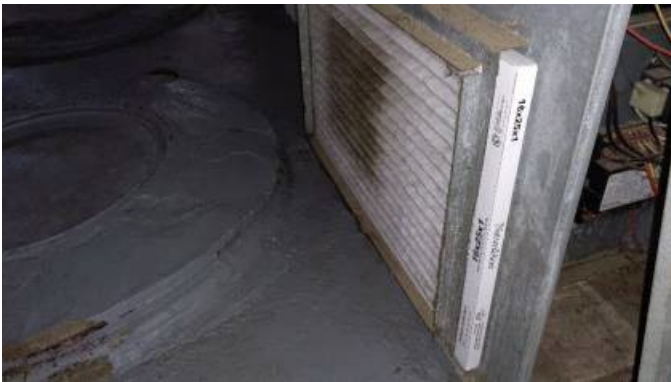
**The filter is dirty and should be replaced as it could restrict airflow across the heat exchanger.**

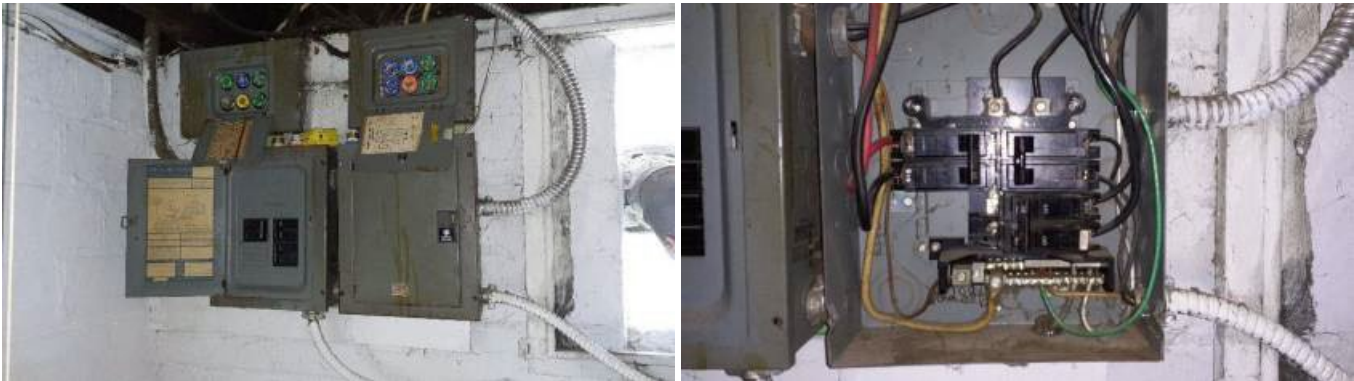
**The breakers are not marked as to the rooms, areas, or appliances controlled. It is recommended that they be noted for safety.**

**Rust and corrosion observed in the panel, which may be a possible safety hazard. Recommend review by a qualified electrician for repair or replacement as needed if concerned.**

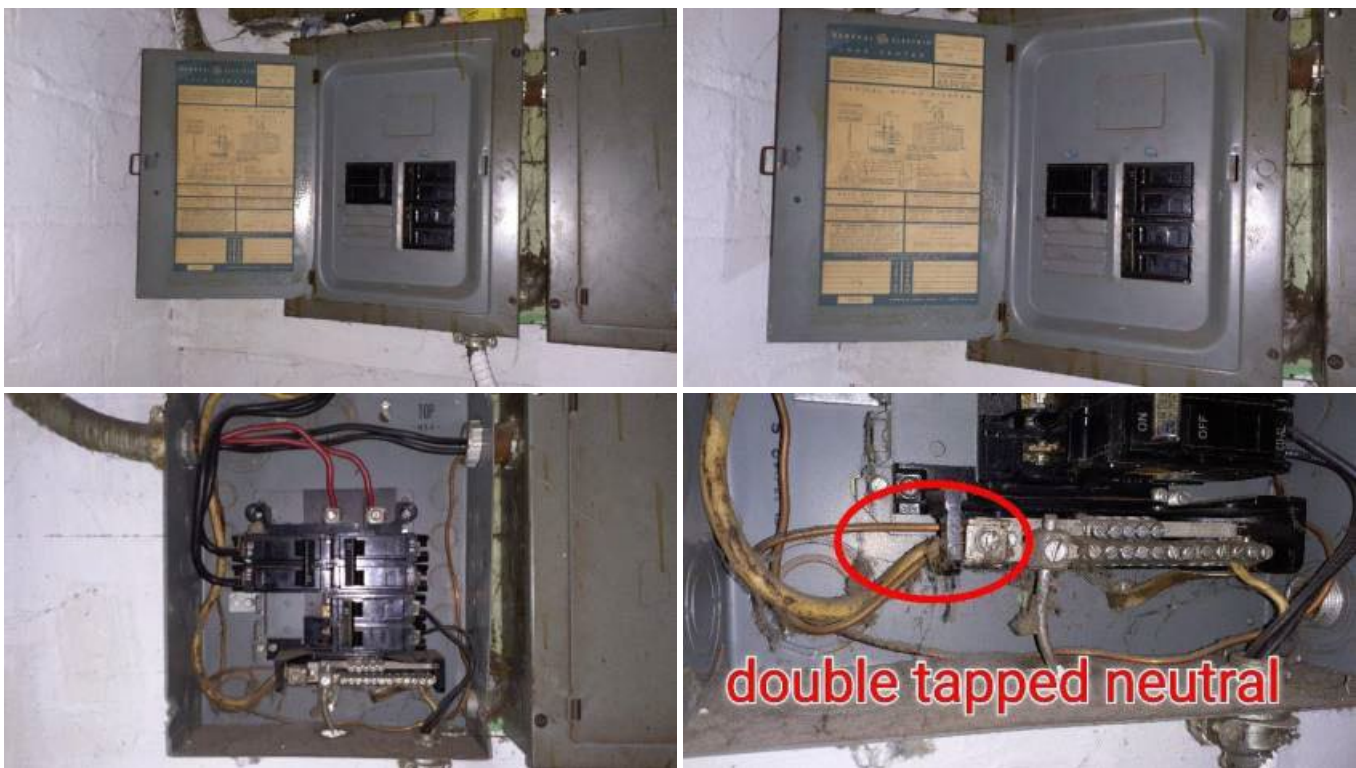
**The breakers are not marked as to the rooms, areas, or appliances controlled. It is recommended that they be noted for safety.**

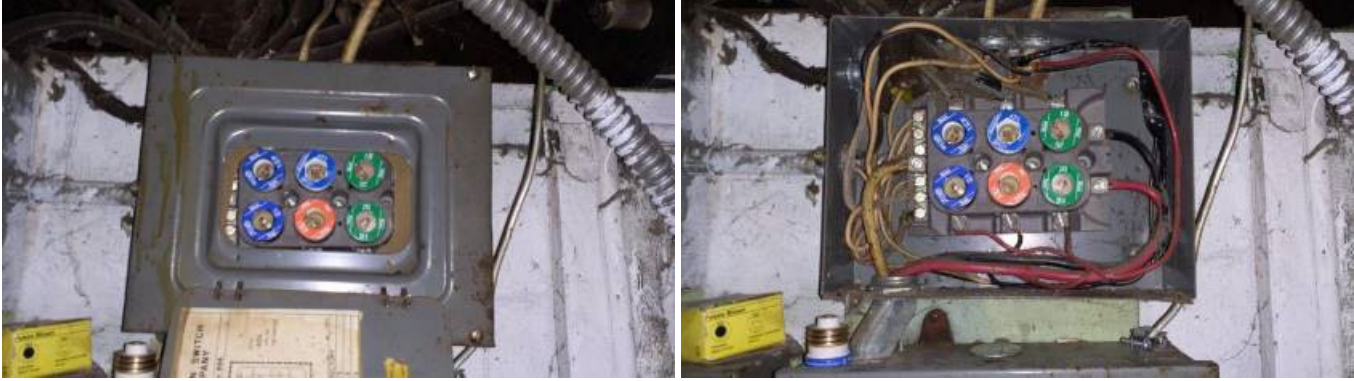
**The structure is equipped with a fuse type main power panel, usually a combination of pullout fuse blocks and screw type fuses. This was the standard for new construction until the 60's. Recommend review by a qualified electrician for safety enhancements as needed.**

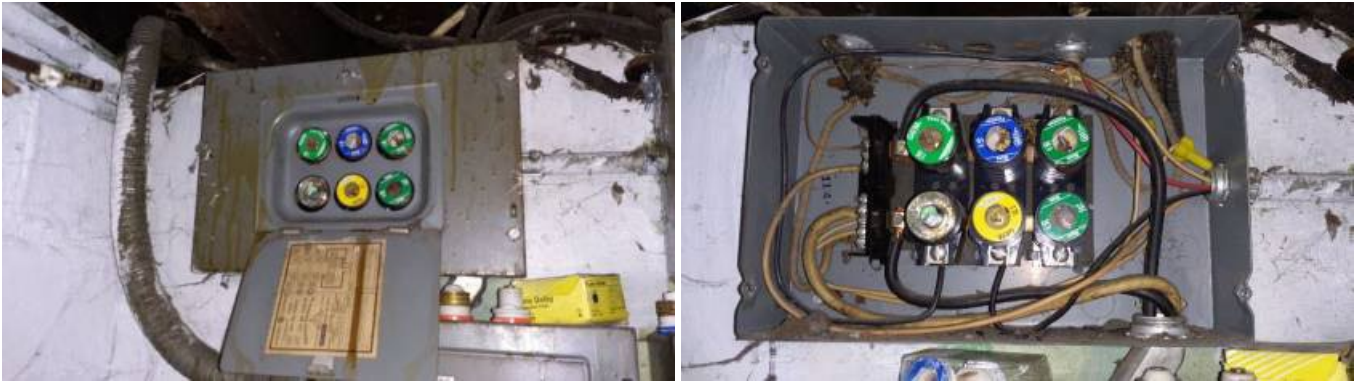
The structure is equipped with a fuse type main power panel, usually a combination of pullout fuse blocks and screw type fuses. This was the standard for new construction until the 60's. Recommend review by a qualified electrician for safety enhancements as needed.

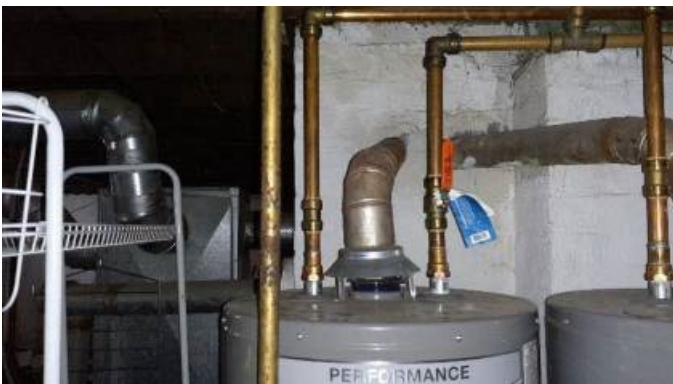
**Ground jumper cable not observed between hot and cold water lines, recommend installing jumper cable to insure proper grounding and safety.**

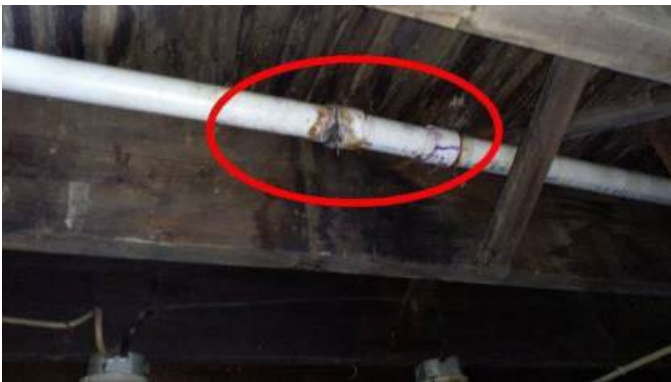
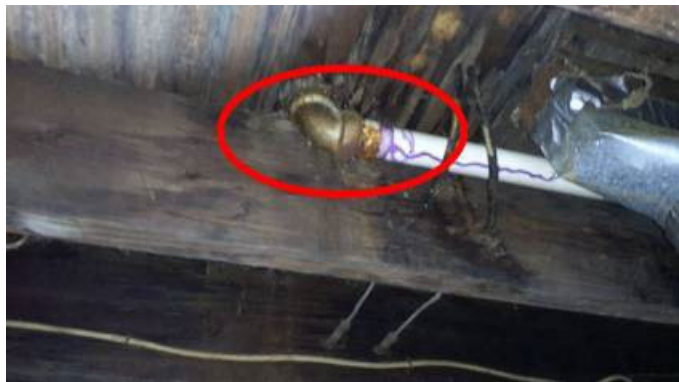
**White plastic (PVC) observed. Plastic supply piping is not normally accepted in hot water applications. We recommend review by a qualified plumber for evaluation and repair or replacement as needed.**

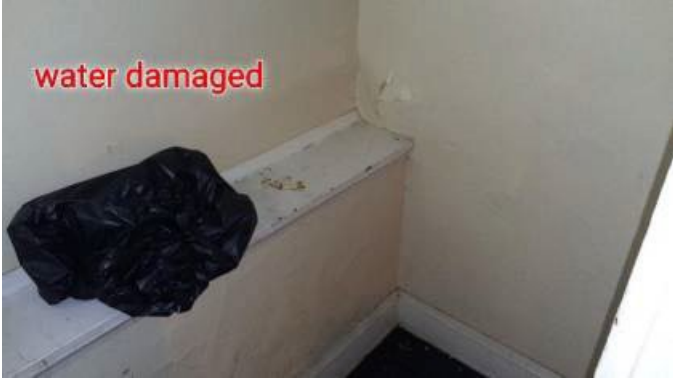
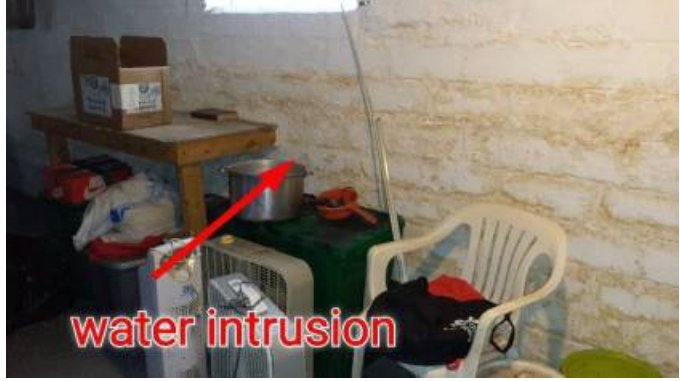
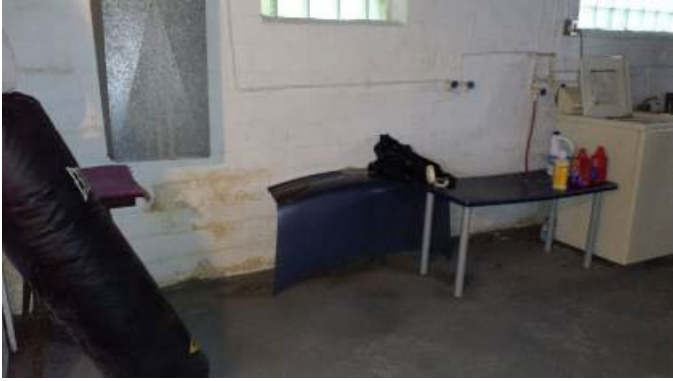
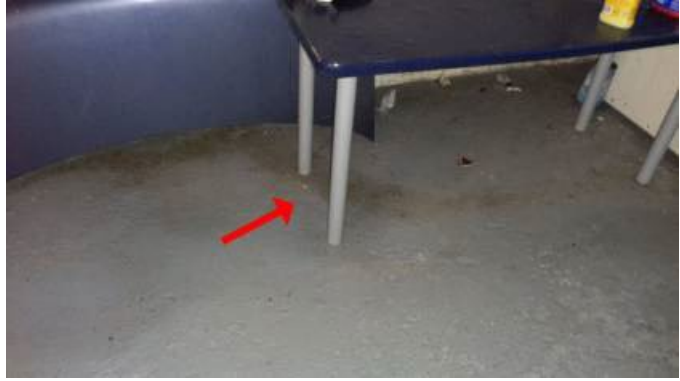
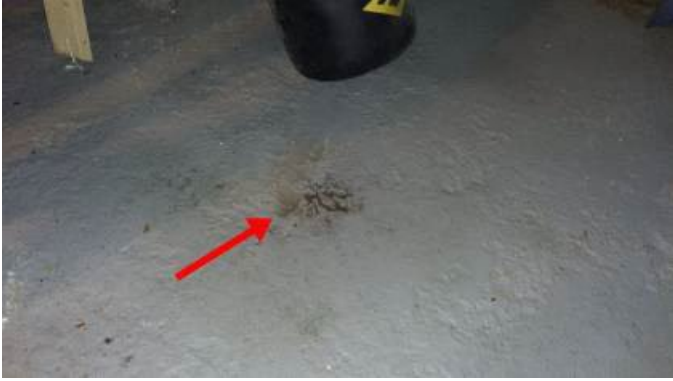
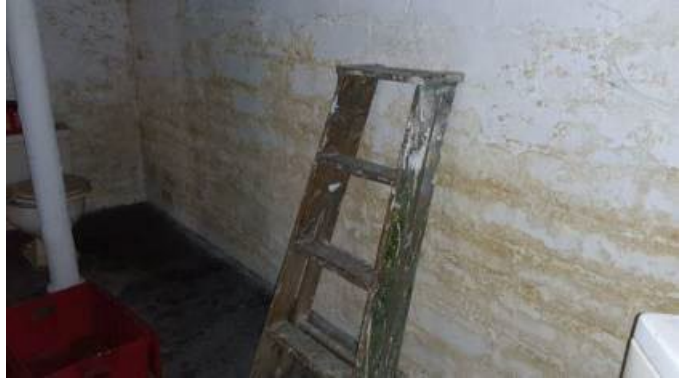
**Moisture intrusion was observed and can damage materials and encourage the growth of microbes such as mold. The source of moisture should be located and corrected to avoid future moisture intrusion. Recommend consulting a licensed contractor or basement waterproofing company for review and repair of the wall.**

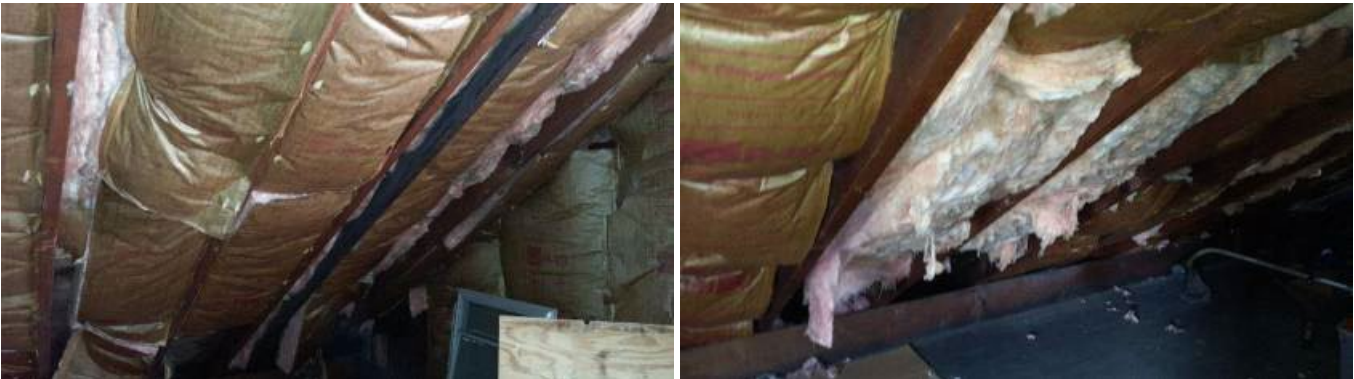
Insulation is falling down or become detached, recommend repair or replacement of insulation by qualified contractor prior to close.

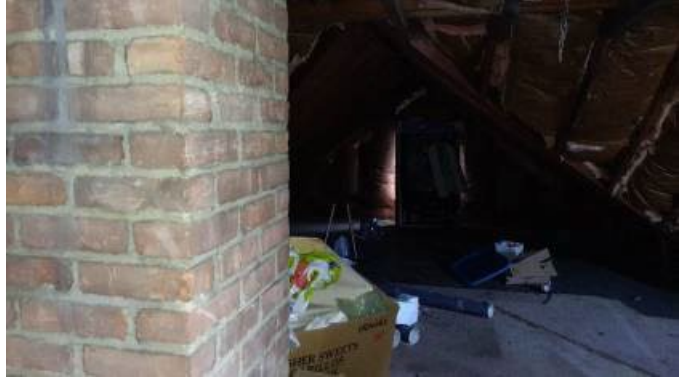
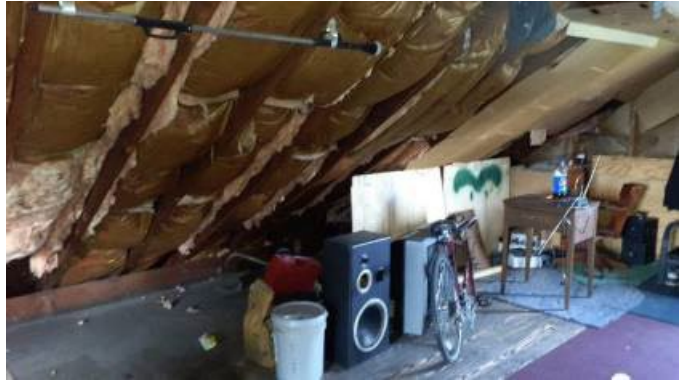
Finished areas observed in attic. Complete access to original attic walls, floors, and ceilings is limited due to the additional construction that is present such as framed-out walls, covered ceilings, and added floor coverings. Suggest consult sellers for additional information.
