Confidential Inspection Report

11939 Triskett Rd
Cleveland OH 44111

May 26, 2022

Inspection: 052622MV - 11939 Triskett Rd Address: 11939 Triskett Rd

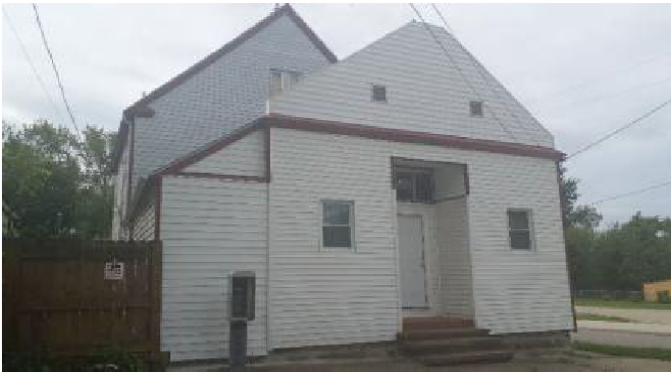
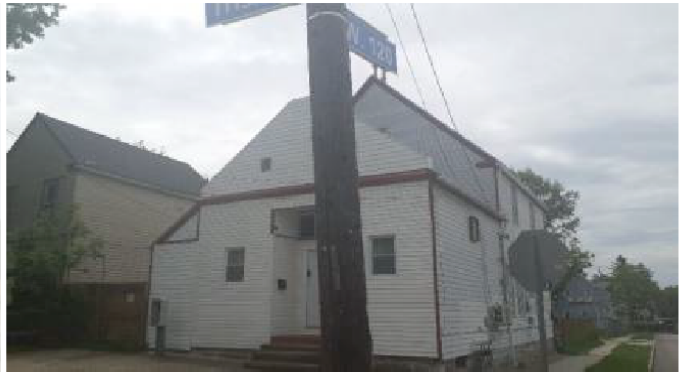
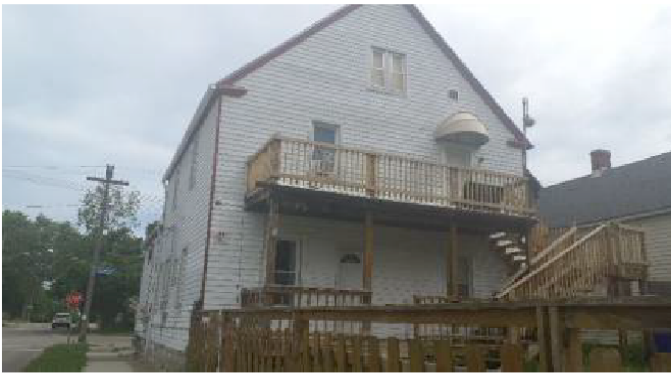
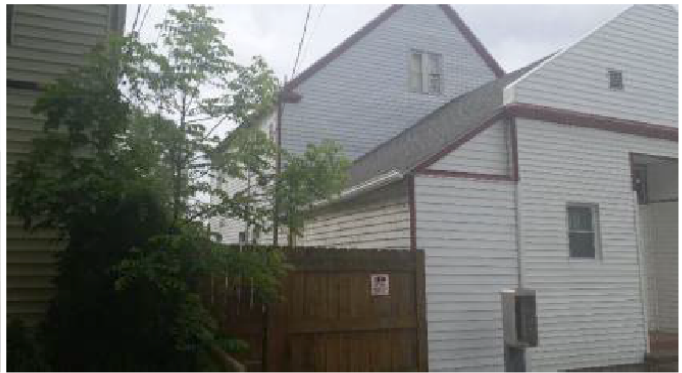
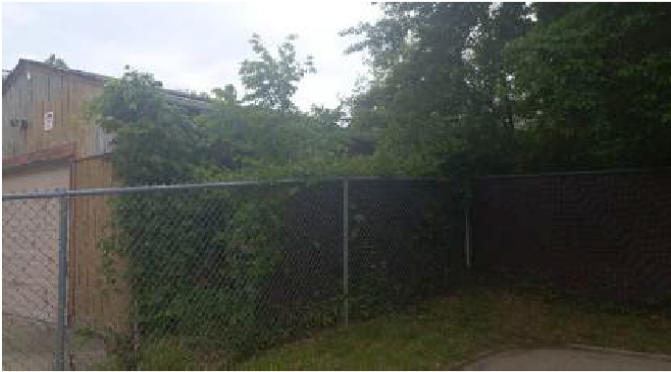
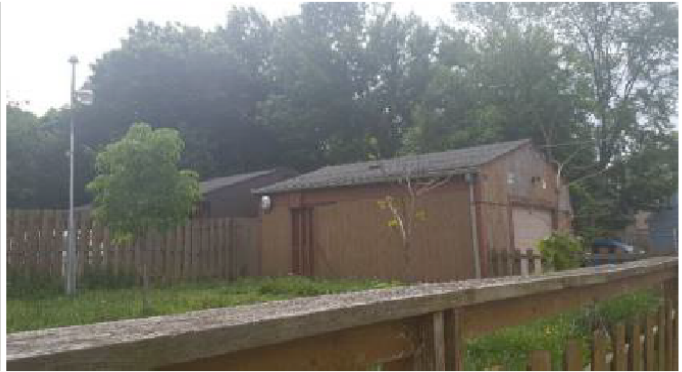
9.2 Siding Condition:

Siding materials consist of vinyl. The inspector is unable to view the condition of the house behind the siding. It is important to keep siding well caulked, sealed/painted to prevent moisture penetration.

The siding is in serviceable condition.

Suggest keeping wood/vinyl/aluminum siding, sealed/painted to prevent moisture penetration. Failure to keep wood siding sealed can cause deterioration and extensive moisture damage to the sheathing and walls. This damage is not always visible or accessible to the inspector at the time of inspection.
