Tri-County Inspections LLC
440-653-1947 (mobile/text)
mike@tri-countyinspections.com | https://tri-countyinspections.com/
Inspection reference: [REDACTED]
Mentor, OH 44060

Confidential Inspection Report

March 12, 2024

Inspection: 031224MV - [REDACTED] Address: [REDACTED]

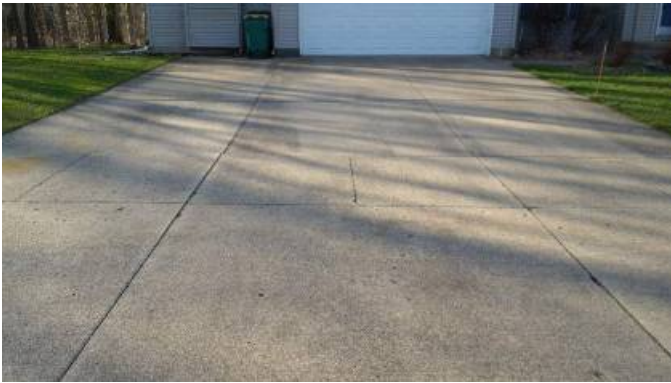
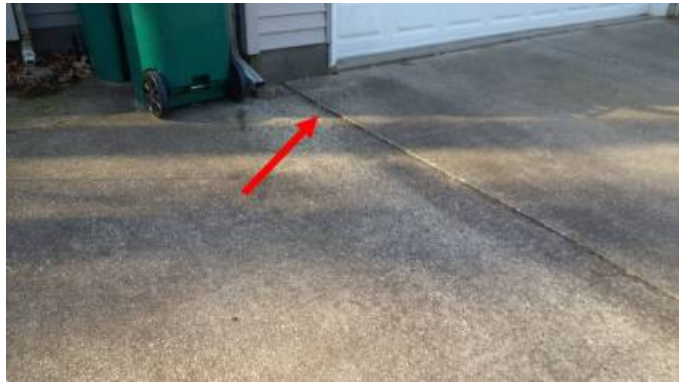
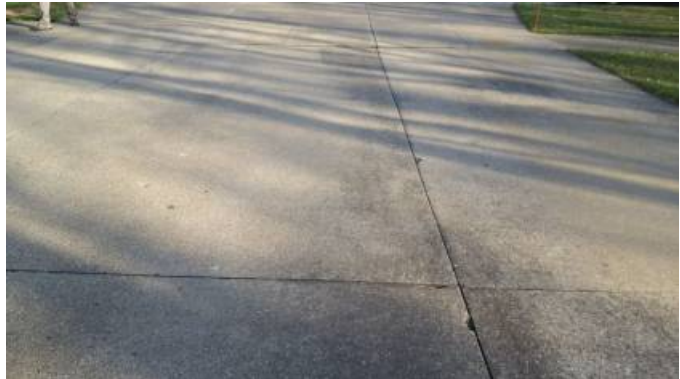
2.2 Driveway Condition:

Possible trip hazard noted at various locations. This is a safety concern. Suggest repair/replacement as needed to ensure safety.

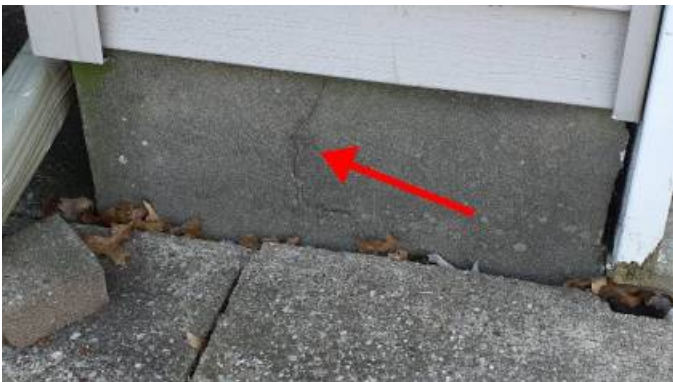
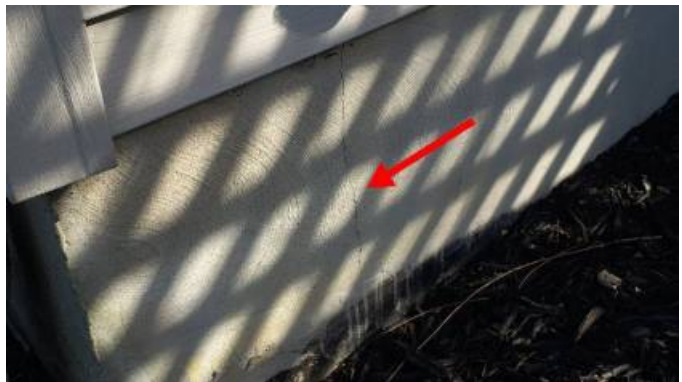
2.15 Location of Wall Cracks and Description:

Common cracks observed. Suggest sealing any cracks in concrete/brick/block surfaces to prevent water penetration as a routine maintenance effort.

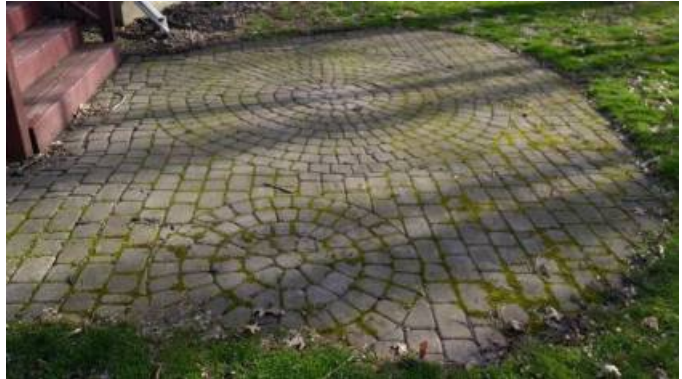
Recommend cleaning moss and/or algae from the patio block.

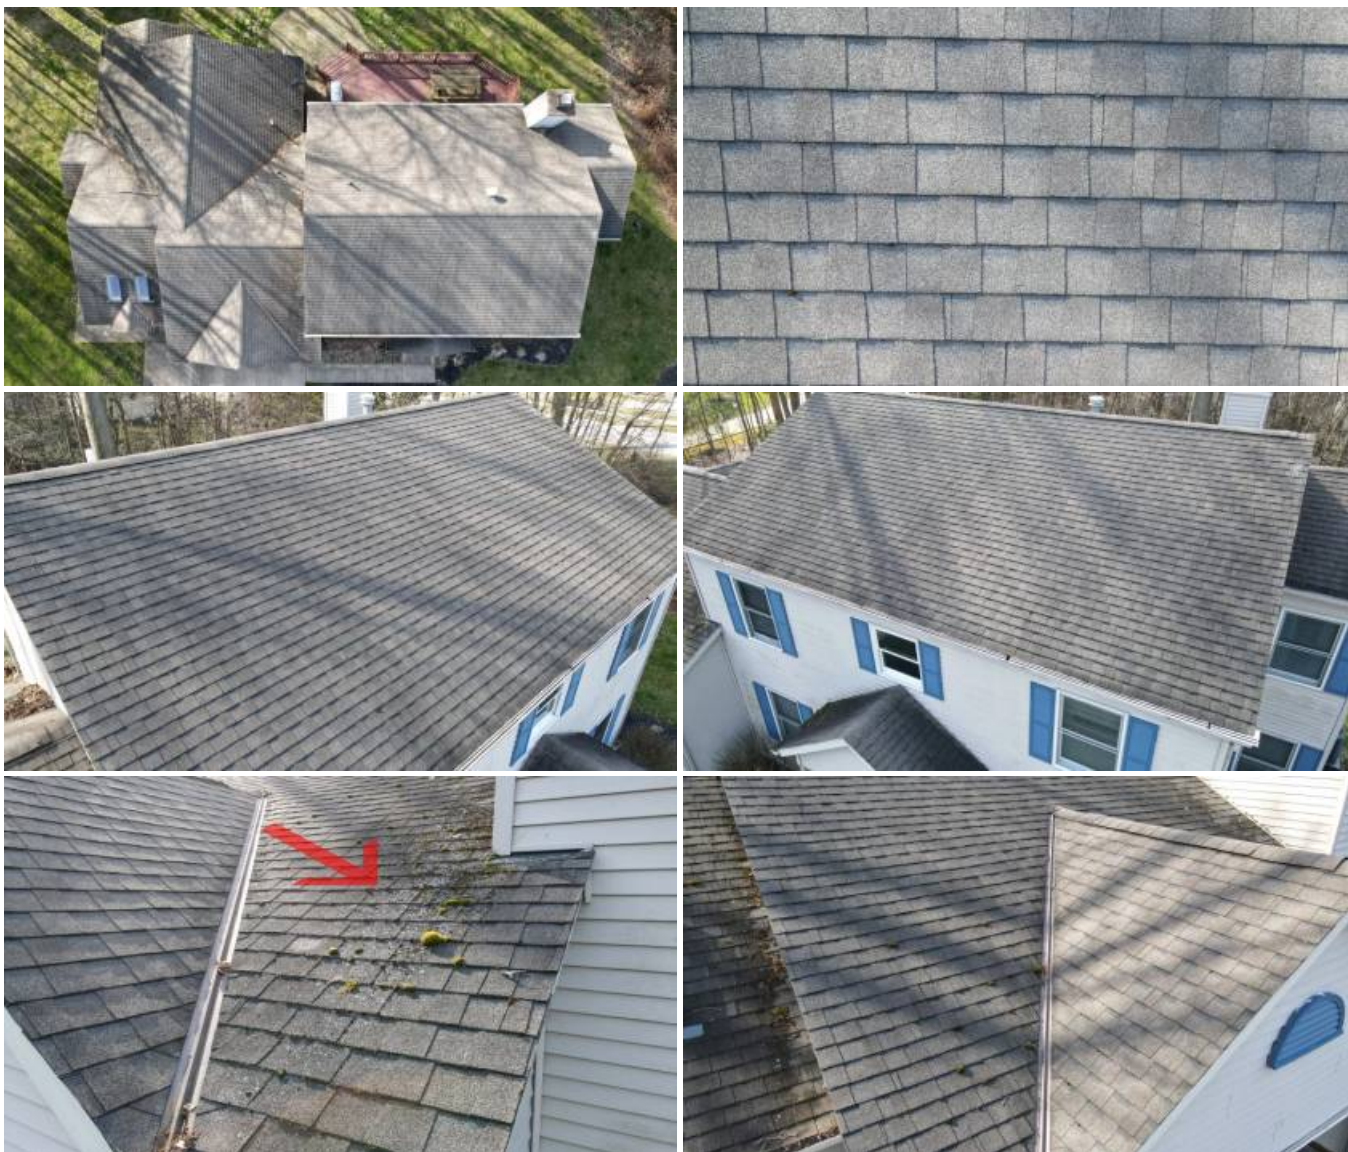
3.3 Condition of Roof Covering Material:

Recommend removing debris to allow for proper drainage and to prevent deterioration of roofing materials.

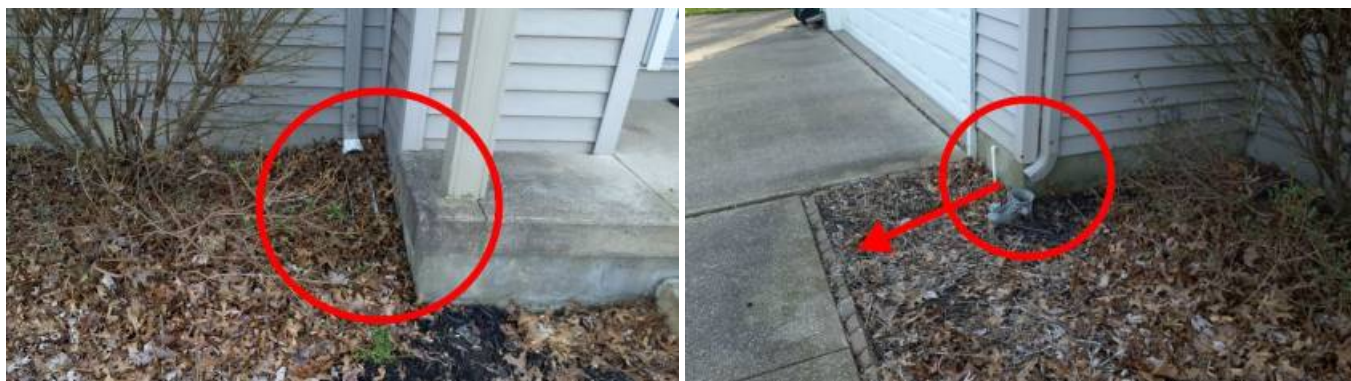
3.8 Roof Gutter System:

Downspout extensions need to extend six feet away from foundation to divert water away. The extensions should slope down at a rate of 1 inch per foot.

Gutter guards observed. Although gutter guards prevent leaf and debris from entering your gutter system, they are not 100% effective. **Recommend checking gutters annually to make sure they are not blocked or dirty.**

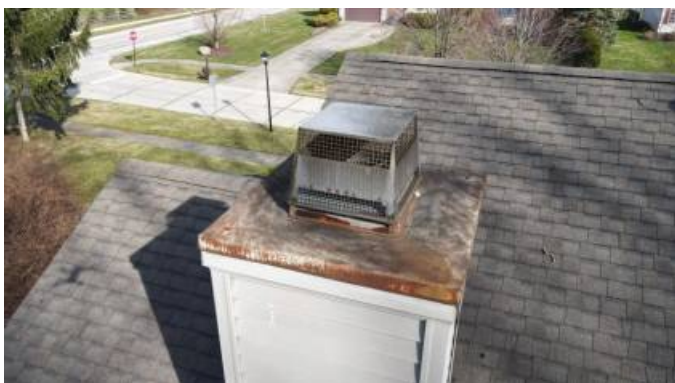
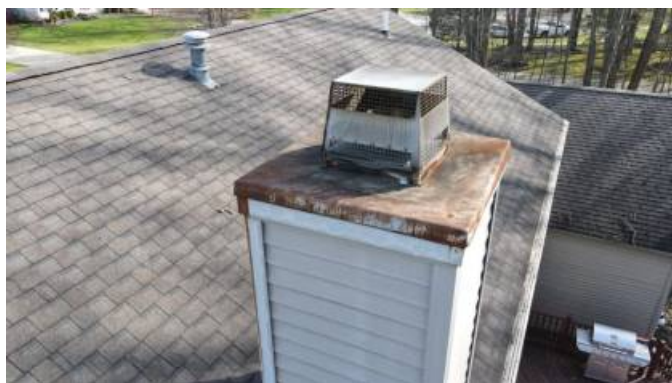
Metal chimney crown is rusted. Chimney crown is the metal that seals the top of the chimney. This is a neglected maintenance item in most homes. Recommend repair or replacement as needed.

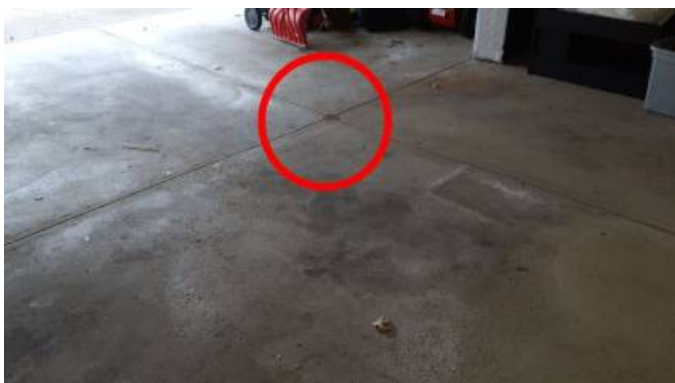
This is a limited inspection due to the amount of personal property observed. Many areas were covered and the inspector was unable to view. Recommend contacting seller or review the Disclosure Statement regarding the condition of the covered areas.

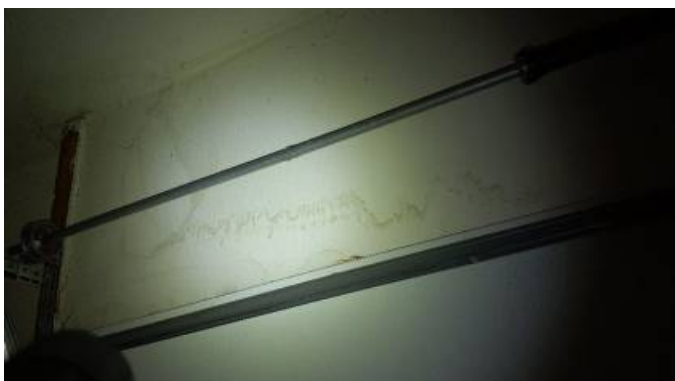
5.15 Walls Condition:

Stains observed. The inspector probed stains with a moisture detector, which showed normal moisture present at time of inspection. Client is advised to consult seller to determine the source of staining and verify that corrections have been made.

This is a limited inspection due to the amount of personal property observed. Many areas were covered and the inspector was unable to view. Recommend contacting seller or review the Disclosure Statement regarding the condition of the covered areas.

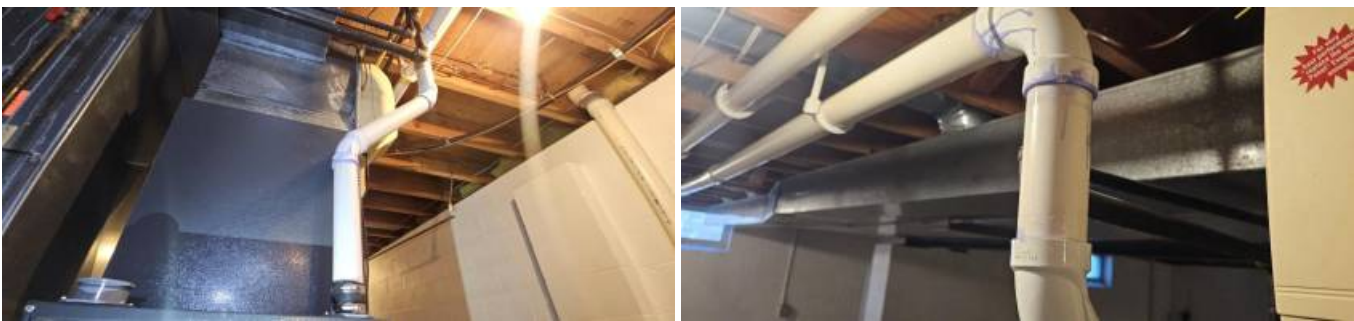
12.7 Condensate Line:

Active leaks observed on condensate line. Recommend review and repair by a qualified plumber.

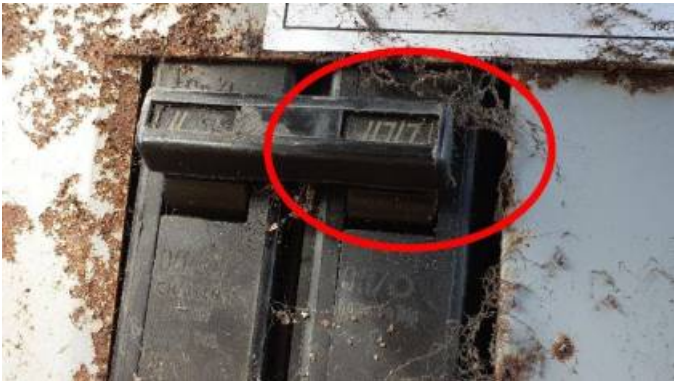
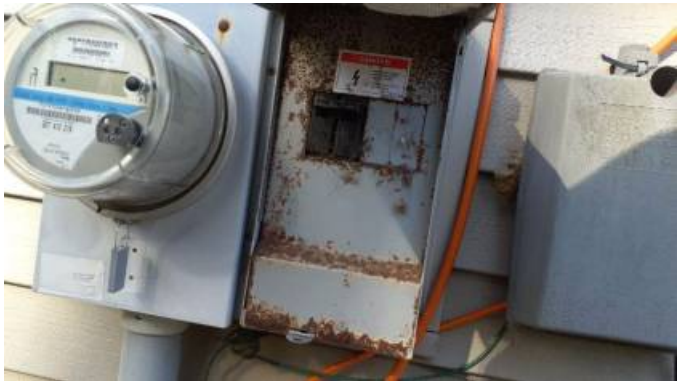
Inspector observed disconnected box was rusted; recommend review for repair or replacement as needed by a qualified electrician.

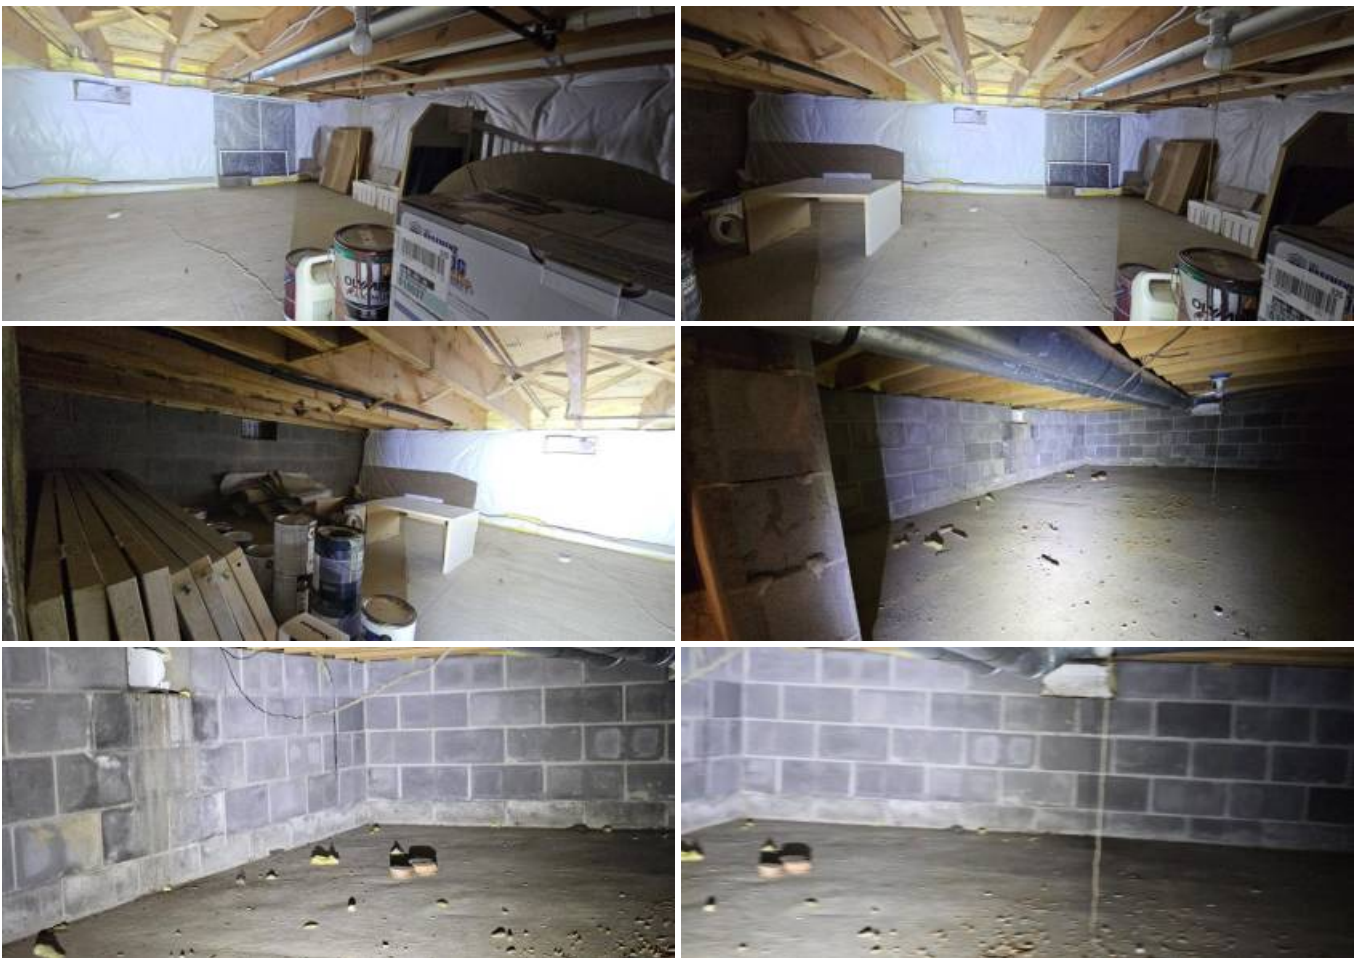
Efflorescence was visible at some of the interior surfaces of the foundation walls. Efflorescence is a white, powdery residue left by moisture seeping through the foundation wall and its presence indicates high moisture levels in soil near the foundation. This may only be cosmetic in nature. However, excessively high moisture levels in soil supporting the foundation can cause various structural problems related to soil movement. The source of moisture should be identified and the condition corrected. Recommend review by qualified contractor as needed.

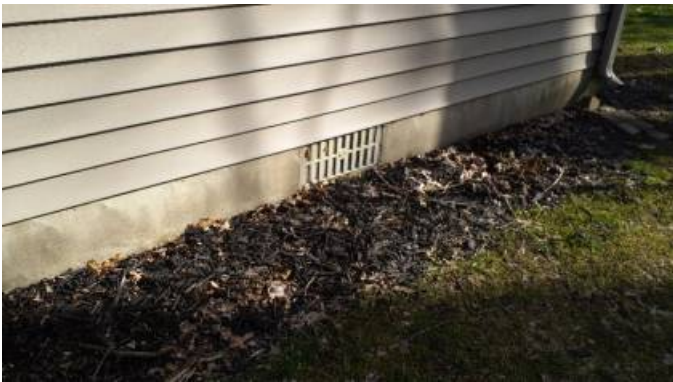
17.6 Crawlspace Comments:
Recommend removing property and paint cans as needed.
