**Mixed Use Store
Front/Apts
Sample Report**

13375 Madison
Lakewood OH 44107

September 16, 2022

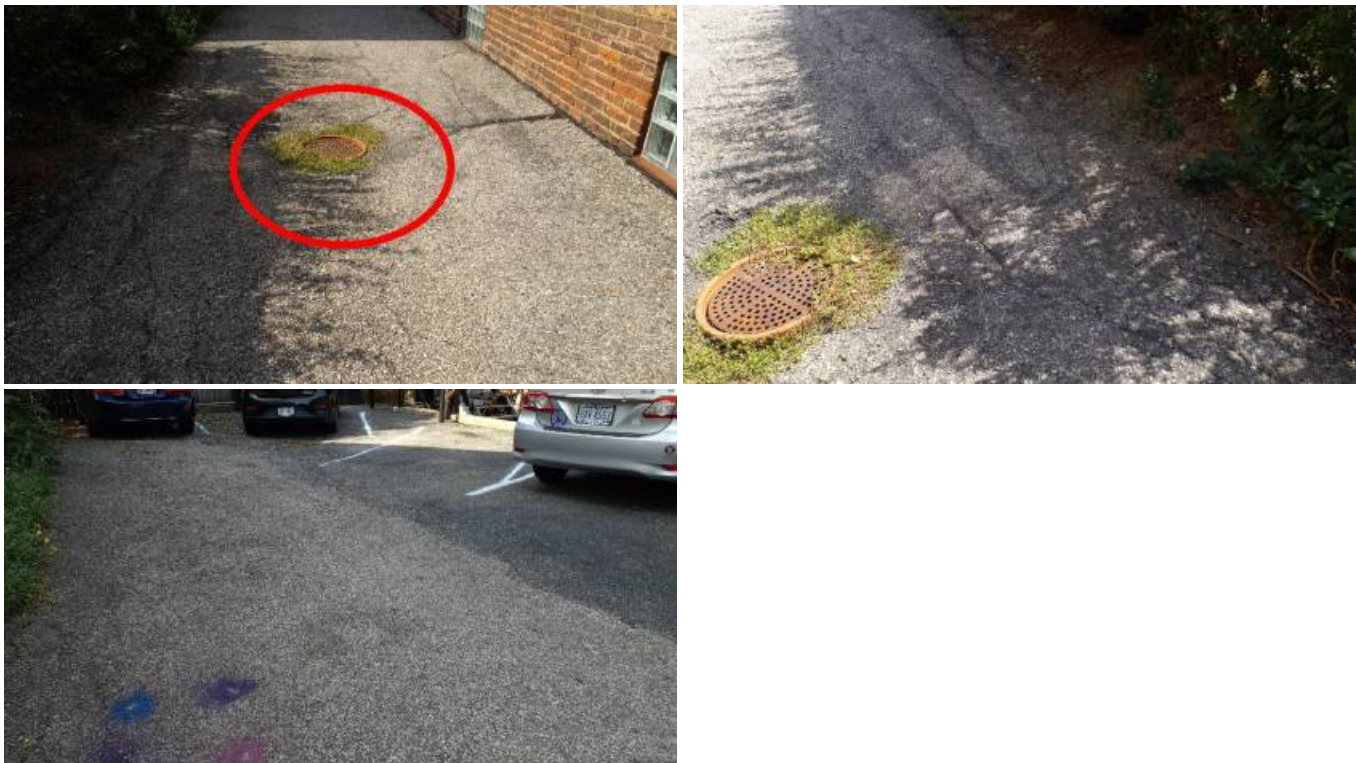
2.2 Driveway Condition:

The driveway surface material is in functional condition with only normal deterioration noted. Common cracks observed; primarily a cosmetic concern. Suggest sealing all concrete slab joints as well as any cracks in concrete/asphalt/brick surfaces to prevent water penetration as a routine maintenance effort.

Underground drains observed. Underground drainage systems are not within the scope of this inspection and a functional water flow test is not performed.

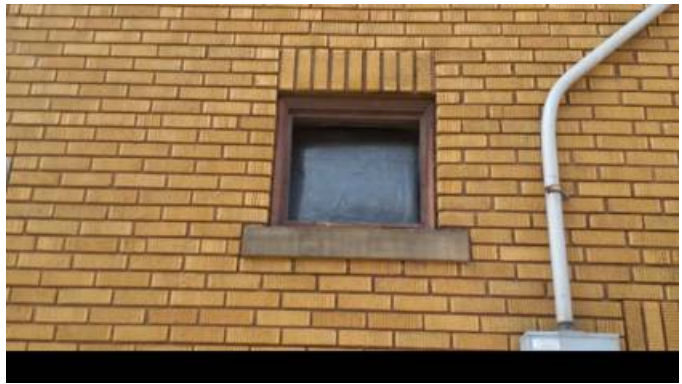
2.3 Exterior Window Condition:

In the inspectors opinion many of the windows/frames are near the end of their useful life due to age and poor condition. Recommend review by a qualified professional for repair or replacement, as needed, prior to close.

Suggest windows and frames be kept caulked, sealed/painted to prevent moisture penetration. Failure to keep windows and frames sealed can cause deterioration and extensive moisture damage to the interior walls and surrounding sub-flooring. This damage is not always visible or accessible to the inspector at the time of inspection.

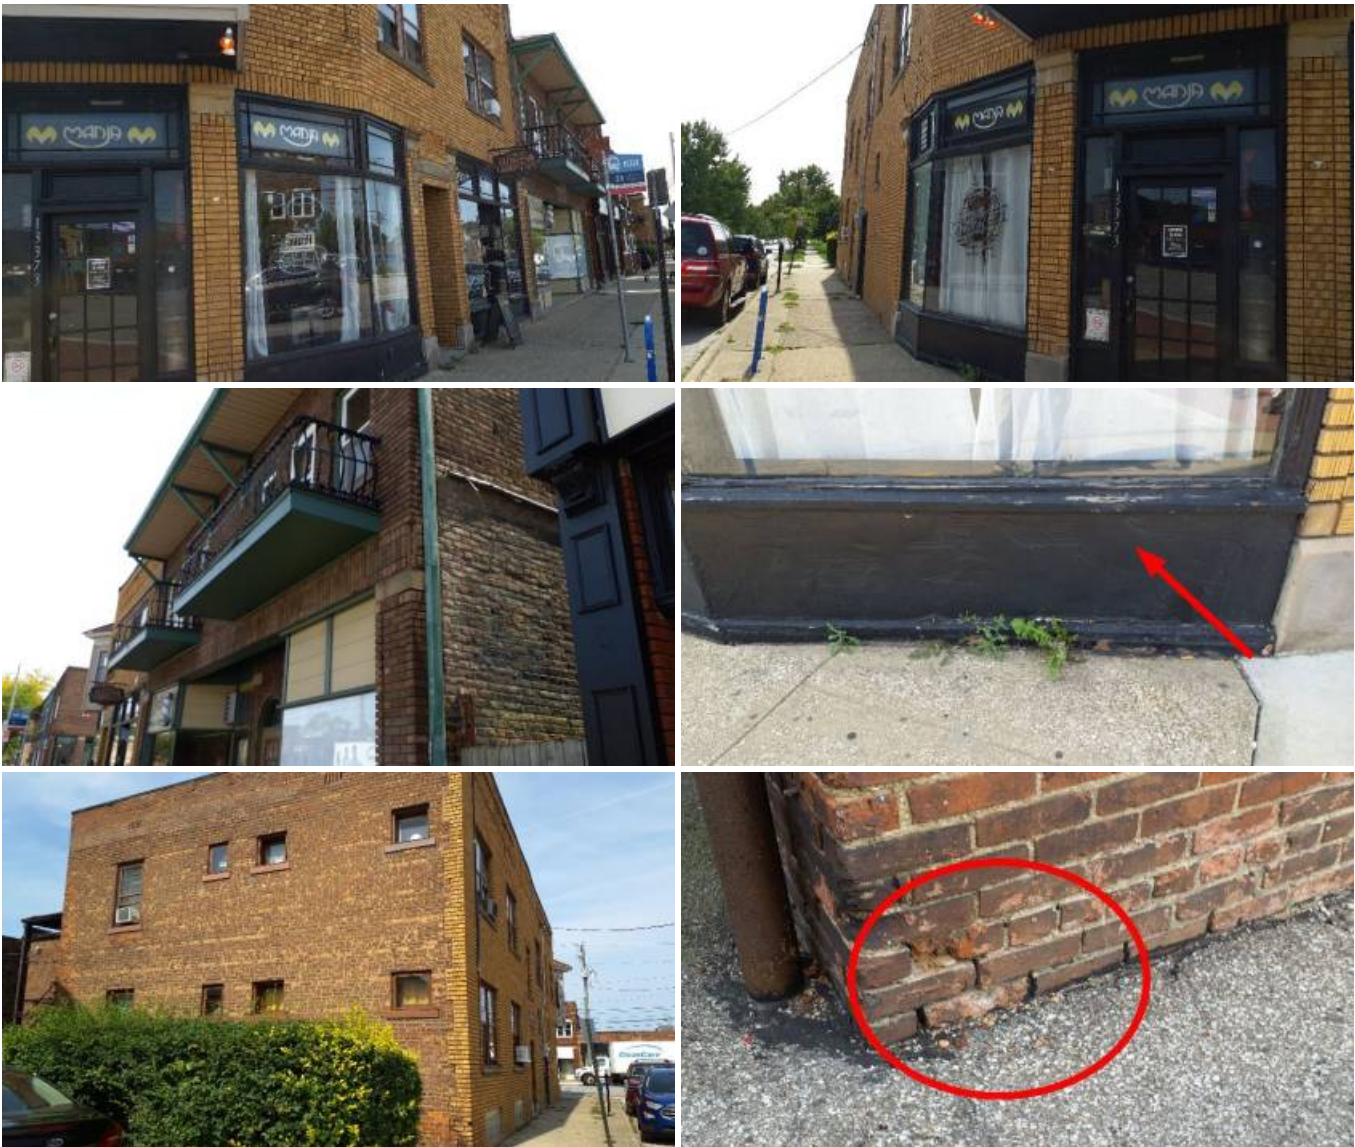
2.6 Siding Condition:

Some portion of the exterior siding material or finish is in a deteriorated condition. Recommend review by a qualified contractor review for repair or replacement as needed.

Deteriorated mortar observed, suggest tuckpointing as needed to prevent further damage.

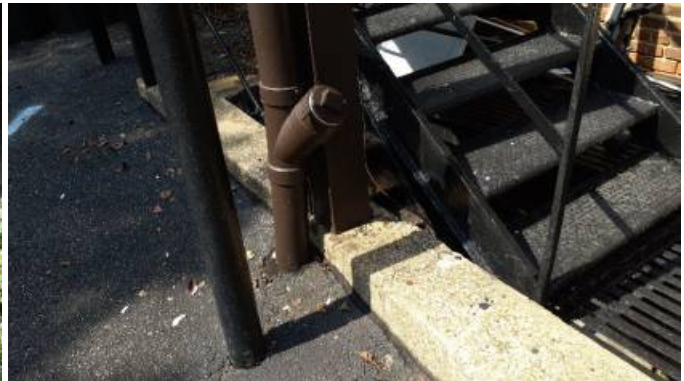
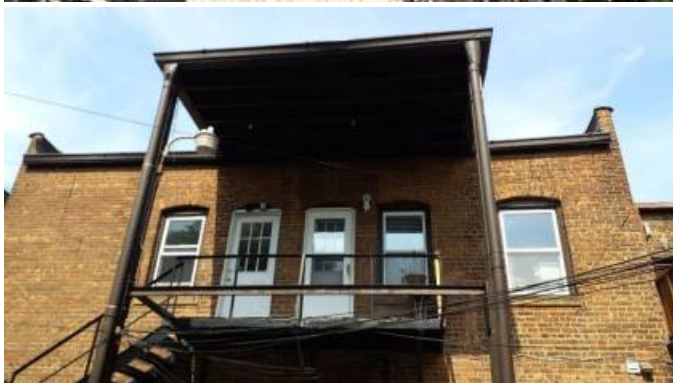
2.8 Trim Condition:

Moisture damaged trim observed at various areas; The extent of damage could not be determined without destructive analysis (maintenance and/or repairs should be performed). Whenever there is water damage, there is the possibility of hidden mold growth and pest infestation. If you have concerns regarding mold, we suggest review by a qualified professional. Anytime there is a mold or mildew condition we suggest clean-up be performed per EPA guidelines to correct the condition and that corrective measures be taken to limit moisture in the home.

Peeling paint observed at various areas; suggest scraping and painting as needed as part of normal maintenance.

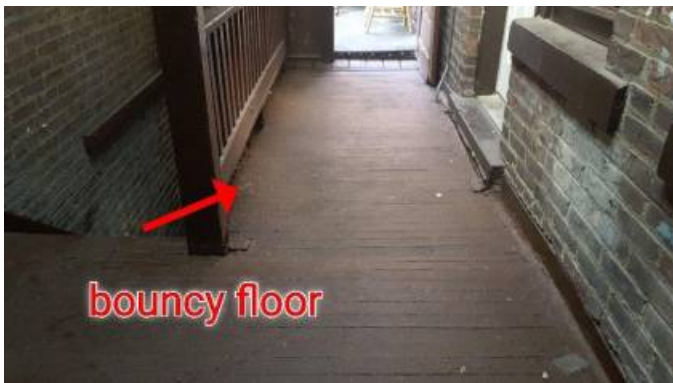
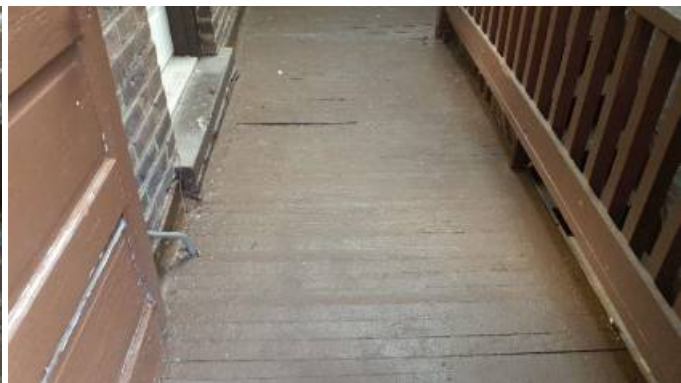
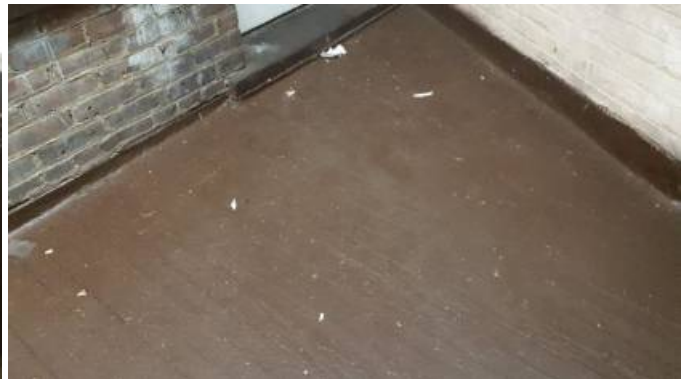
2.17 Condition of Materials:

The porch deck is very springy, poorly framed, inadequately supported or severely overspanned. Recommend review by a qualified professional for repair or replacement as needed.

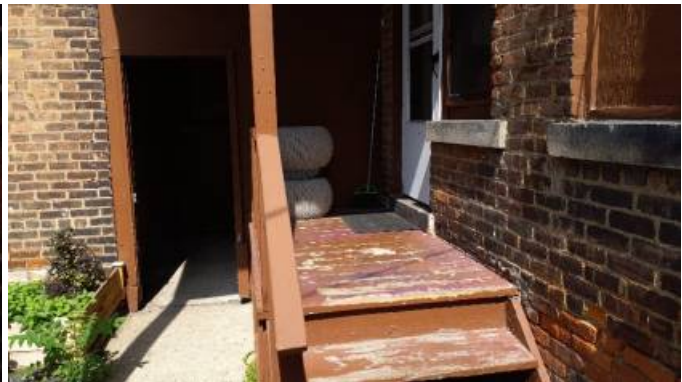
2.21 Condition of Materials:

The porch is deteriorated, recommend review by a qualified contractor for repair or replacement needed.

Peeling paint observed at various areas, suggest scraping and painting as needed as part of normal maintenance.

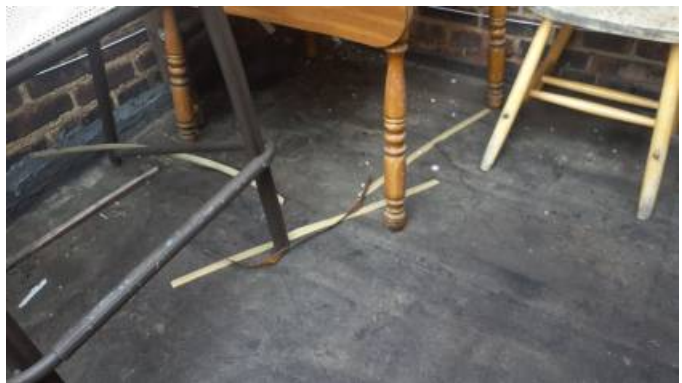
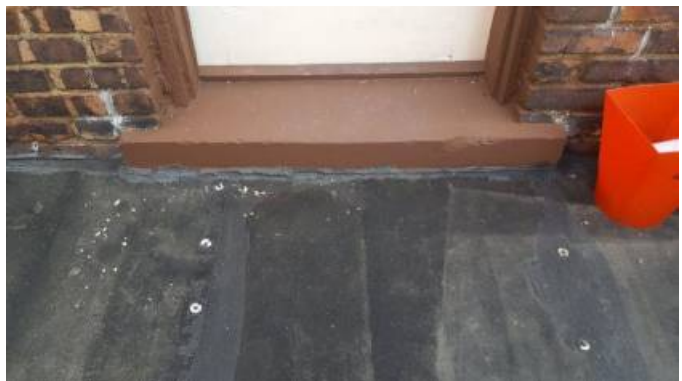
2.26 Condition of Materials:

The balcony is deteriorated, recommend review by a qualified contractor for repair or replacement needed.

Settling observed. Recommend review by a qualified contractor for repair or replacement as needed.

Peeling paint observed at various areas, suggest scraping and painting as needed as part of normal maintenance.

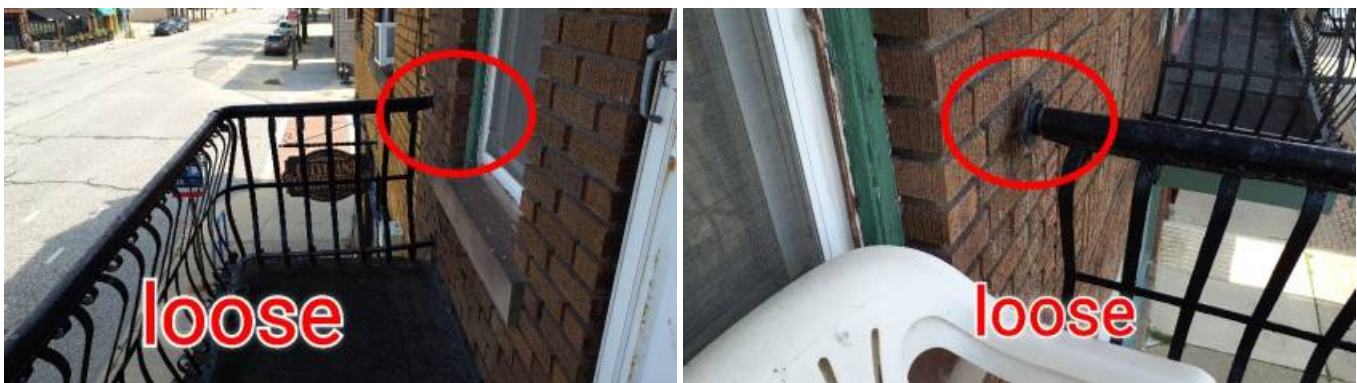
2.29 Condition of Materials:

The balcony is deteriorated, recommend review by a qualified contractor for repair or replacement needed.

Railings are loose; recommend review by a qualified contractor for repair or replacement as needed to ensure safety.

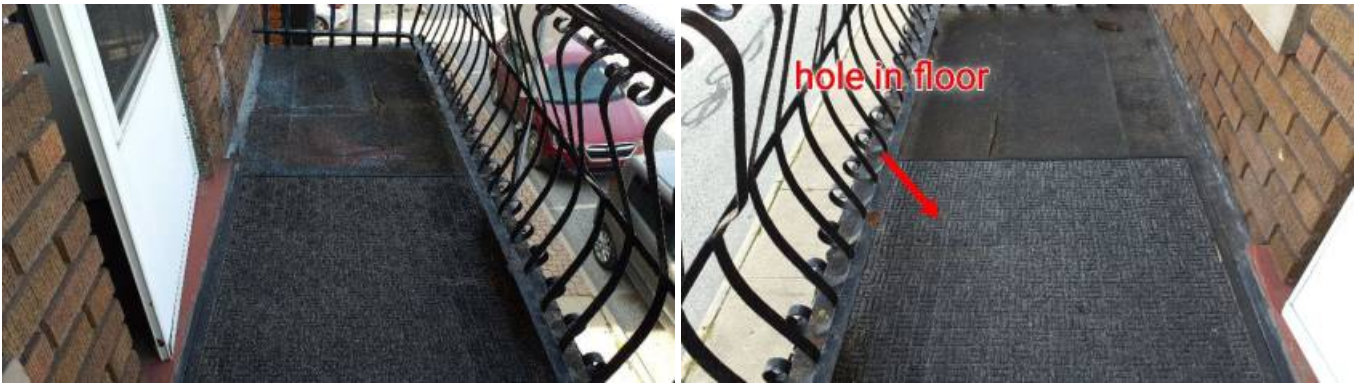
2.33 Condition of Materials:

The balcony is deteriorated, recommend review by a qualified contractor for repair or replacement needed.

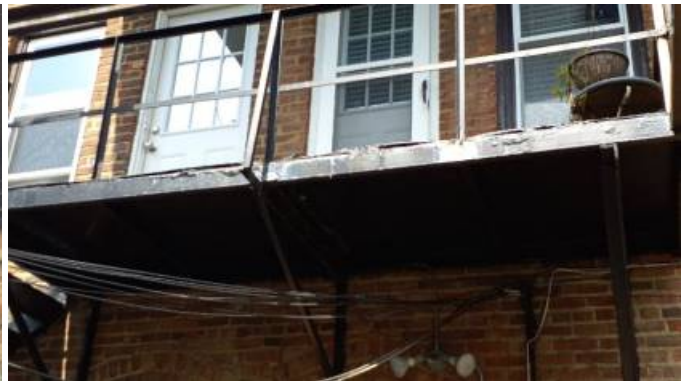
2.36 Condition of Materials:

The balcony is deteriorated, recommend review by a qualified contractor for repair or replacement needed.

Damaged material observed recommend repair or replacement as needed..

Excessive load may result in structural failure. Recommend review by a qualified contractor for repair or replacement as needed.

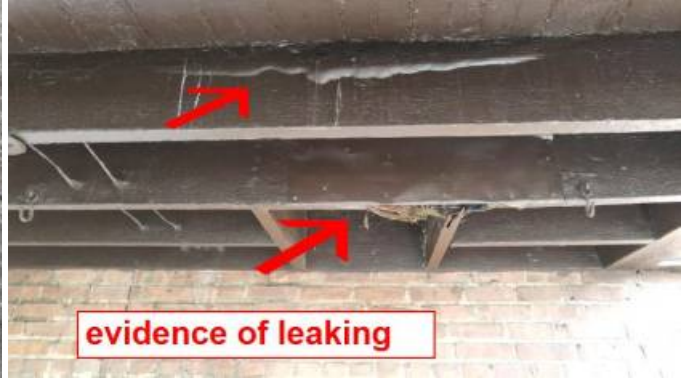
3.3 Condition of Roof Covering Material:

The roof was old and exhibited widespread delamination and deterioration. Delamination is separation of the surface layer of covering. This is a common failure mode for older roofs. The roof appeared to be at or near the end of its useful life. The Inspector recommends that you consult with a qualified roofing contractor to gain an idea of options and costs for replacement.

Evidence of ponding observed. if water ponding is an ongoing concern. Ponding on a flat roof can lead to water leaks and moisture intrusion. Recommend review by a qualified roofing to make the necessary corrections.

Small cracks a.k.a "Alligator Cracking" observed on roof covering. Thermal splitting occurs due to changes in temperature that cause roof material to expand and contract. This can cause the roof covering to split, which may lead to leaks and lower wind resistance. Recommend review and repair by a qualified roofing contractor as needed.

Evidence of patching noted on the roof. Consult sellers prior to close to find out additional information. Recommend review by a qualified roofer for additional information, repair or replacement as needed.

Deteriorated roof covering should be replaced to prevent further deterioration or damage due to leakage. Recommend review by a qualified roofer for repair or replacement as needed.

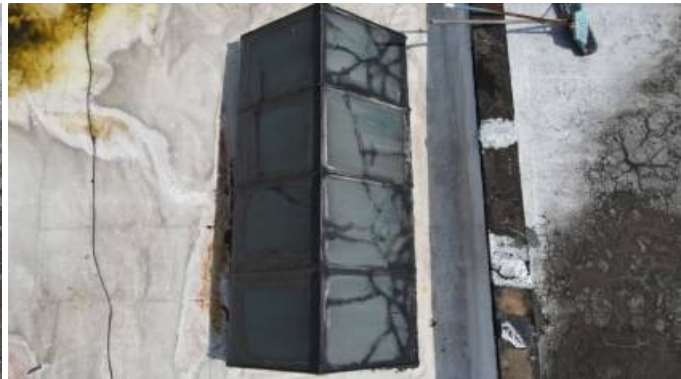
3.4 Roof Comments:

The skylight shows signs of leakage. Recommend review by a qualified roofer for repair or replacement as needed.

In the inspectors opinion the skylight has exceeded its designed life expectancies. We make no warranty, guarantee or estimation as to the remaining useful life of this window.

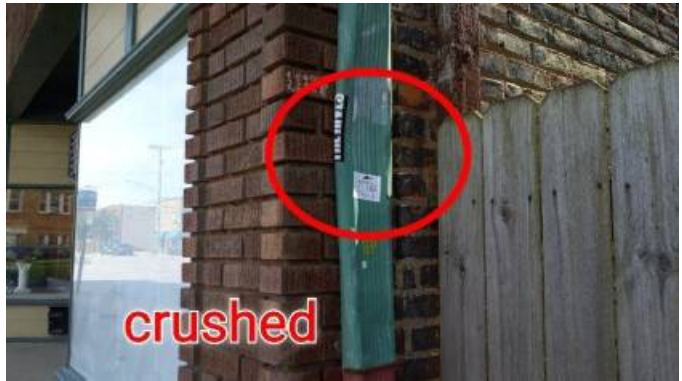
Damage observed. Recommend review for repair or replacement as needed.

One or more downspouts exit into an underground drainage pipe. Underground drainage systems are not within the scope of this inspection and a functional water flow test is not performed. If concerned about underground drainage, recommend having a sewer/storm drain scope from a qualified plumber.

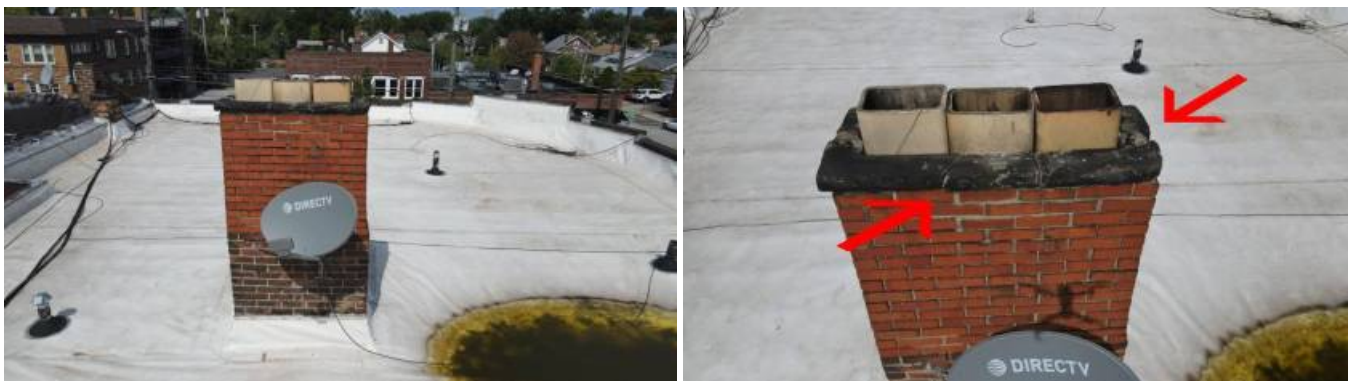
4.2 Visible Condition:

Chimney crown is cracked. Chimney crown is the cement that seals the top of the chimney brick. This is a neglected maintenance item in most homes. Recommend repair or replacement as needed.

Chimney crown appears to be deteriorated. Chimney crown is the cement that seals the top of the chimney brick. This is a neglected maintenance item in most homes. Recommend repair or replacement as needed. Recommend review or repair as needed by qualified contractor.

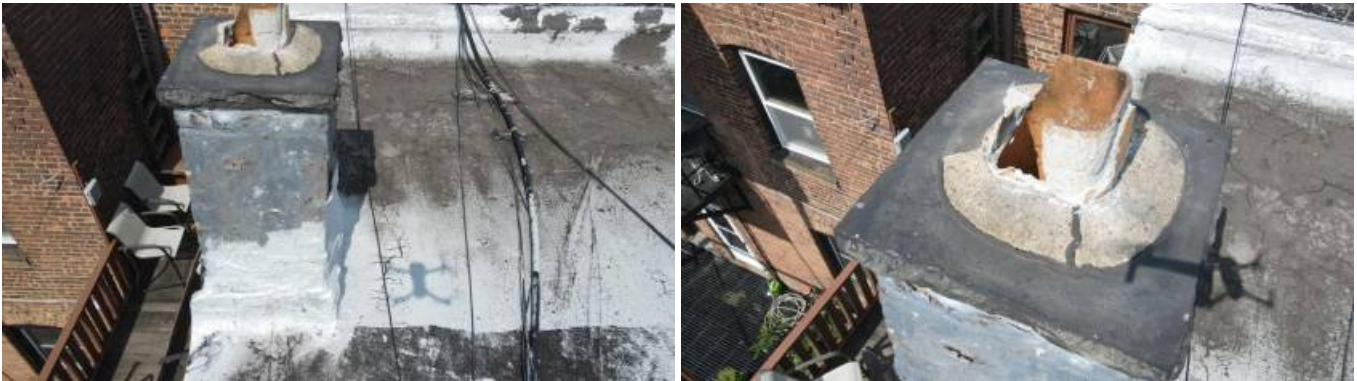
Chimney crown appears to be deteriorated. Chimney crown is the cement that seals the top of the chimney brick. This is a neglected maintenance item in most homes. Recommend repair or replacement as needed. Recommend review or repair as needed by qualified contractor.

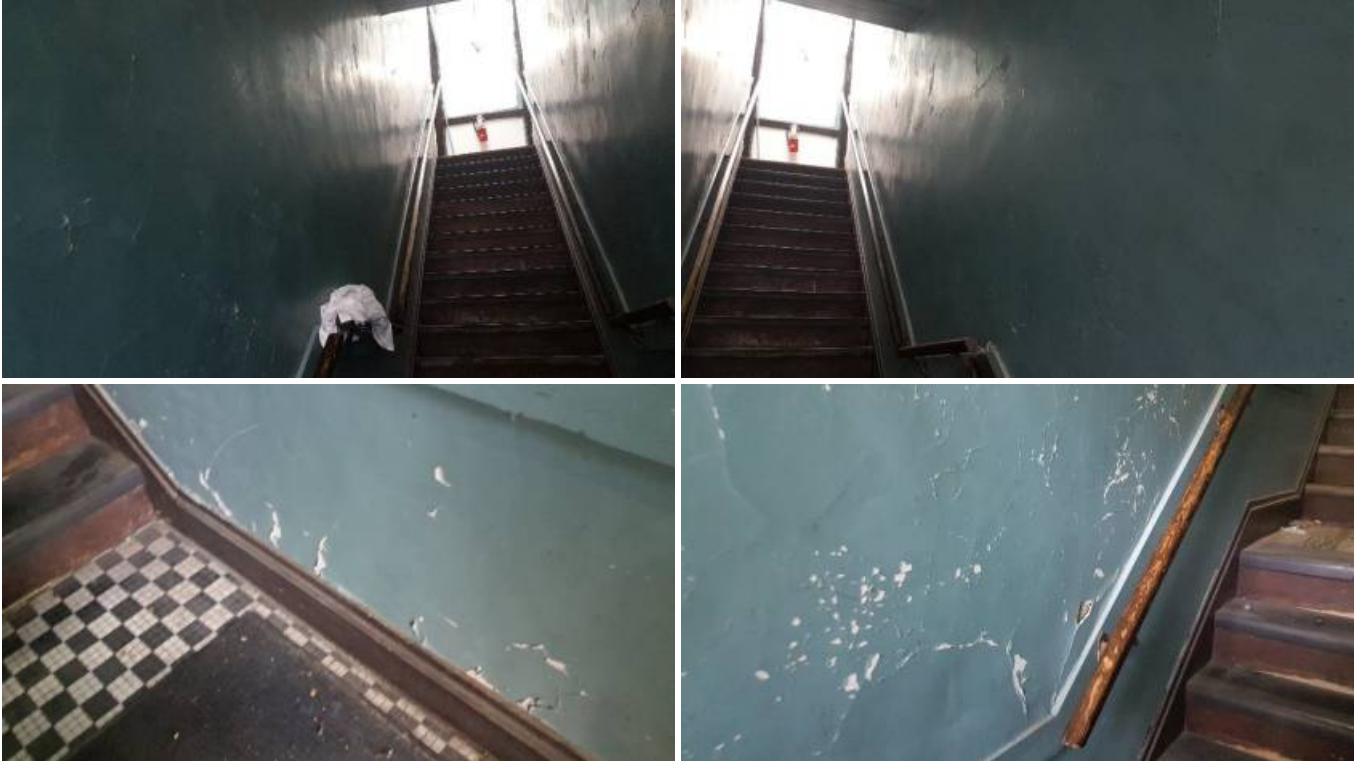
8.4 Ceiling:

Water stains, bulging walls, or other damage was observed that indicate leaks or possible concealed leaks. Client is advised to obtain further review by a qualified contractor prior to closing to determine extent of damage for repair or replacement as needed. Whenever there is water damage, there is the possibility of hidden mold growth and pest infestation. Because certain types of mold may be toxic and result in adverse health effects, or if you have concerns regarding mold, we suggest review by a qualified professional. Anytime there is a mold or mildew condition we suggest cleanup be performed per EPA guidelines to correct the condition and that corrective measures be taken to limit moisture in the home.

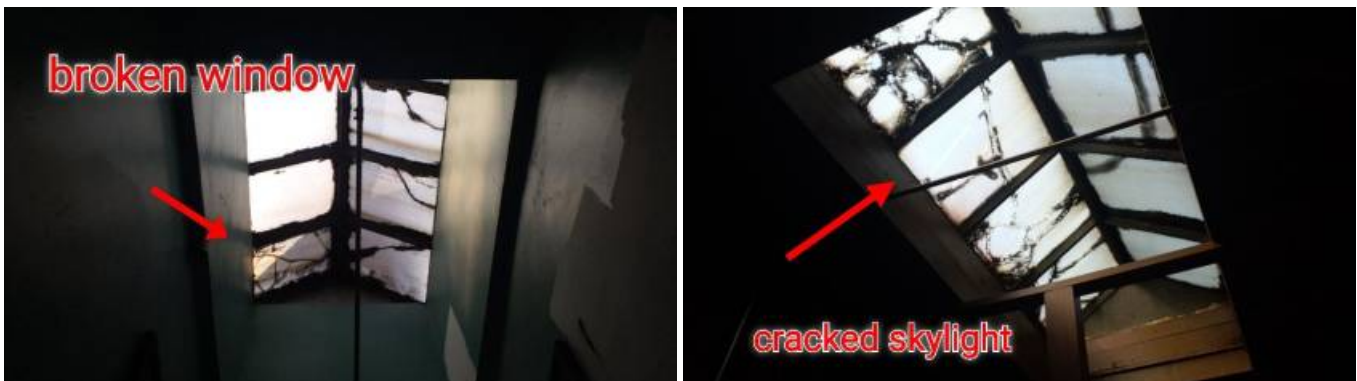
9.2 Windows:

Broken/cracked pane(s) observed. Recommend review for repair or replacement as needed.

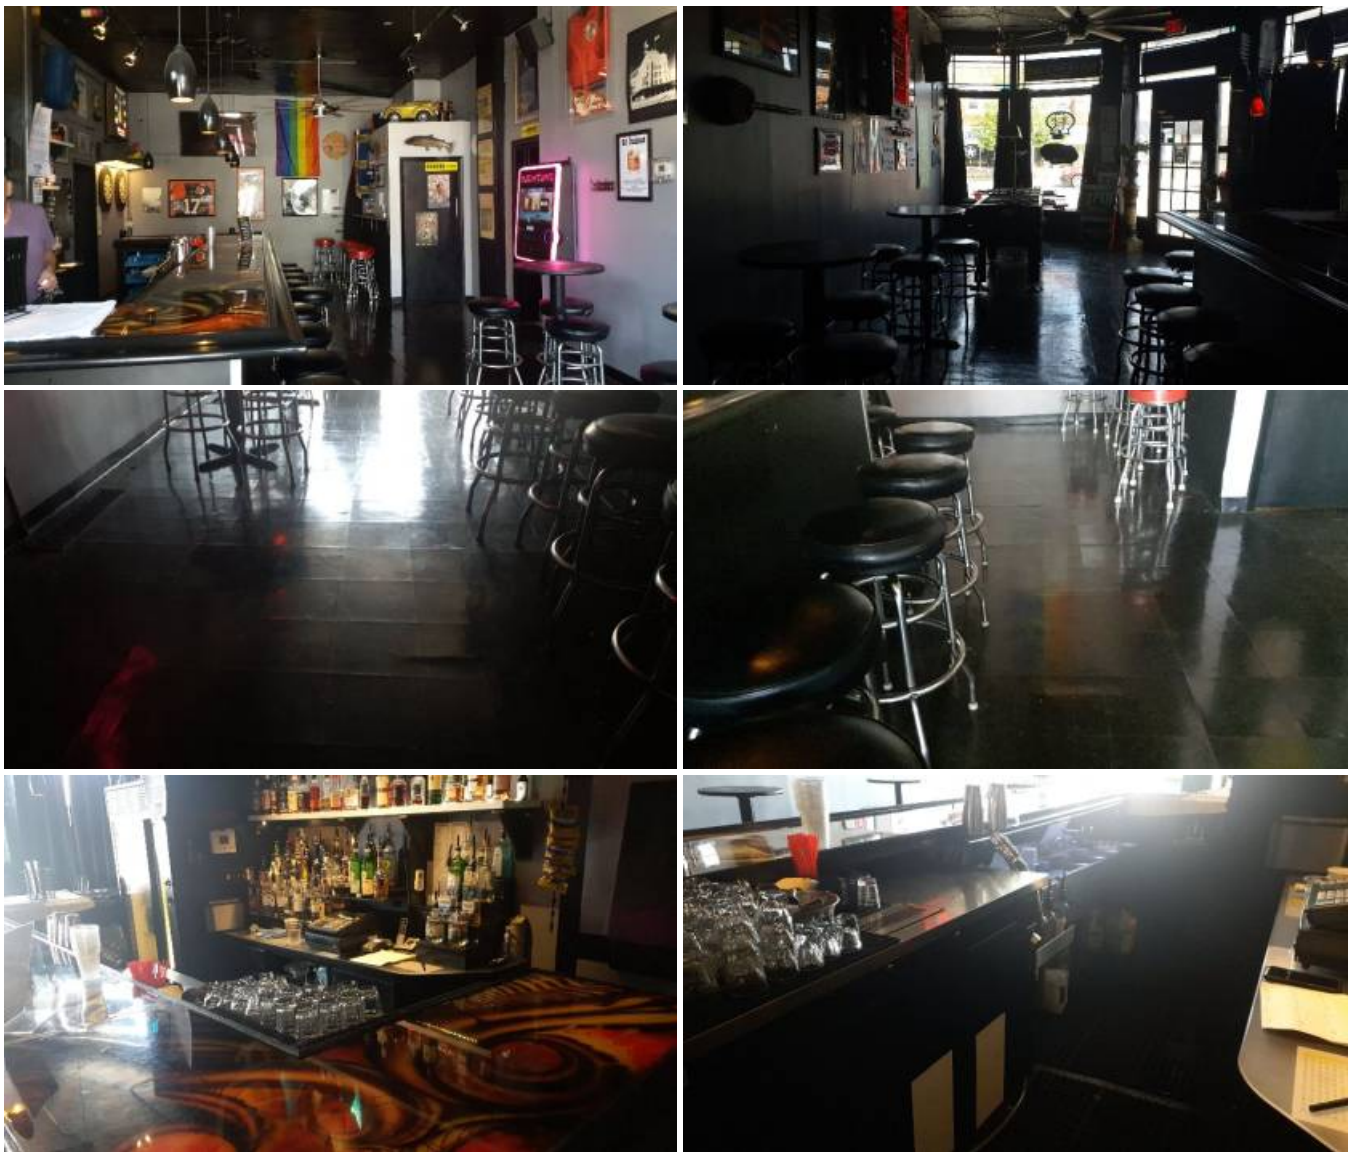
Bar electric appears to be connected 2nd floor apartment so part of basement are not working. Recommend review and repair by a licensed electrician.

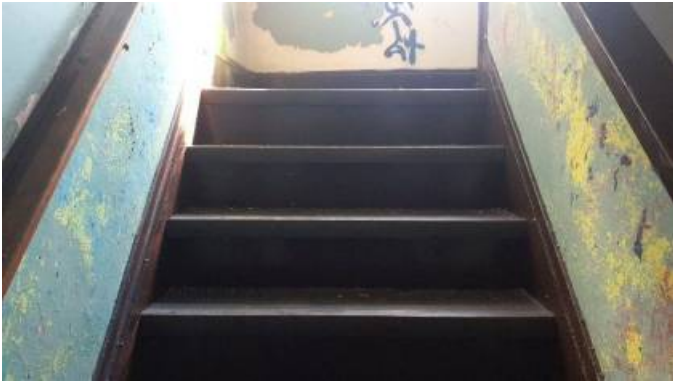
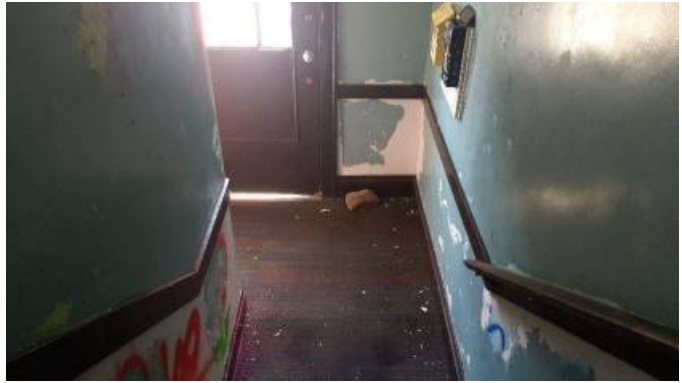
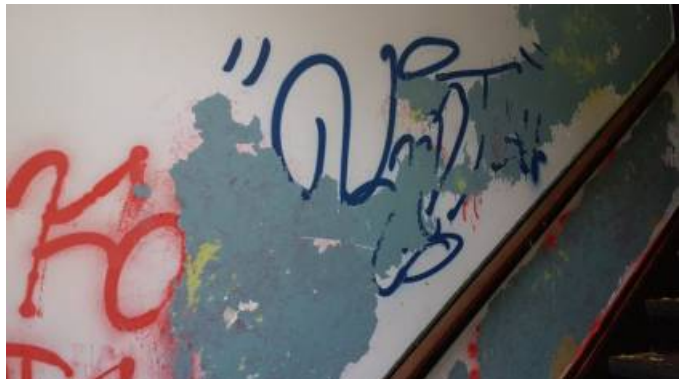
Peeling paint and graffiti observed in hall. Recommend repairs be made as needed.

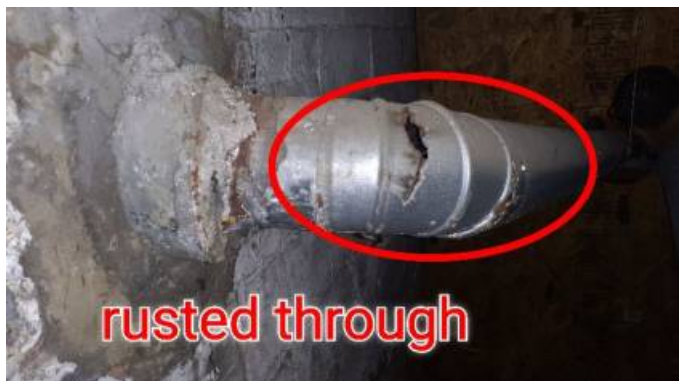
Corrosion and holes observed in vent pipe, which is a safety concern. Recommend review by a qualified contractor for repair as needed, prior to close.

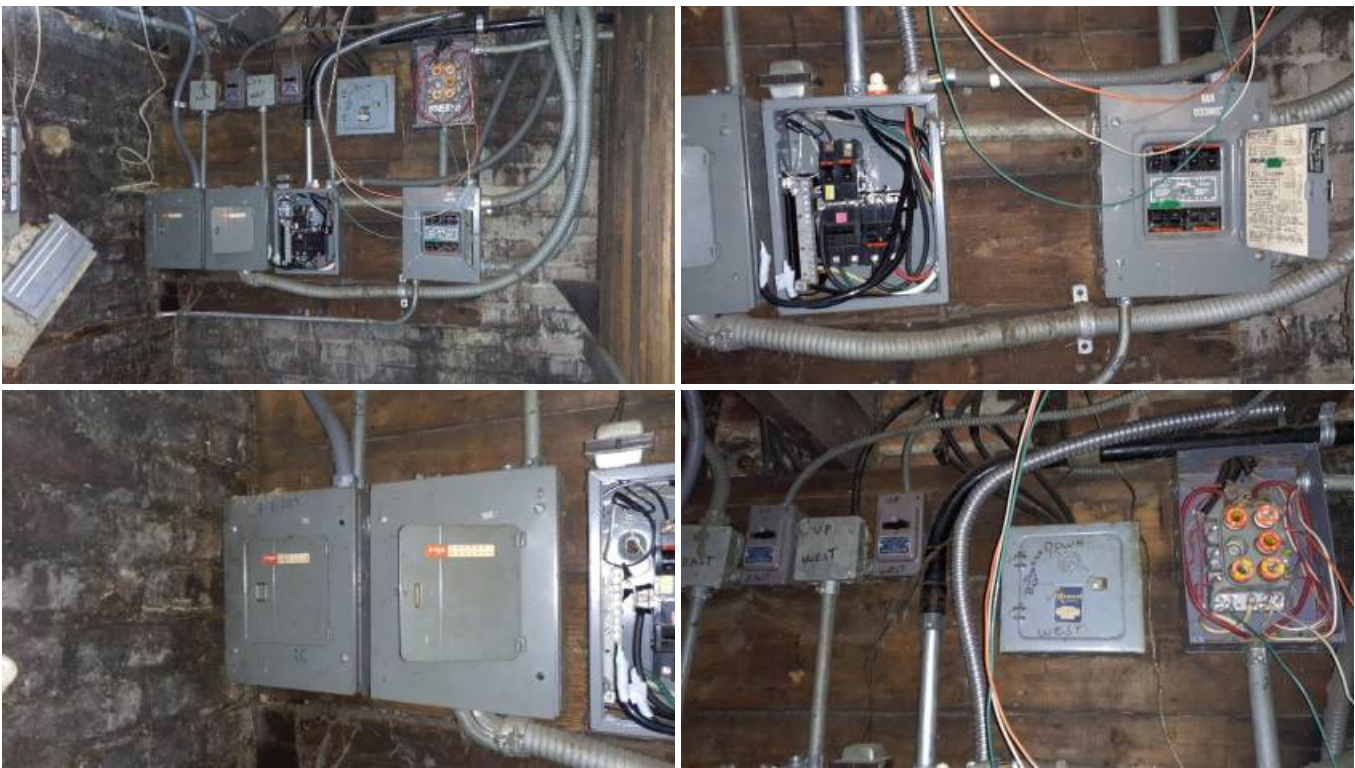
In the inspector's opinion, the electrical panel has exceeded its designed life expectancies. We make no warranty, guarantee or estimation as to the remaining useful life of this panel.

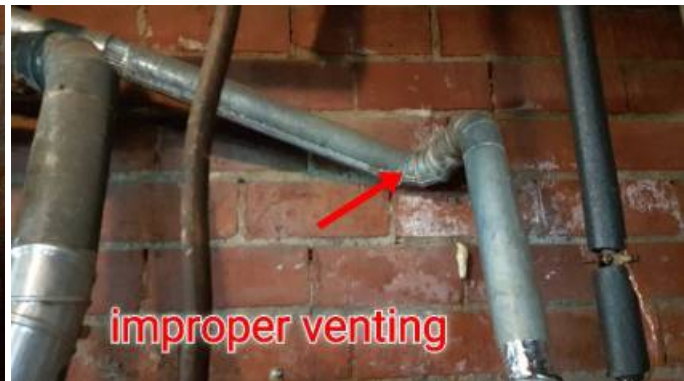
Disconnected vent pipes noted, this will allow products of combustion to escape. This is a "Safety Hazard" requiring attention by a qualified contractor for repairs/replacement as required to ensure safety.

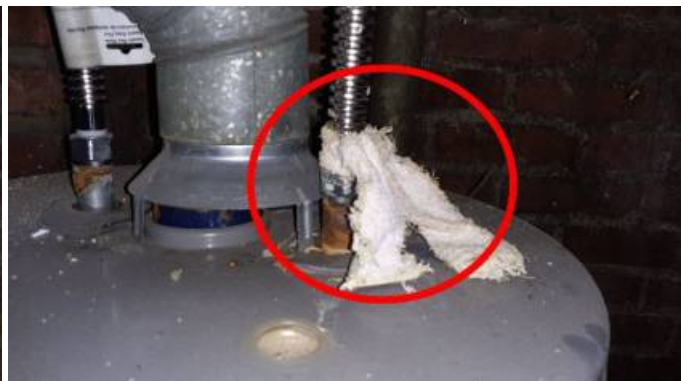
Ground jumper cable not observed between hot and cold water lines, recommend installing jumper cable to insure proper grounding and safety.

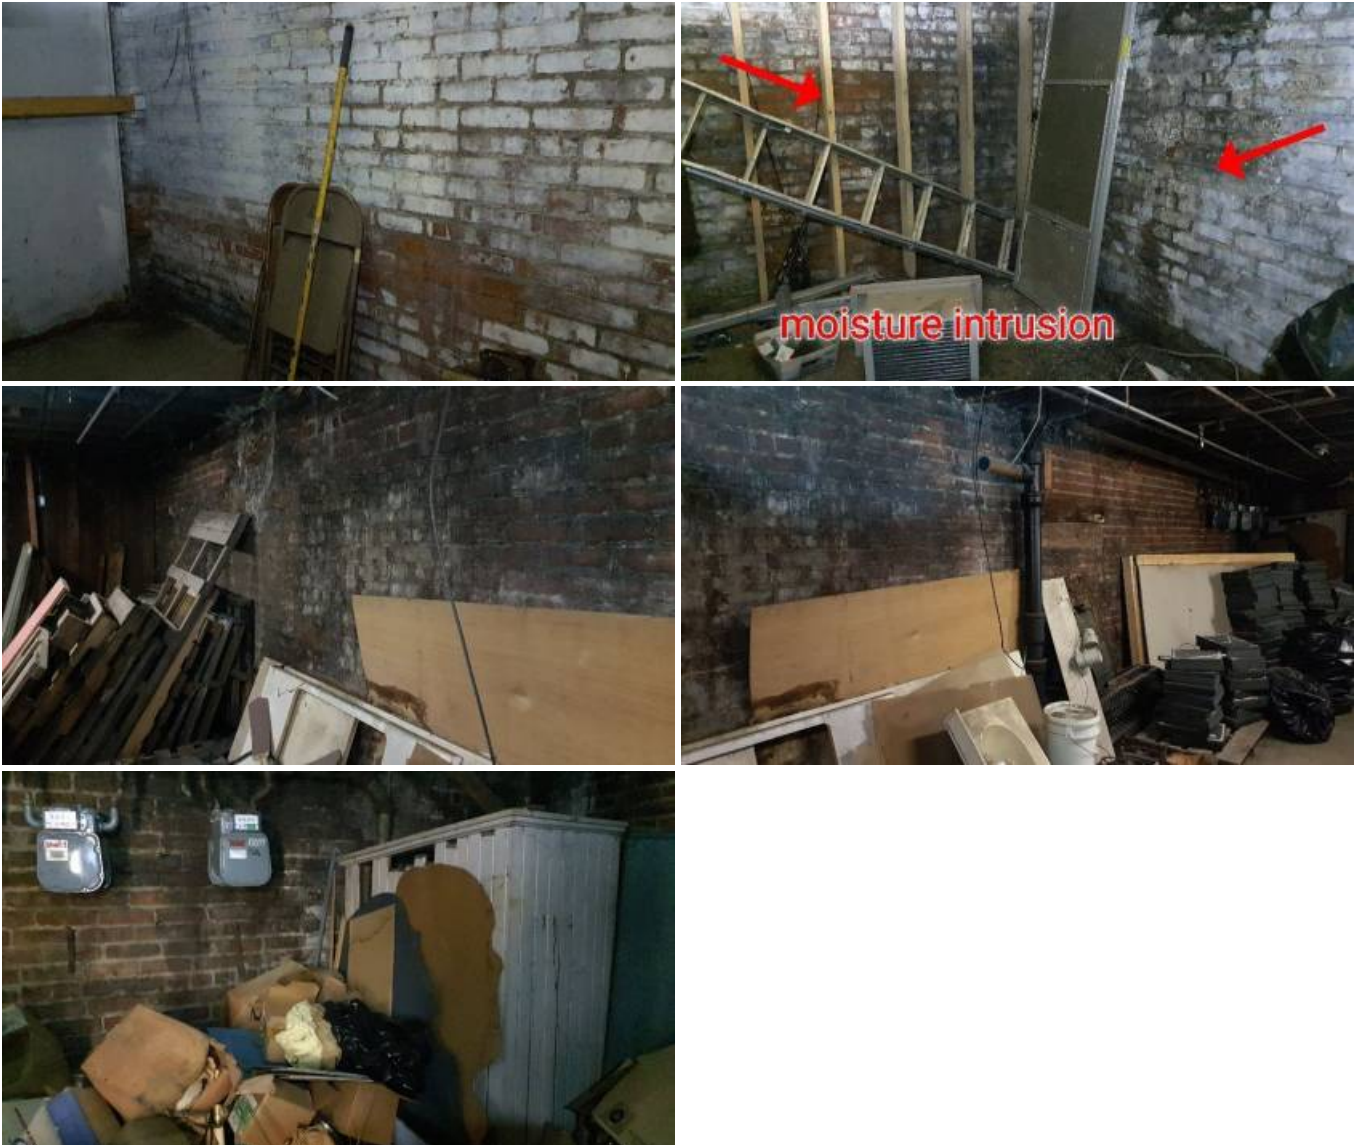
The basement walls exhibited discoloration that appeared to be microbial growth, possibly mold. Confirming the presence of mold would require laboratory analysis. To avoid potential damage to home materials or the development of unhealthy conditions related to mold, the Inspector recommends that the source of moisture be identified and the condition corrected.
