Warehouse Sample Report

Confidential Inspection Report

501 Clark St
Elyria OH 44035

November 11, 2019

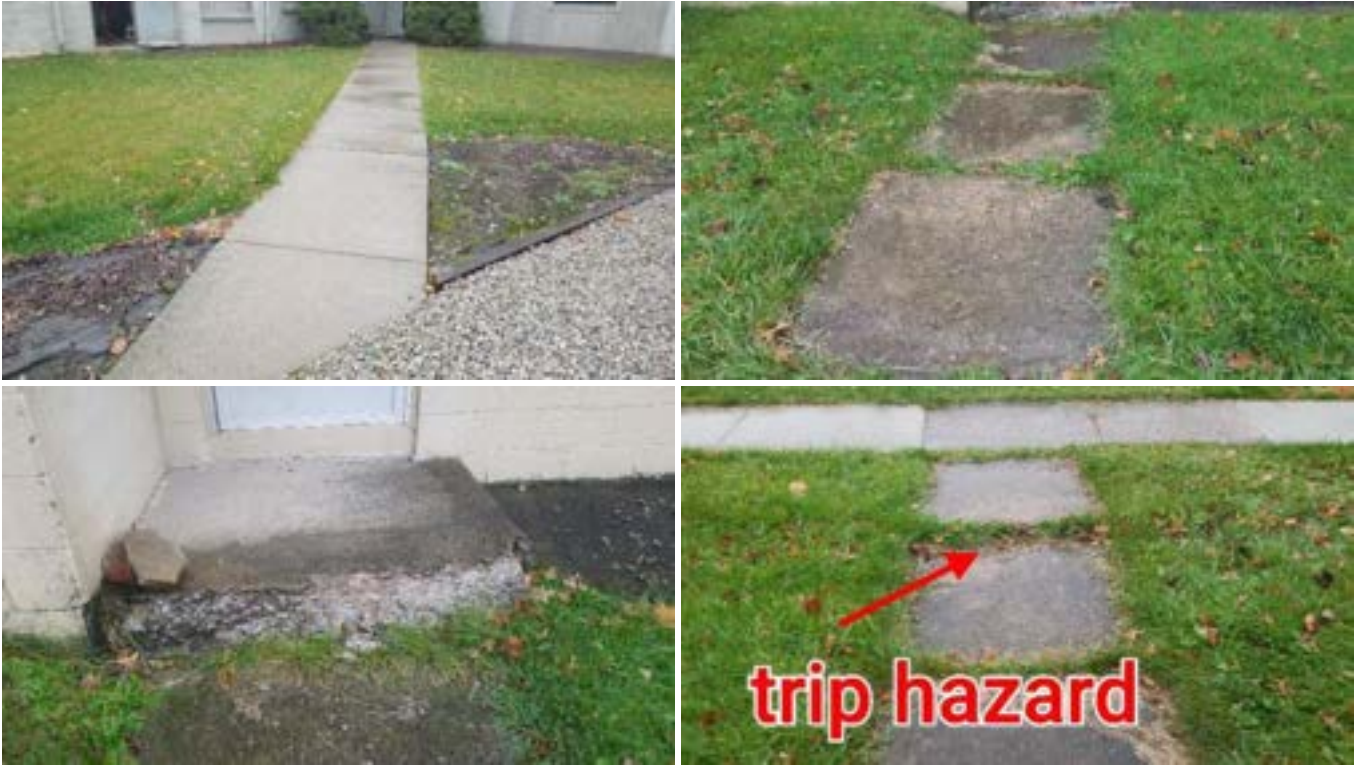
Surface is deteriorated. Recommend review by a qualified contractor for repair or replacement as needed.

Possible trip hazard noted at various locations. This is a safety concern. Suggest repair/replacement as needed to ensure safety.

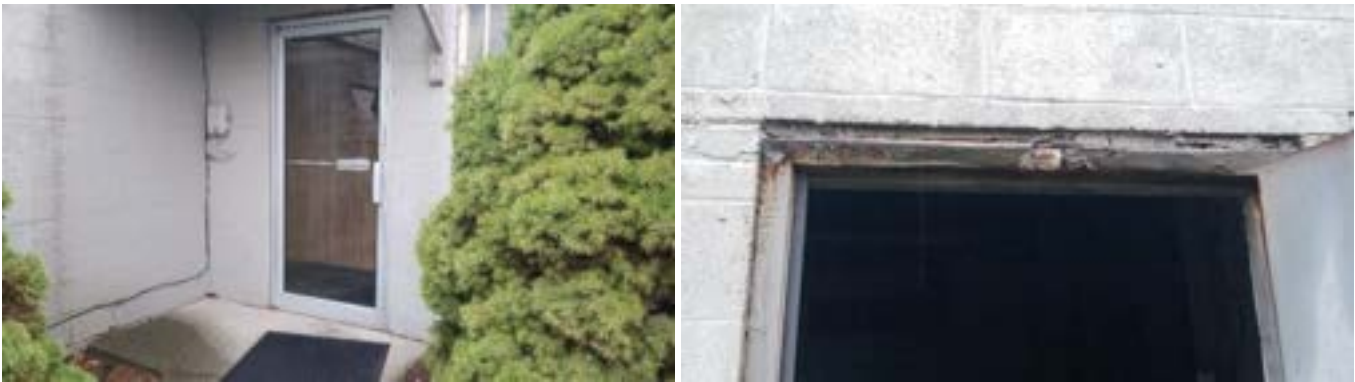
Deterioration observed. Suggest repairs/replacement as needed.

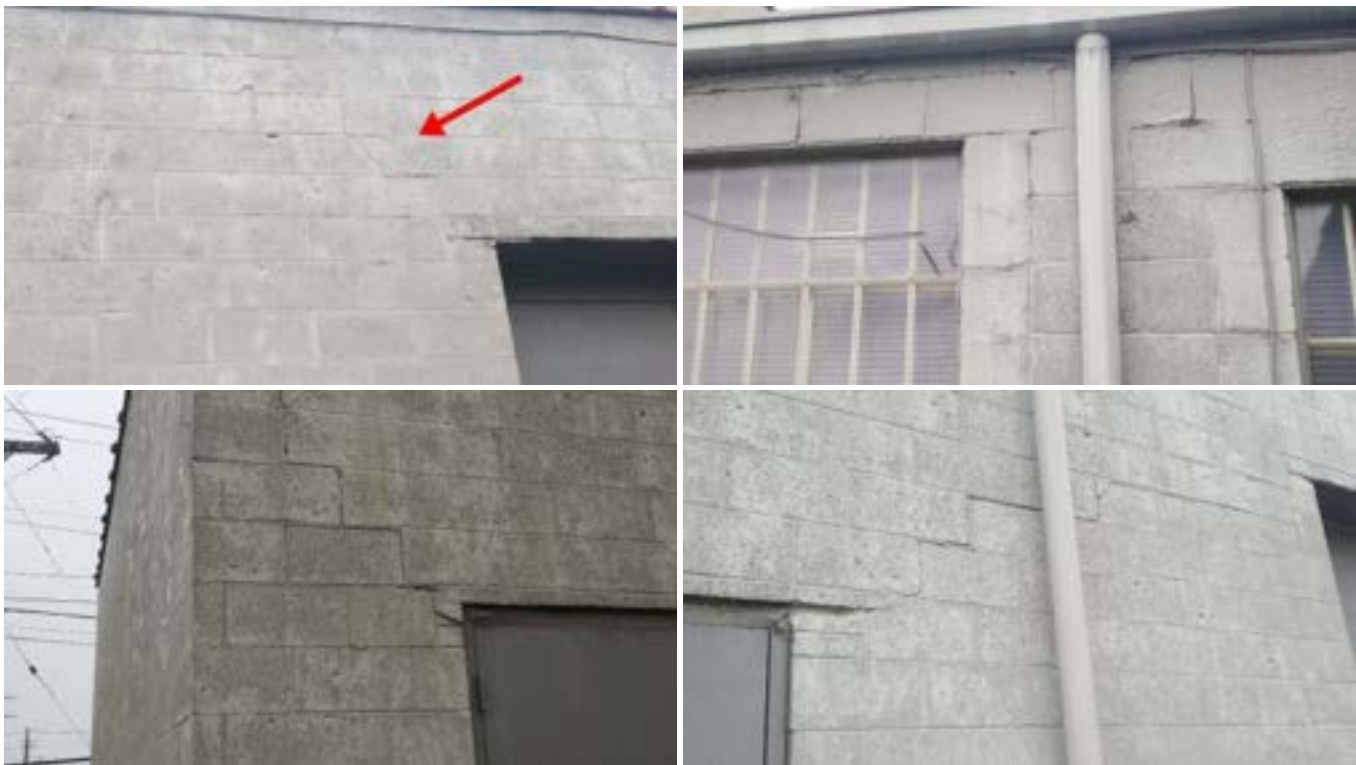
Peeling paint observed at various areas, suggest scraping and painting as needed as part of normal maintenance.

Damaged siding observed in various areas. Recommend review by a qualified contractor for repair or replacement as needed.

Horizontal crack(s) were visible in the interior block wall/foundation. This indicates some inward movement has occurred. Due to conditions observed, component may require some level of maintenance, repair or replacement in the foreseeable future. You should plan or budget for additional expenses on this component or have it evaluated further by a qualified specialist prior to closing on this property.

Suggest removing vegetation from siding materials.

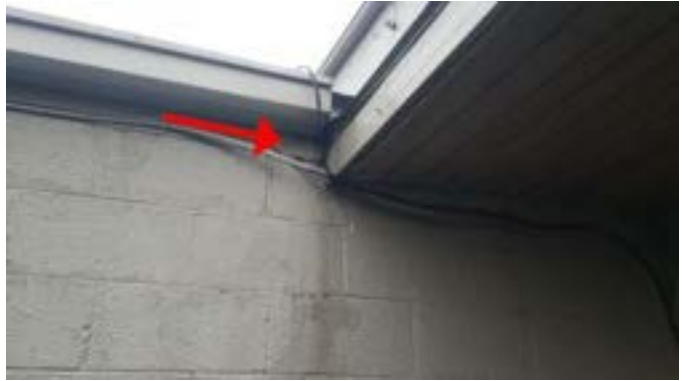
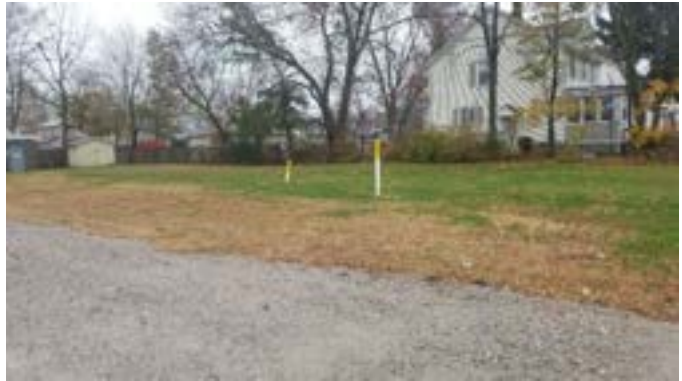
Evidence of ponding observed. Grade improvements, landscape alterations, or the installation of surface drains may be needed if water ponding is an ongoing concern. Ponding near foundation may result in basement/crawlspace seepage or foundation damage. This inspection does not include determining if the property is above the 100 year flood plain. For further information regarding elevation of the lot, check with your survey and appraiser.

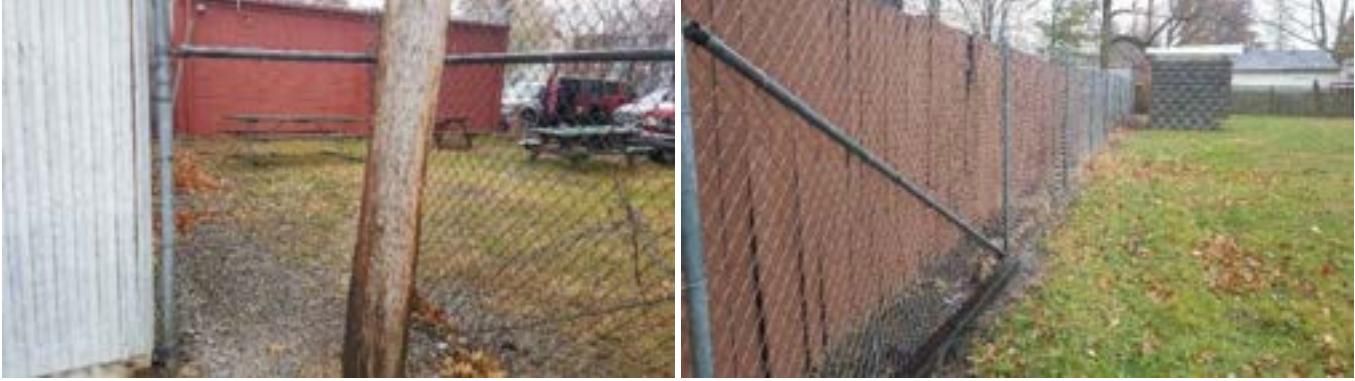
Fence damaged in various areas recommend review for repair or replacement as needed. Missing chain link section behind garage. Recommend repair or replacement of chain link as needed.

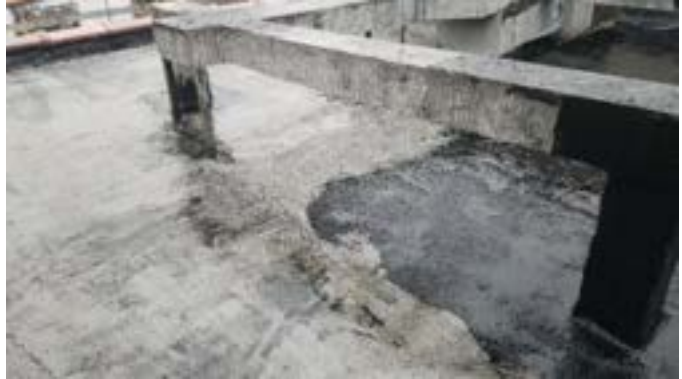
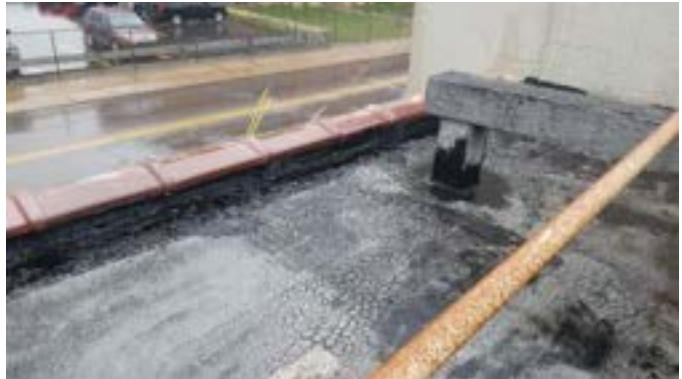
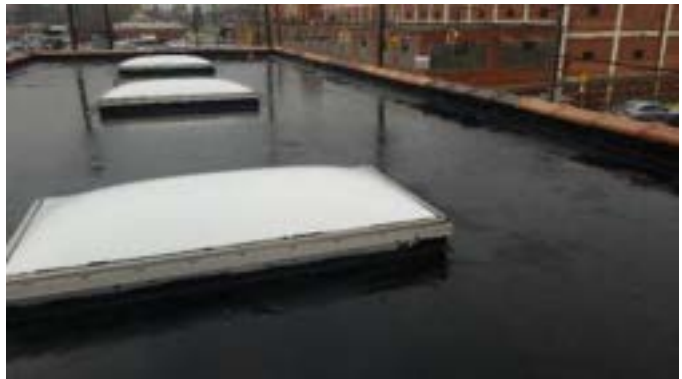
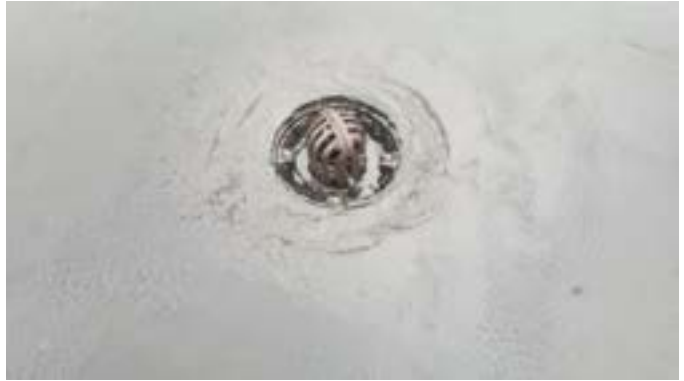
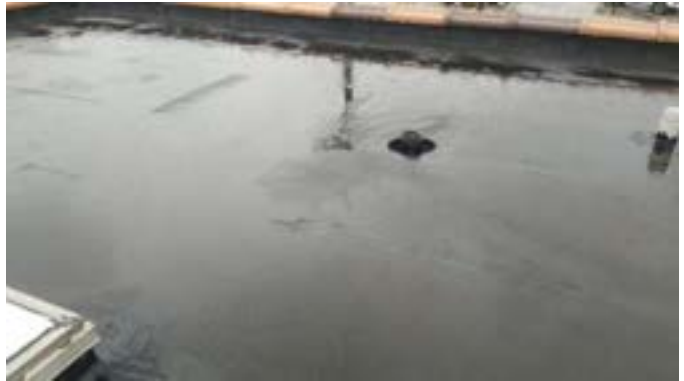
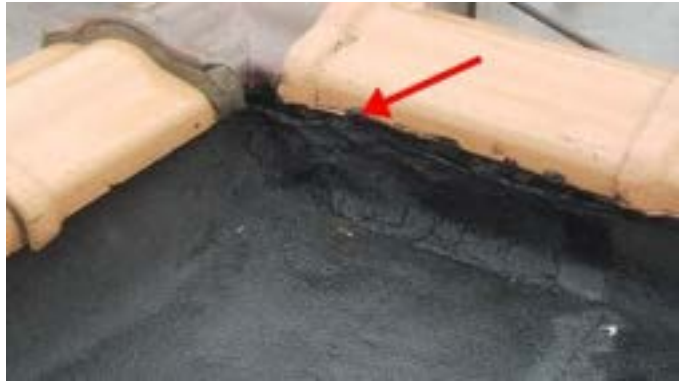
Deteriorated area of the roof should be replaced or repaired to prevent further deterioration or damage due to leakage. Recommend review by a qualified roofer for repair or replacement as needed.

Small leaks observed in main garage area. Recommend repair of roof leaks by qualified contractor.

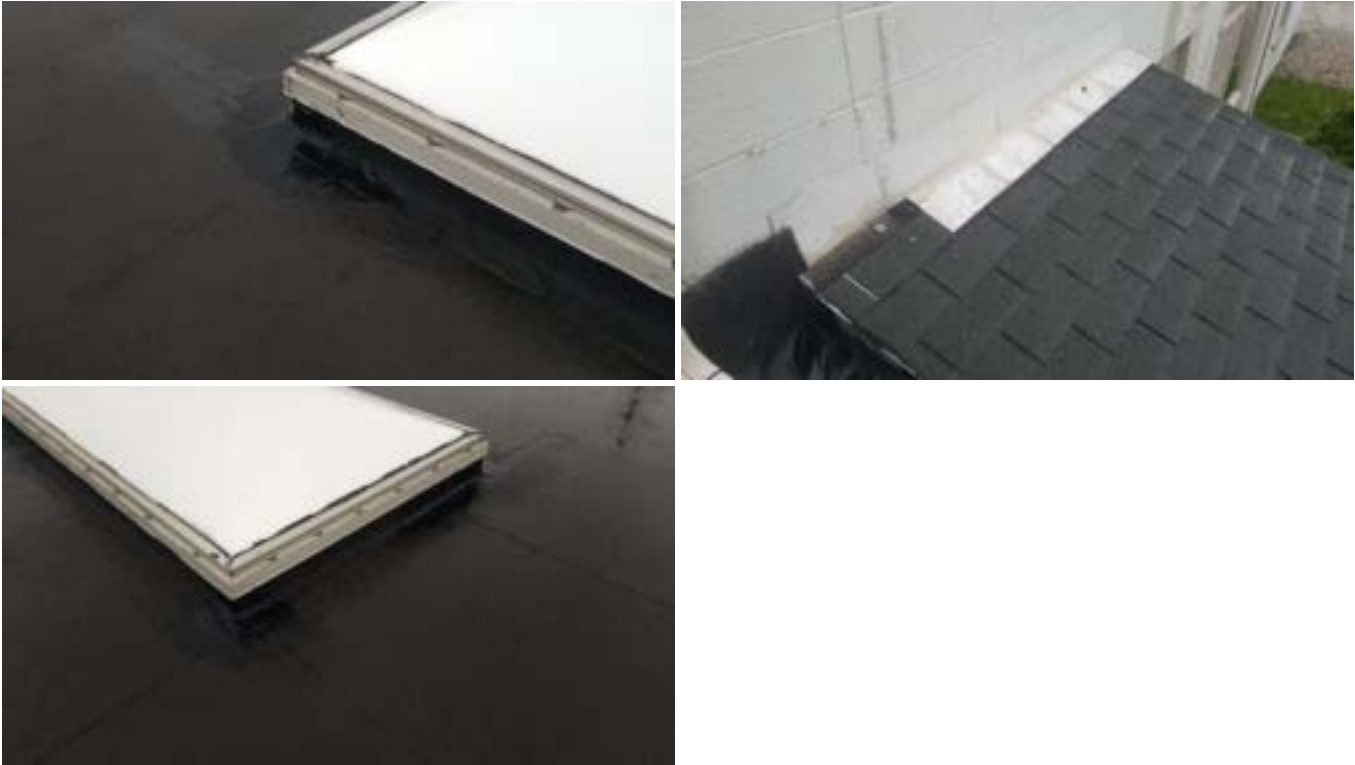
Flashings are covered with roofing cement, which may indicate previous water penetration into the structure at this location. Recommend review by a qualified roofer for repairs or replacement as needed.

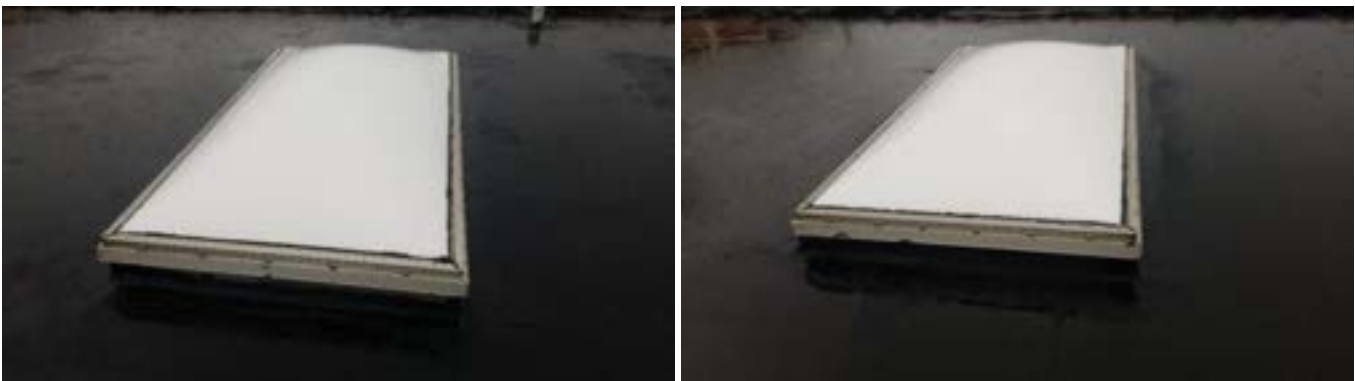
Flashings are covered with roofing cement, which may indicate previous water penetration into the structure at this location. Suggest client consult with sellers for additional information or review by a qualified roofer for repair or replacement as needed.

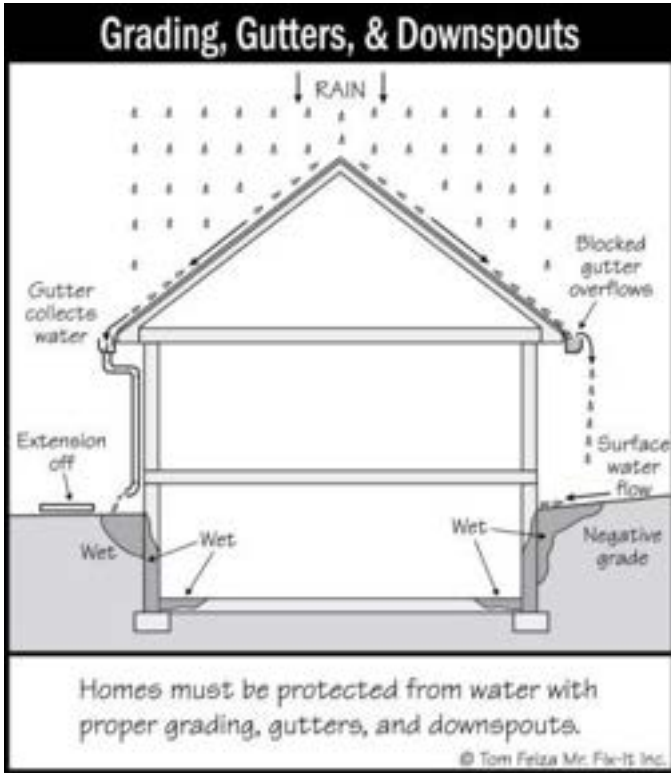
Downspout extensions need to extend six feet away from foundation to divert water away. The extensions should slope down at a rate of 1 inch per foot.

One or more areas of the building have no gutter system is present, suggest client consider installing a full gutter system to more effectively divert roof runoff.

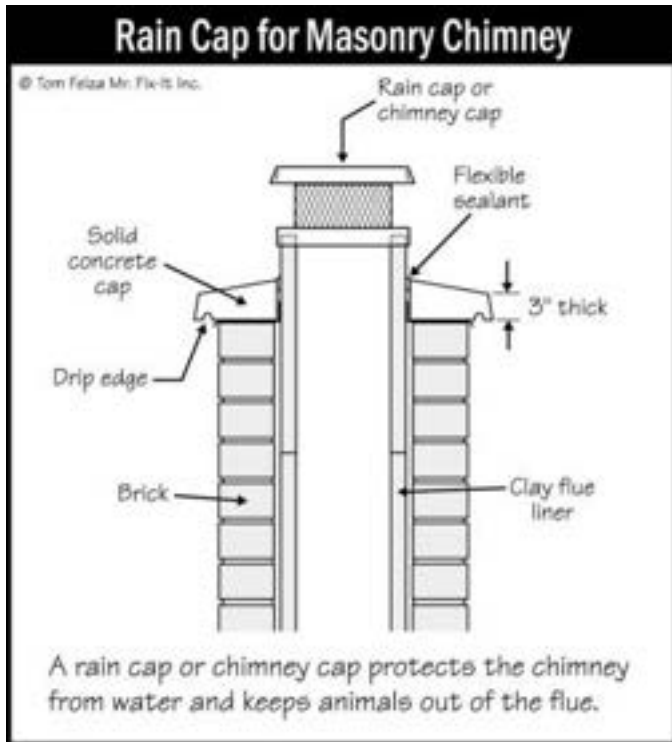
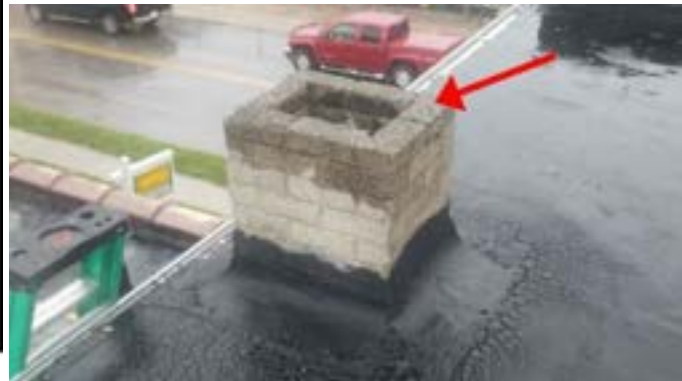
No chimney rain cap observed, suggest installing a screened chimney raincap to prevent the entrance of the elements, local wildlife, and to preserve the life of the chimney as well as minimize maintenance.

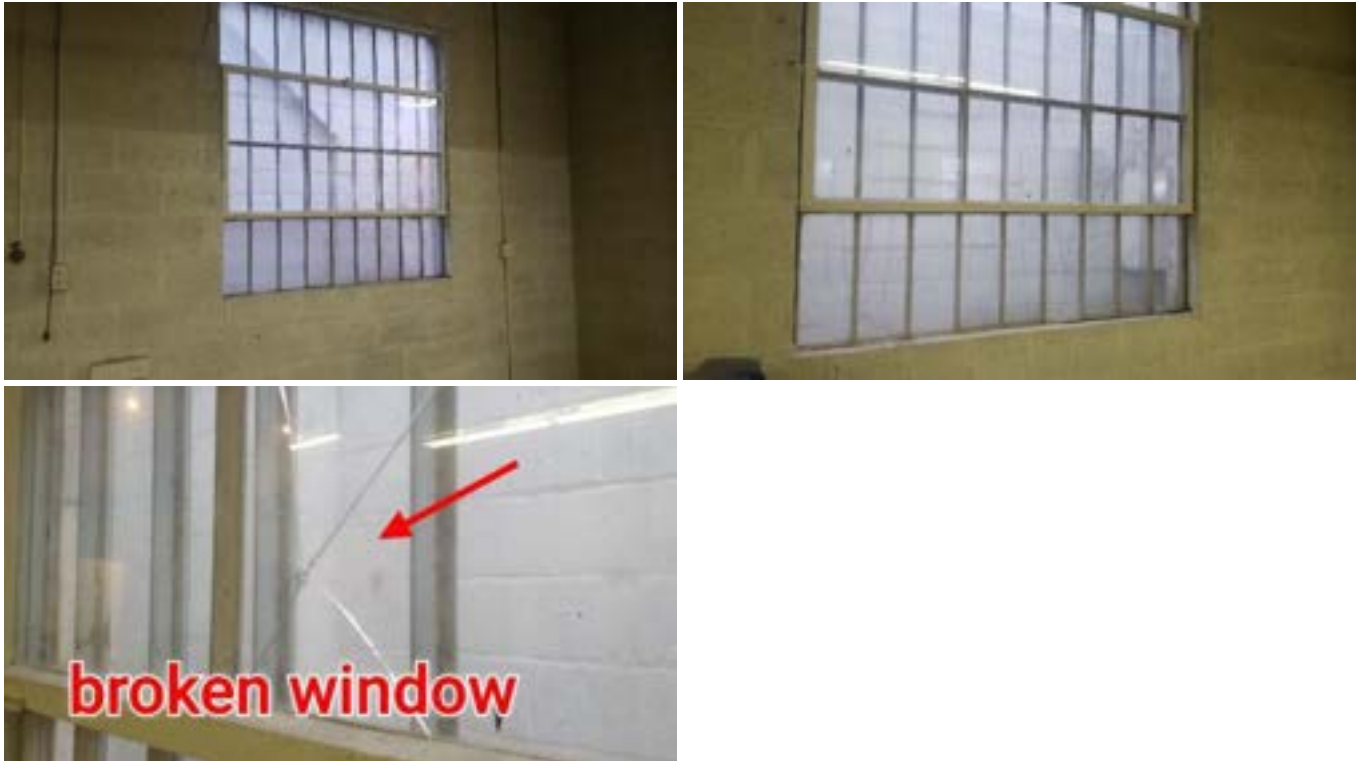
Moisture damaged trim and/or sill observed. The extent of damage could not be determined without destructive analysis. Maintenance and/or repairs should be performed. Whenever there is water damage, there is the possibility of hidden mold growth and pest infestation.

Broken/cracked pane(s) observed. Recommend review for repair or replacement as needed.

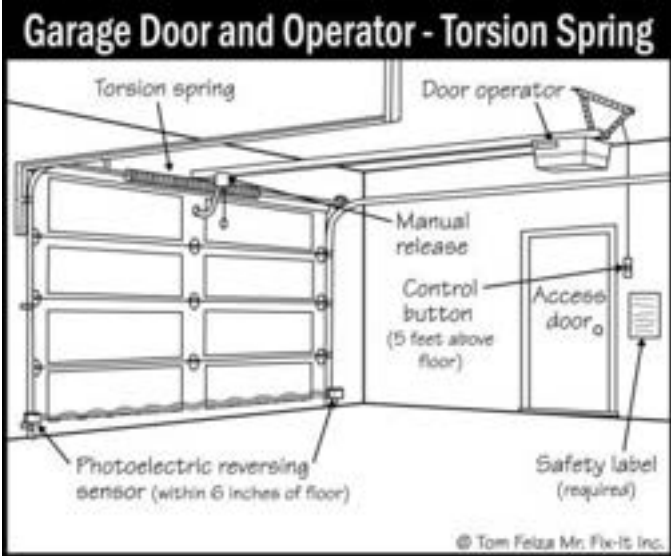
Peeling paint observed, suggest scraping and painting as needed as part of normal maintenance.

In the inspectors opinion, two of the garage doors are near the end of its useful life and do not work as designed. Recommend review by qualified contractor for repair or replacement as needed.

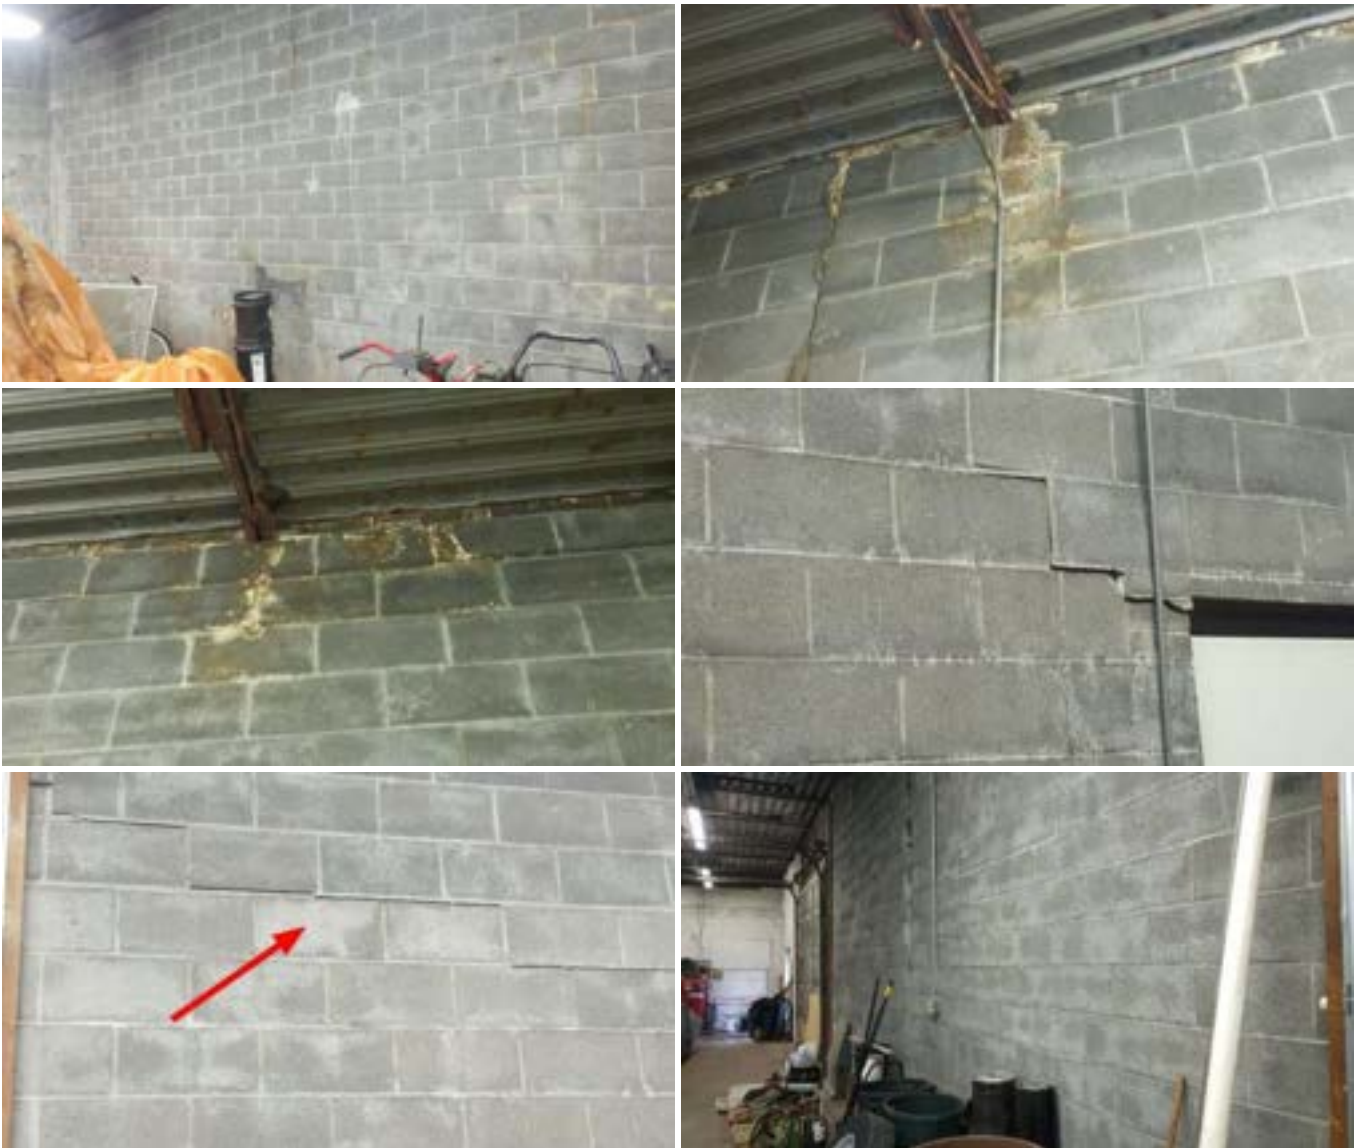
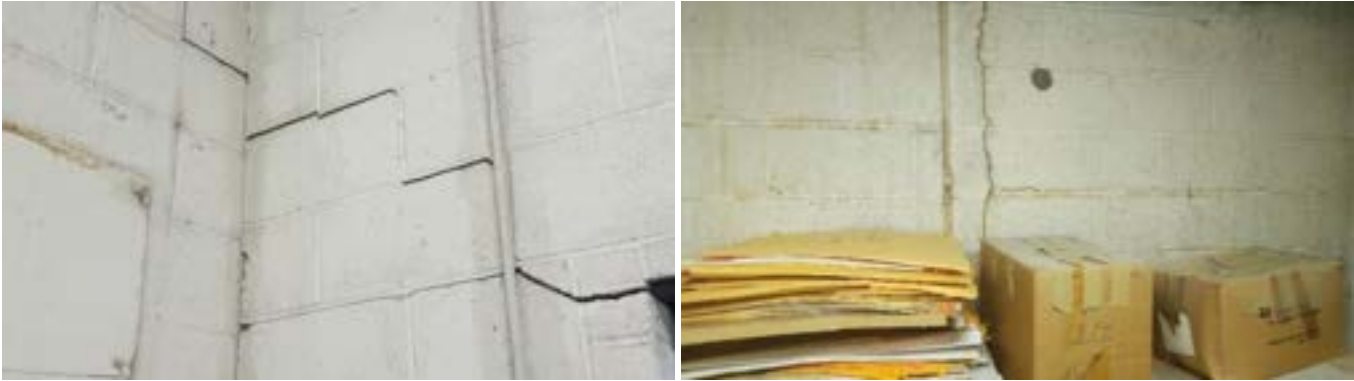
Stains observed. The inspector probed stains with a moisture detector, which showed normal moisture present at time of inspection. Client is advised to consult seller to determine the source of staining and verify that corrections have been made.

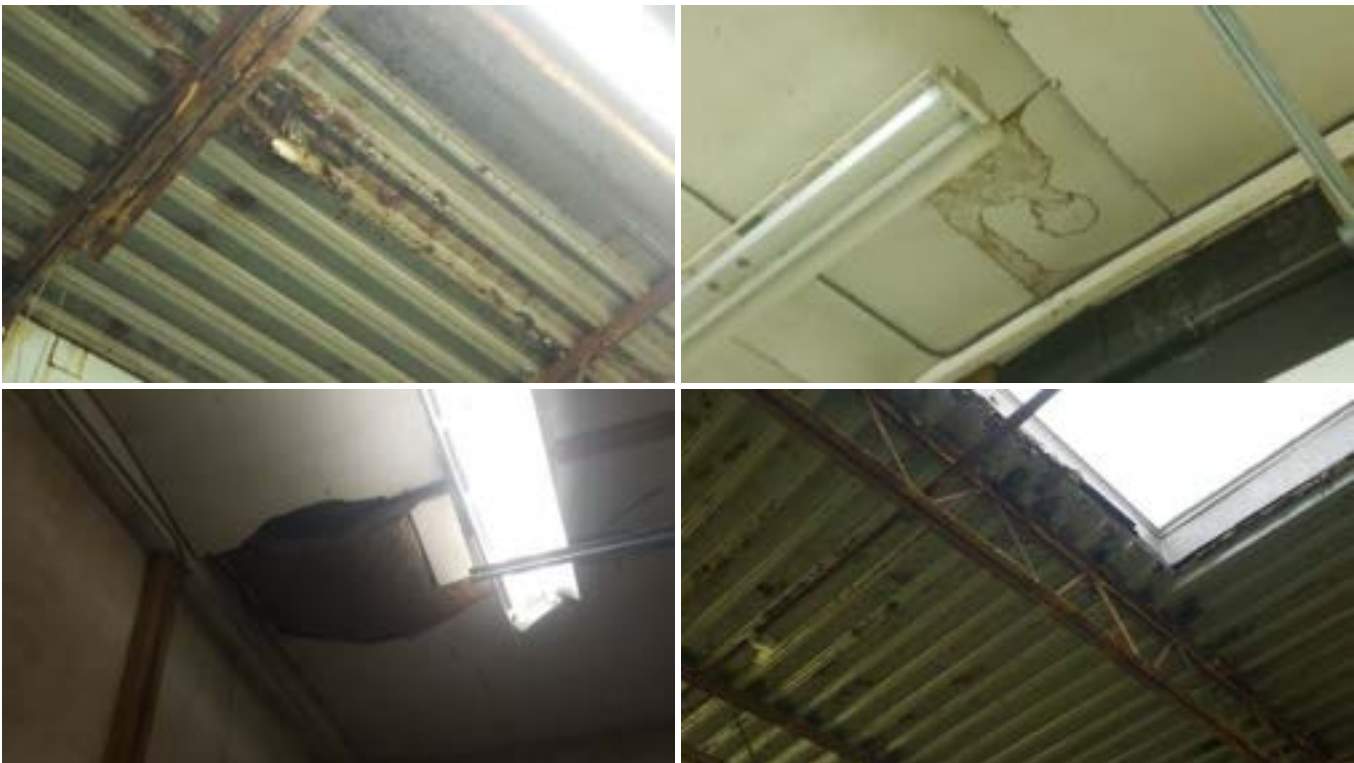
Stains observed. The inspector probed stains with a moisture detector, which showed normal moisture present at time of inspection. Client is advised to consult seller to determine the source of staining and verify that corrections have been made.

Moisture damaged ceiling observed. The extent of damage could not be determined without destructive analysis (maintenance and/or repairs should be performed). Whenever there is water damage, there is the possibility of hidden mold growth and pest infestation. Because certain types of mold may be toxic and result in adverse health effects, or if you have concerns regarding mold, we suggest review by a qualified professional. Anytime there is a mold or mildew condition we suggest clean-up be performed per EPA guidelines to correct the condition and the corrective measures be taken to limit moisture in the garage.

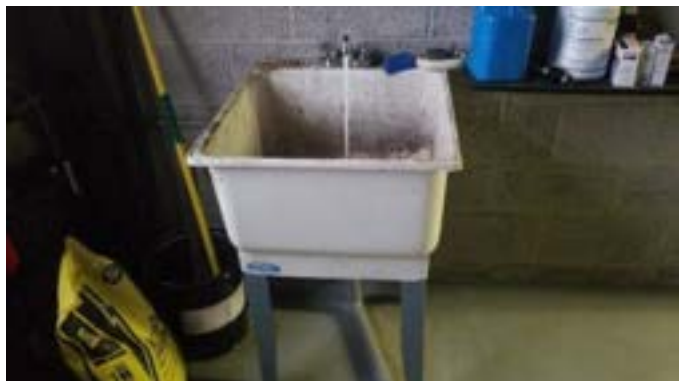
Drain, **No water flow. Unable to determine the condition of the system and/or the function of plumbing fixtures. We recommend confirming proper operation of all plumbing appliances and fixtures prior to close.**

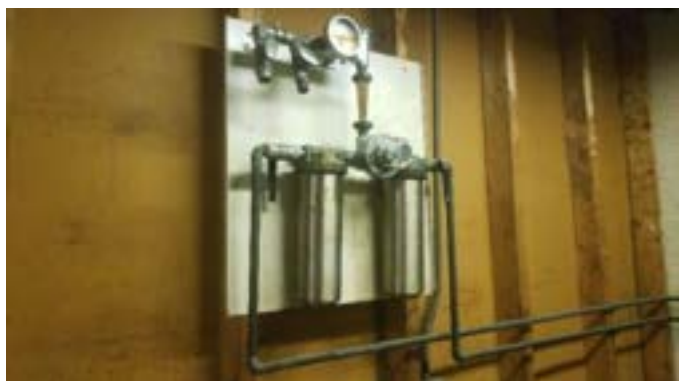
There was no water flow at this faucet at the time of the inspection and was not tested. Recommend consulting seller for additional information.

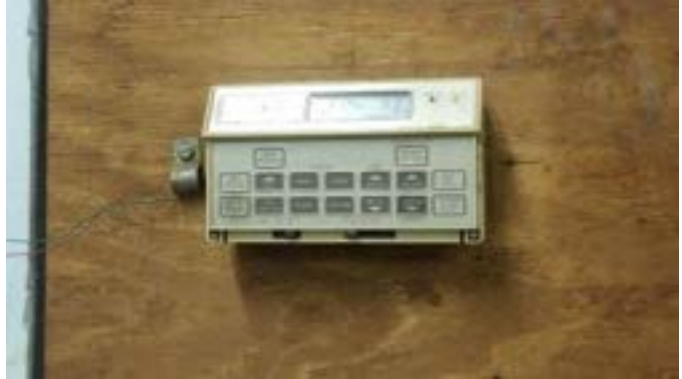
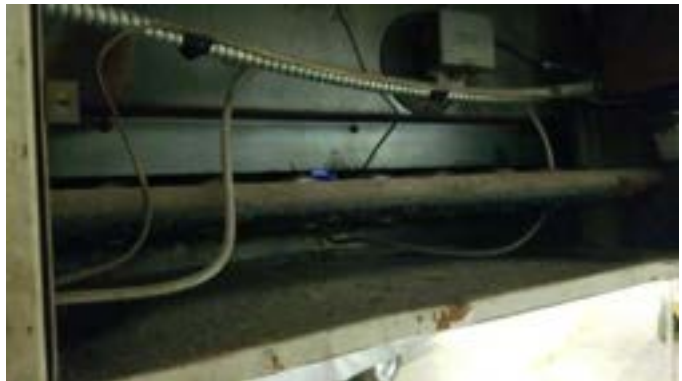
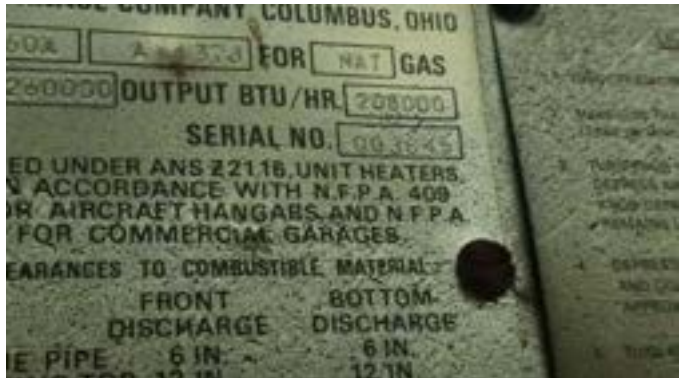
Some of the ceiling heaters in main garage area do not appear to be connected and working properly. Recommend consulting sellers to find out more information.

appear not functional, consult seller

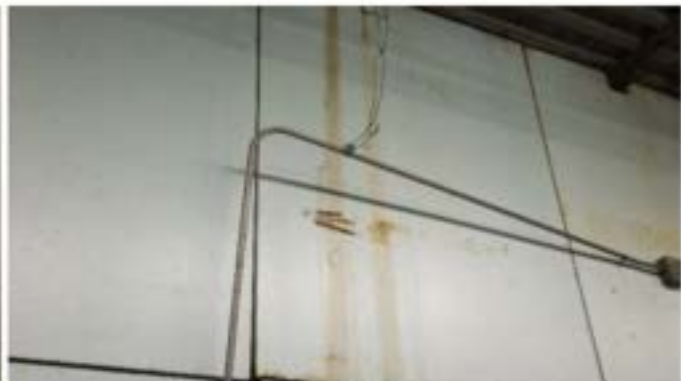
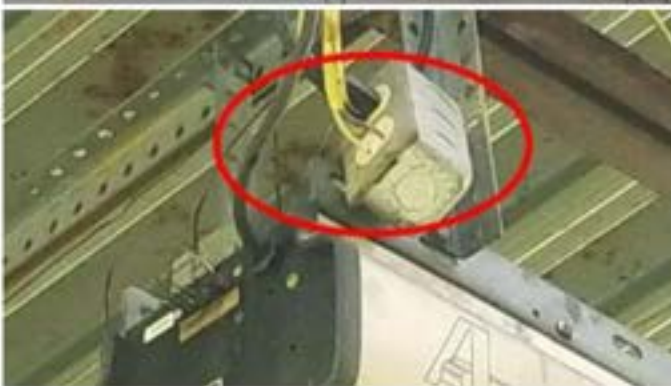
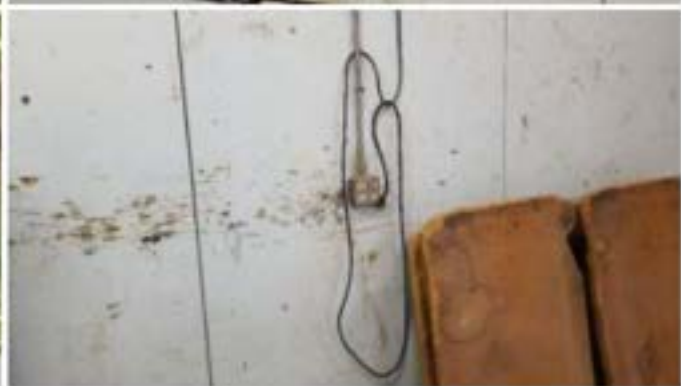
Switch and/or receptacle covers are damaged/missing. Recommend review by a qualified electrician for repair or replacement as needed.

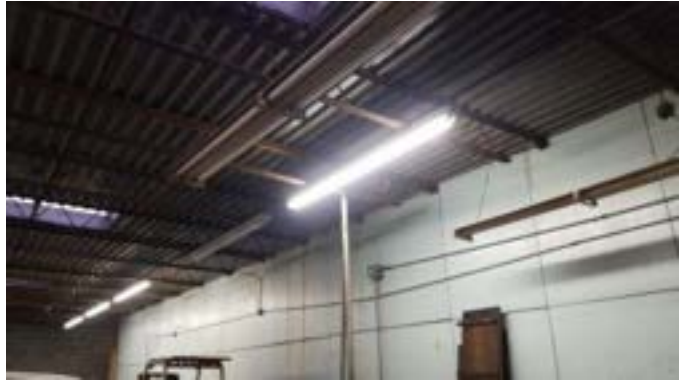
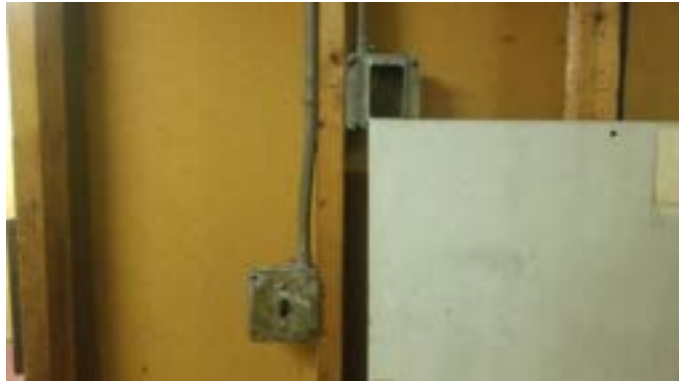
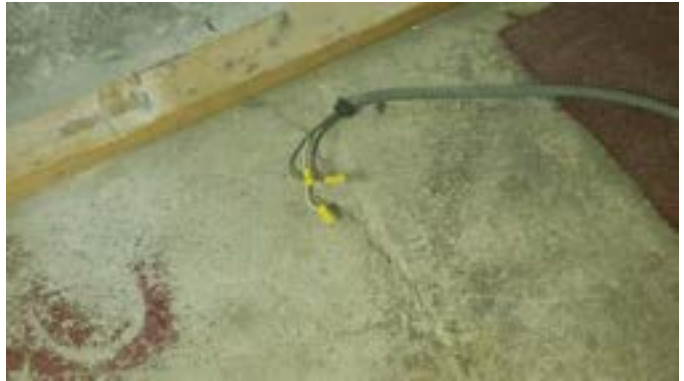
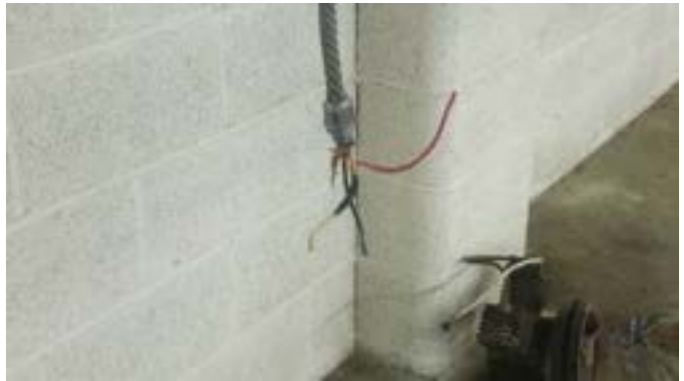
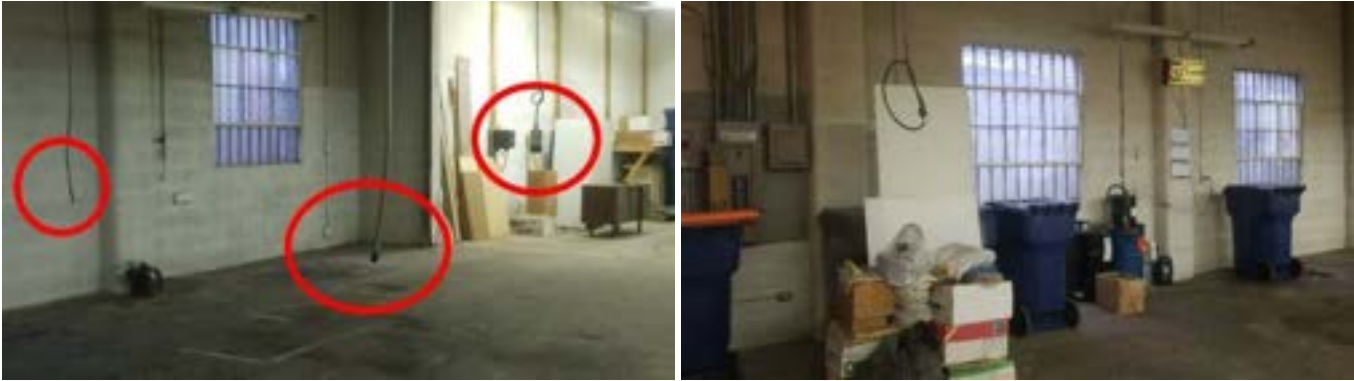
7. Loose wires observed throughout the garage and loose conduit pipe observed. Recommend securing these wires to ensure safety.

Exposed wiring was observed. Recommend review by a qualified electrician for repair or replacement as needed.

Open splices were observed. This is a "Safety Concern". Whenever an electric wire is cut and reconnected, the "splice" should be encased in a covered "junction box" to prevent shocks and separation of the splice. Recommend review by a qualified electrician for repair as needed for safety.

Visible wiring appeared to have some locations that need to be secured or rerouted for safety reasons. Recommend review by a qualified electrician for repair as needed.

Improperly terminated wiring was observed. Recommend review by a qualified electrician for repair or replacement as needed.

Loose wires observed throughout the garage and loose conduit pipe observed. Recommend securing these wires to ensure safety.

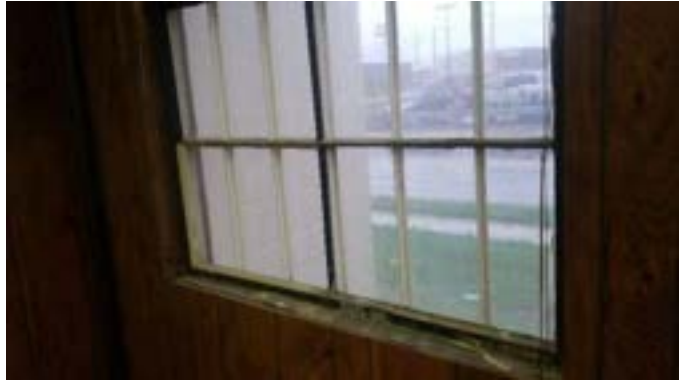
Moisture damaged trim and/or sill observed. The extent of damage could not be determined without destructive analysis. Maintenance and/or repairs should be performed. Whenever there is water damage, there is the possibility of hidden mold growth and pest infestation.

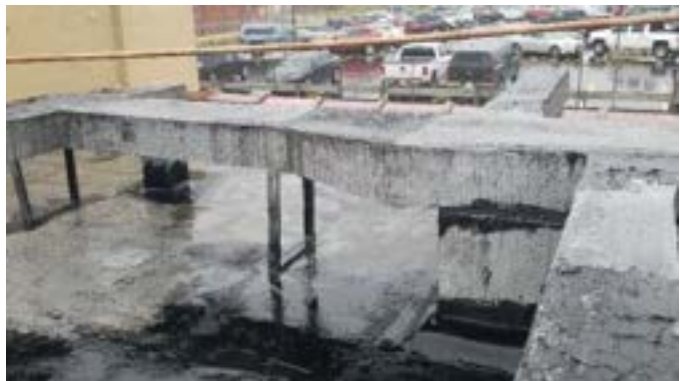
Ducts/Registers located on the roof top. Ducts are covered with roof cement and unable to determine condition. If concerned, recommend consulting qualified HVAC contractor.

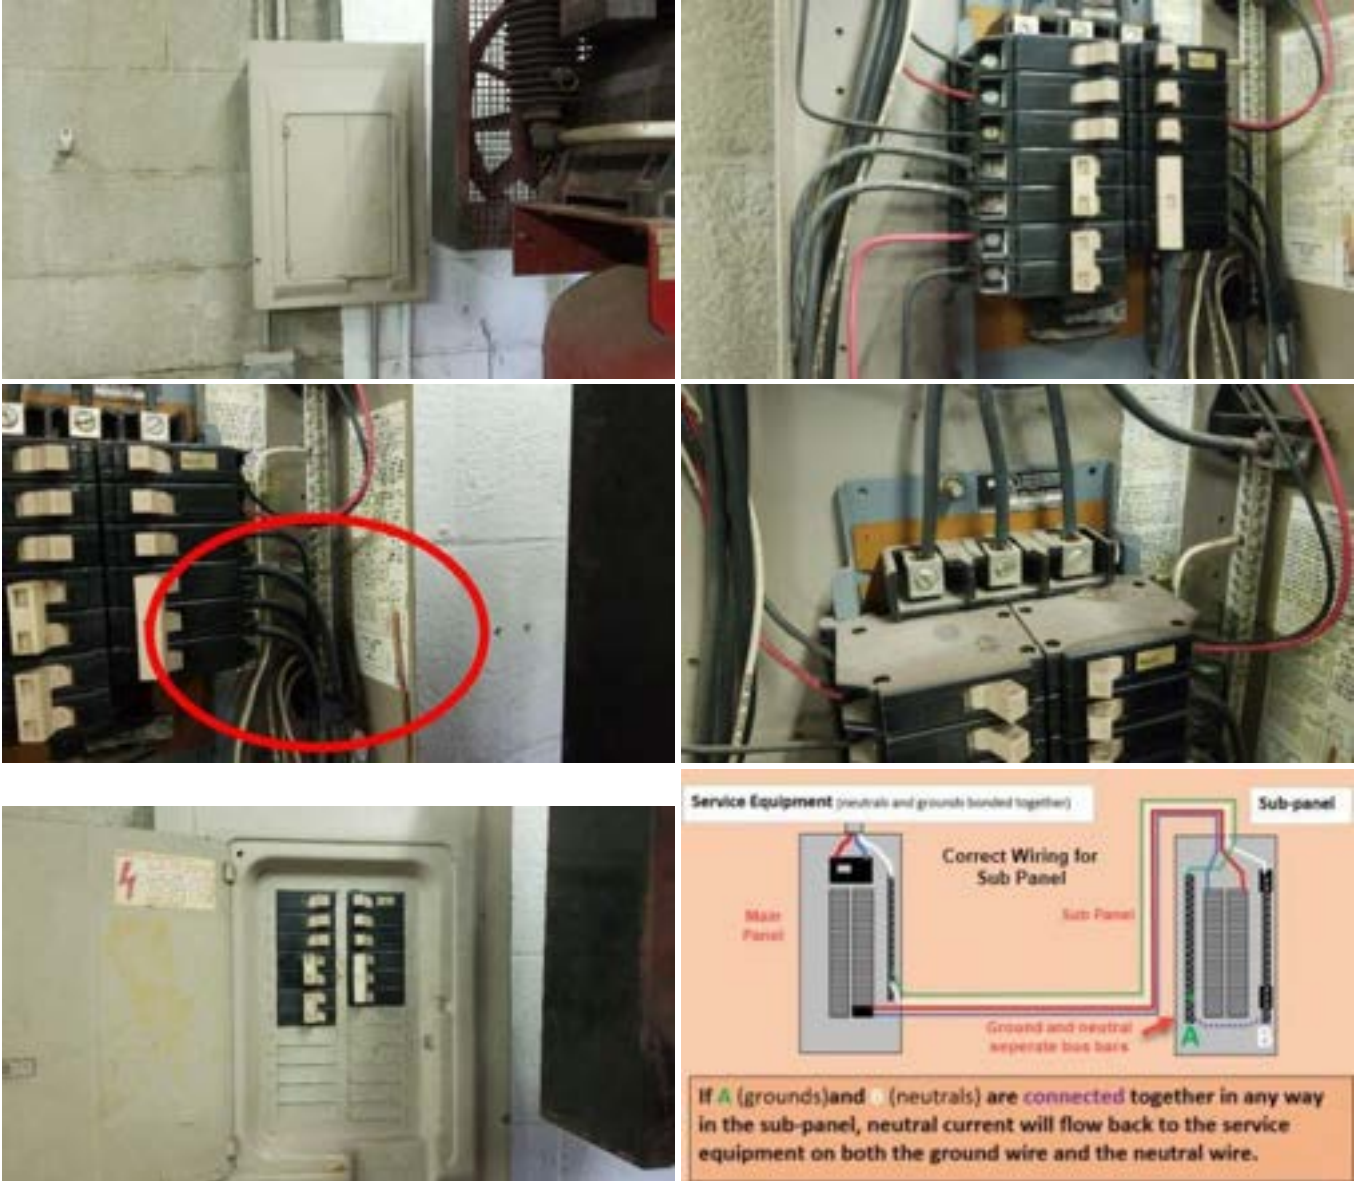
12. **Bonding in Sub Panel - Ground and neutrals are bonded in the sub panel. Sub panel neutrals and grounds should be floating (not connected). Recommend review for safe and proper operation prior to close.**

Ground wire was floating and not terminated to any grounding screw. Recommend review by a qualified electrician for repair.

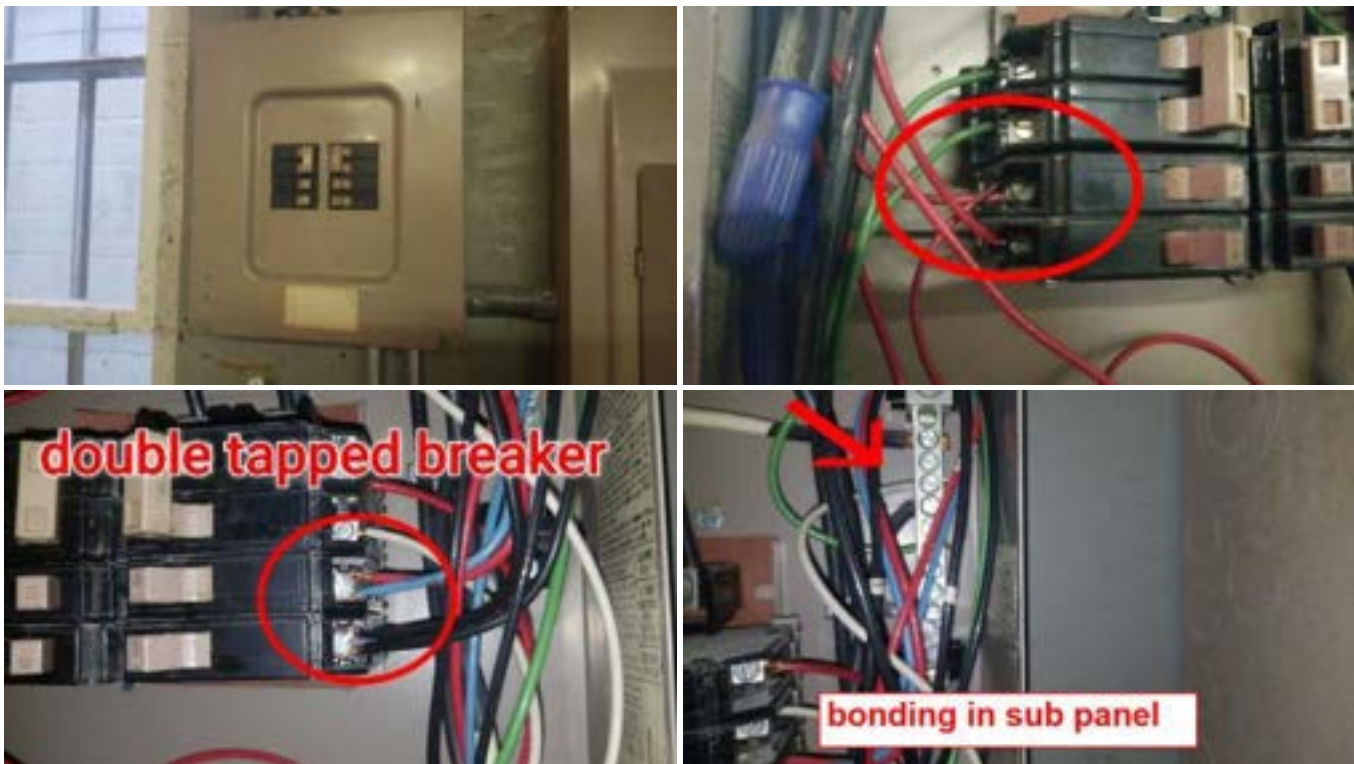
13. **Double tapping observed in panel. Double tapping (i.e. 2 wires under a single screw) at breaker or neutral bus bar, can cause possible overheating of the wire and is a safety concern. Recommend review by a qualified electrician for repair as needed.**

Ground and neutrals are bonded in the sub panel. Sub panel neutrals and grounds should be floating (not connected). Recommend review for safe and proper operation prior to close.
