Warehouse Sample Report

Confidential Inspection Report

501 Clark St
Elyria OH 44035

November 11, 2019

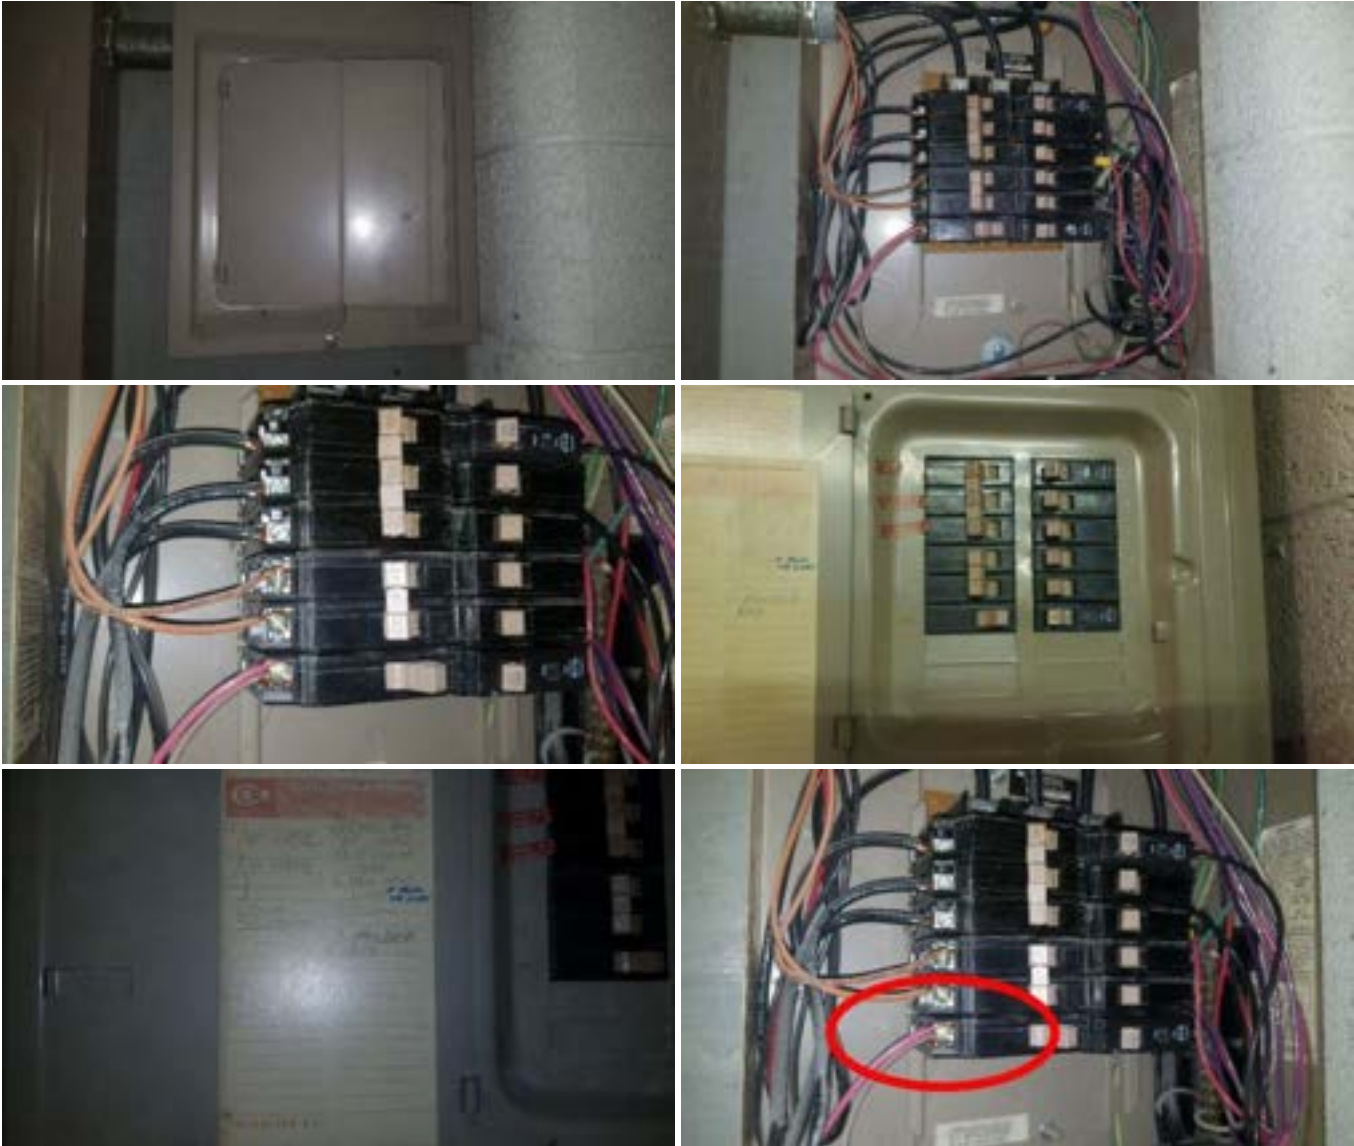
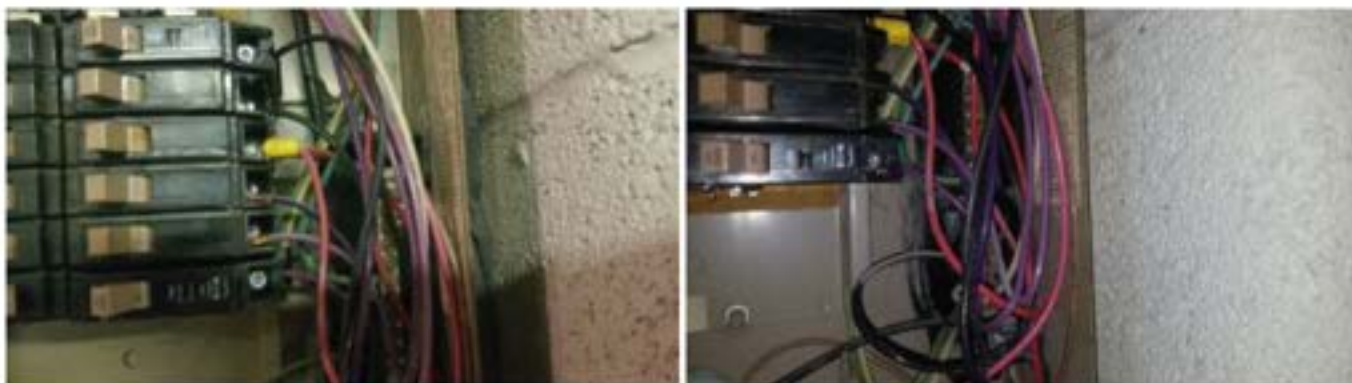
14. **Double tapping observed in panel. Double tapping (i.e. 2 wires under a single screw) at breaker or neutral bus bar, can cause possible overheating of the wire and is a safety concern. Recommend review by a qualified electrician for repair as needed.**

Ground and neutrals are bonded in the sub panel. Sub panel neutrals and grounds should be floating (not connected). Recommend review for safe and proper operation prior to close.

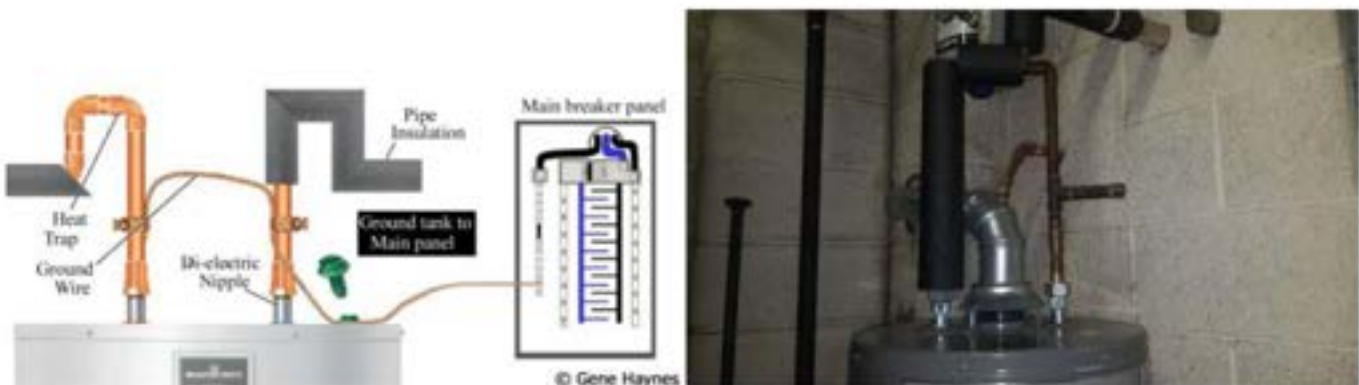
Ground jumper cable not observed between hot and cold water lines, recommend qualified electrician install jumper cable to insure proper grounding and safety.
