# Confidential Inspection Report

1234 Main Cir Avon  
Lake OH 44012

November 15, 2019

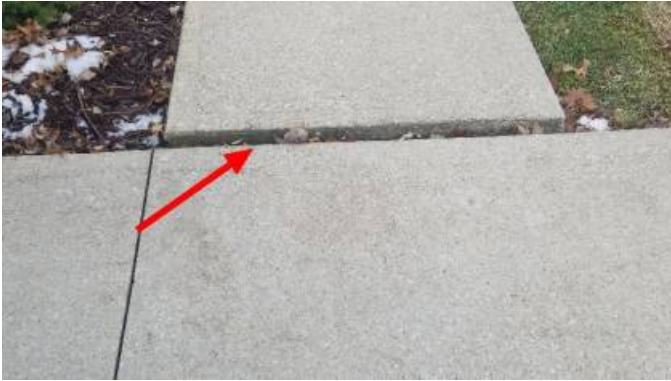
Possible trip hazard noted at various locations. This is a safety concern. Suggest repair/replacement as needed to ensure safety.

Settling observed recommend review by a qualified contractor for repair or replacement as needed.

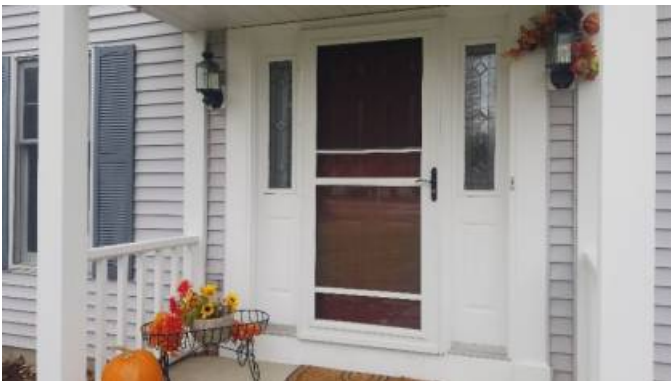
**Peeling paint observed at doors, suggest scraping and painting as needed as part of normal maintenance.**

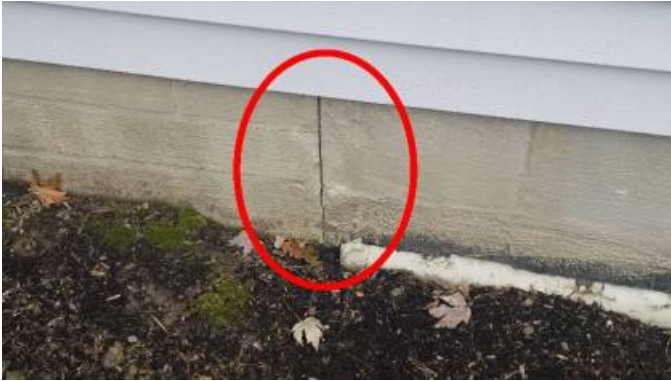
Common cracks observed, primarily a cosmetic concern. Suggest sealing any cracks in concrete/brick/block surfaces to prevent water penetration as a routine maintenance effort.

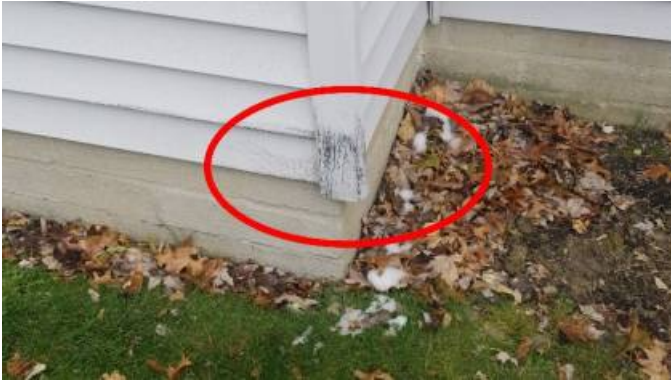
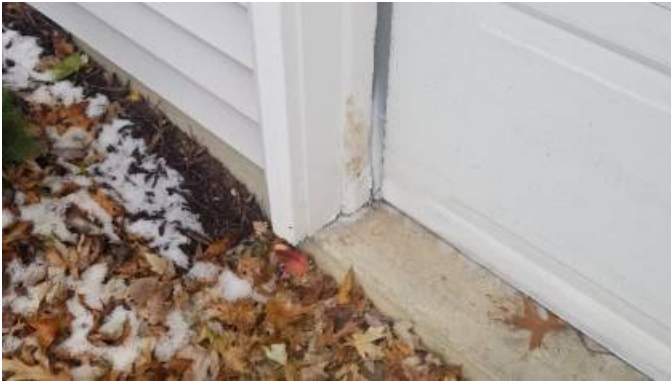
**Loose/damaged trim observed at various areas; suggest repair or replacement as needed.**

**Peeling paint observed at various areas; suggest scraping and painting as needed as part of normal maintenance.**

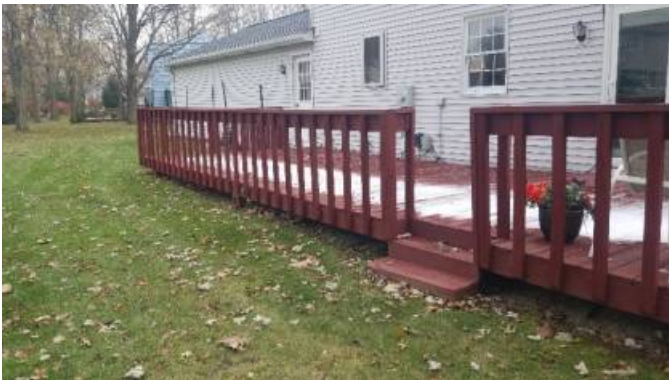
**Deck is weathered: suggest cleaning, staining or sealing as needed to preserve the remaining life of the deck.**

**Peeling paint observed at various areas, suggest scraping and painting as needed as part of normal maintenance.**

**Deck appears to be leaning slightly due to support posts settling over time. If concerned, recommend review by a qualified contractor for repair or correction as needed.**

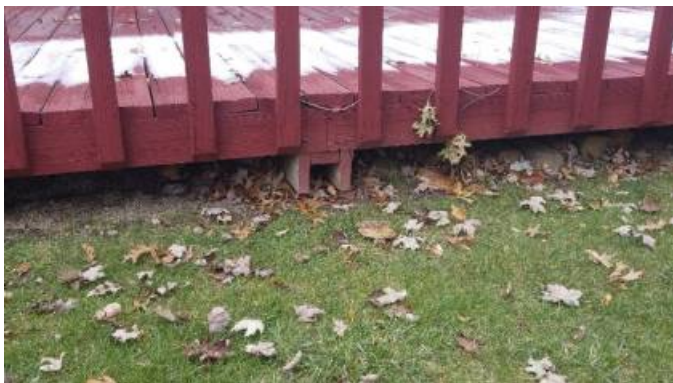
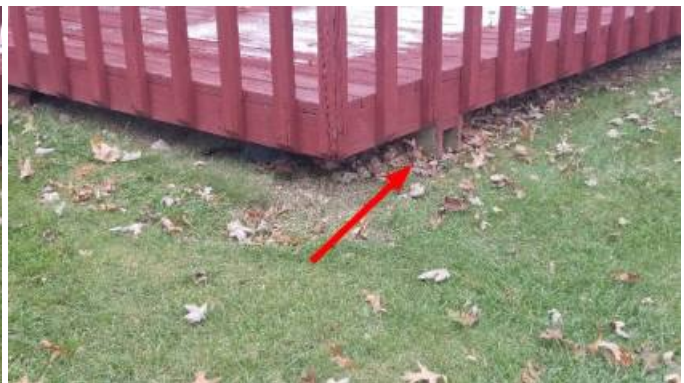
Due to limited visibility under the deck, I was not able to verify the structural condition of the posts, if there is correct drainage, or if framing is bolted to the structure.

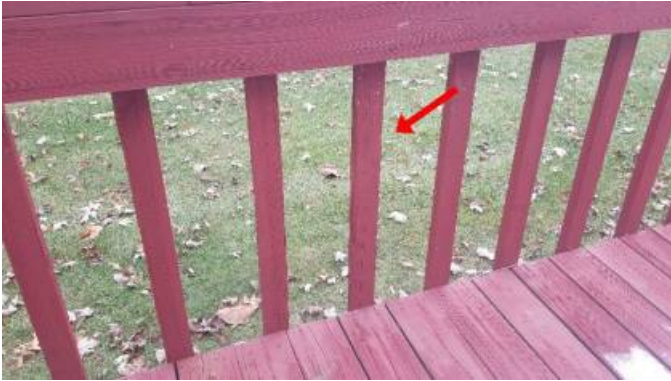
**Spacing between guardrails is larger than 4 inches which may allow small children to crawl through the space. Client may wish to reduce spacing as a child safety enhancement.**

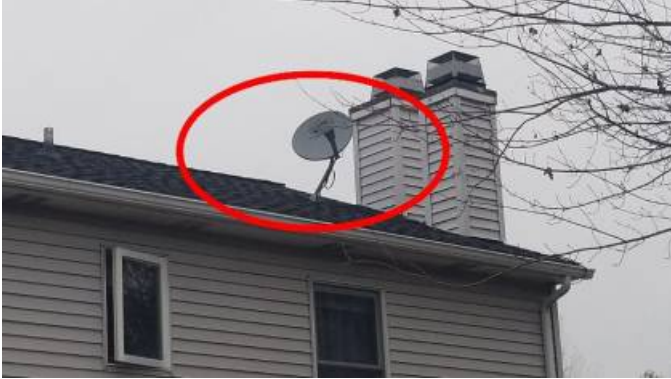
Satellite dish observed mounted directly to roof covering. The securing screws penetrate the roof covering, underlayment and sheathing. Over time, this installation will most likely leak water into the structure causing water damage. A better installation might be to bolt the dish to a vertical structural element and seal the bolts/screws to insure that water does not penetrate the building envelope. Other installations include locations separate or detached from the main structure (preferred). If you choose to remove the dish from it's current location, immediate repair to the roof covering is recommended." Consult with a qualified, professional roofing company to determine the best method for roof covering repairs.

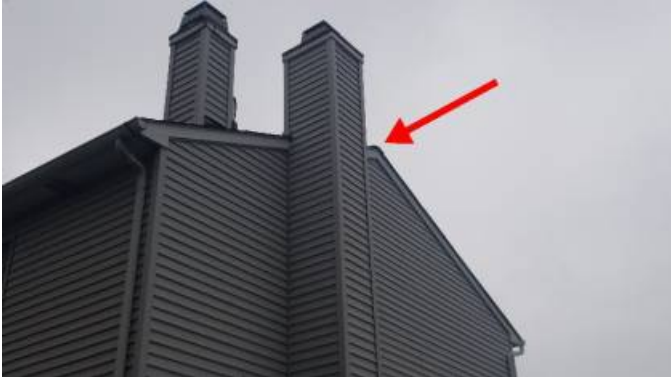
**Metal chimney crown is rusted. Chimney crown is the metal that seals the top of the chimney. This is a neglected maintenance item in most homes. Recommend repair or replacement as needed.**

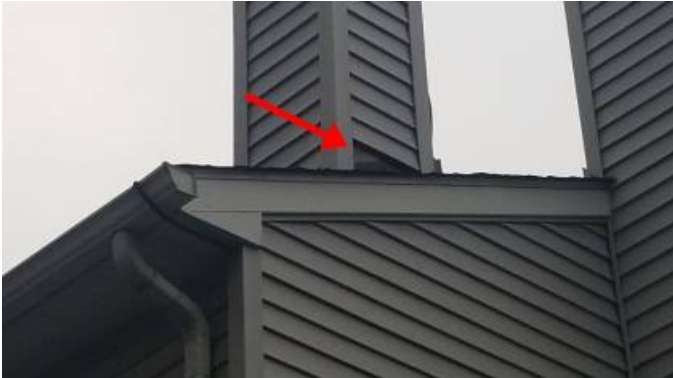
**Metal chimney crown is rusted. Chimney crown is the metal that seals the top of the chimney. This is a neglected maintenance item in most homes. Recommend repair or replacement as needed.**

**Siding missing from chimney, recommend repair of siding.**

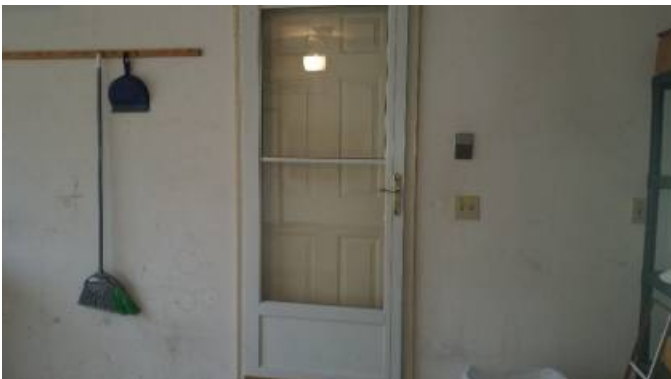
**No self-closer observed. Suggest installing self-closer as a safety enhancement.**

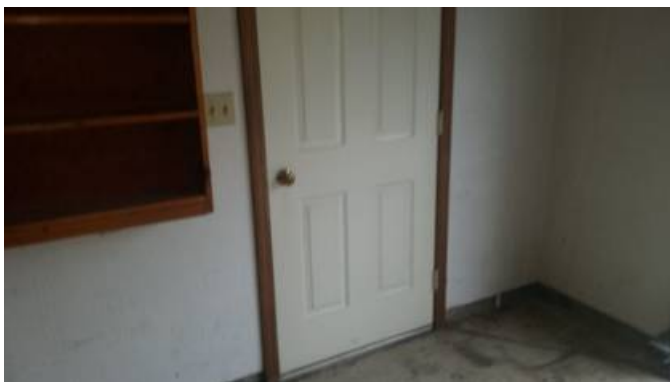
**Peeling paint observed at doors, suggest scraping and painting as needed as part of normal maintenance.**

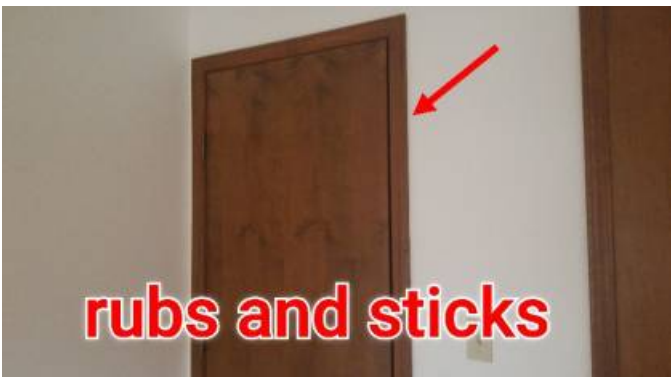
Door rubs jamb and will not close properly, adjustments are needed. This condition is possibly related to minor settlement, which is common in homes built on a conventional foundation. No further signs of settlement were observed in general area of door.

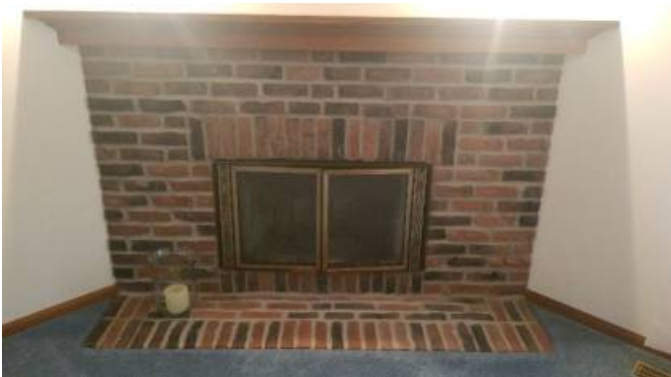
Serviceable.

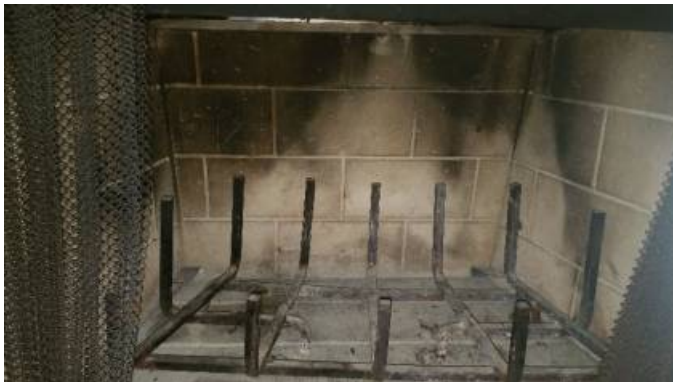
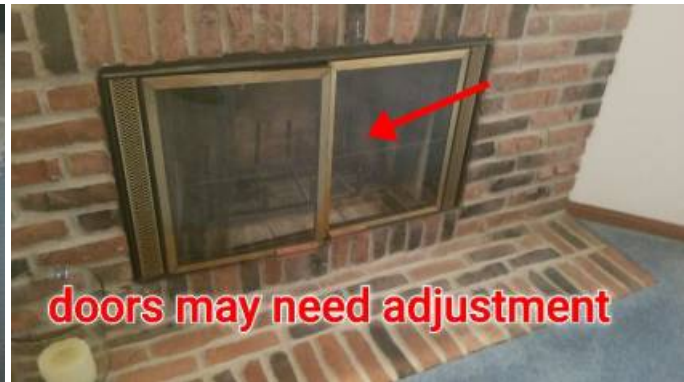
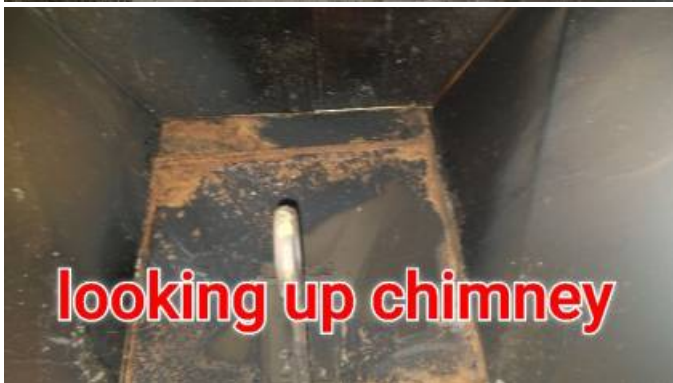
Yes - There is a mantle installed, and it meets the 12" minimum clearance above the firebox.

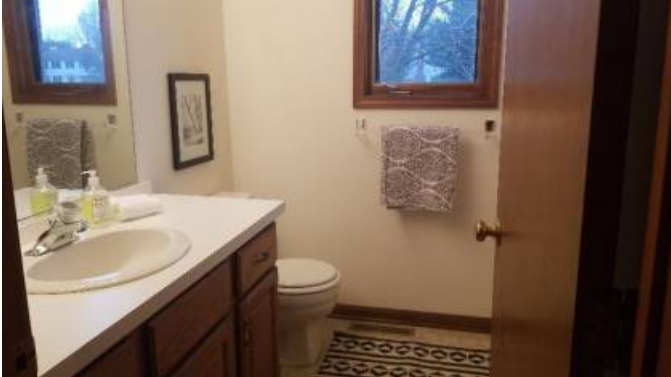
Door rubs jamb and will not close properly, adjustments are needed. This condition is possibly related to minor settlement, which is common in homes built on a conventional foundation. No further signs of settlement were observed in general area of door.

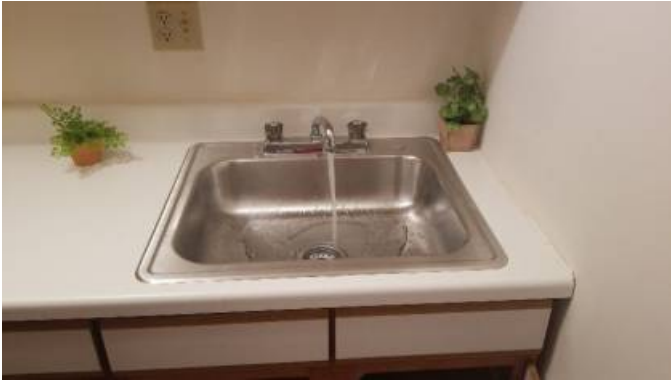
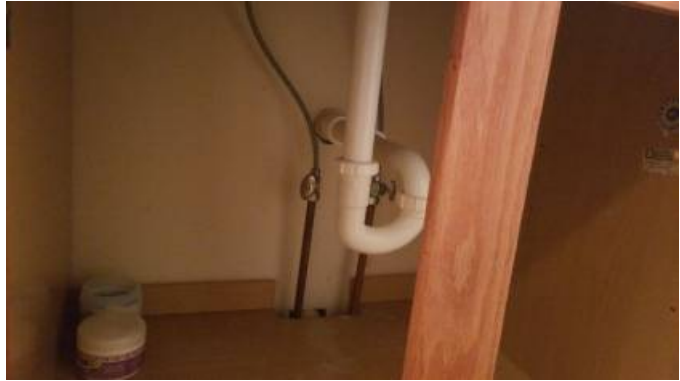
Sink, Serviceable

Faucet, **The hot and cold faucets are reversed, which is a possible safety concern. Recommend review by qualified professional for repair or replacement as needed.**

Drain, Serviceable

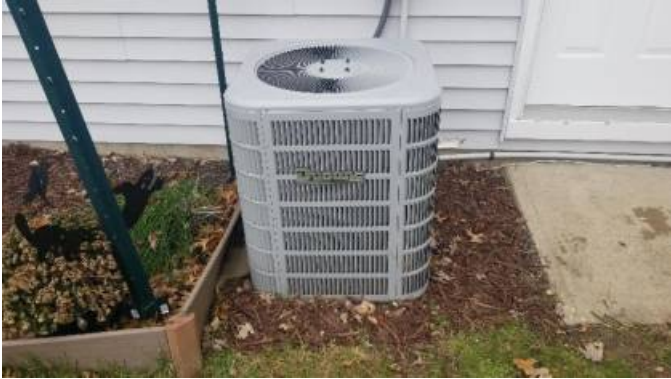
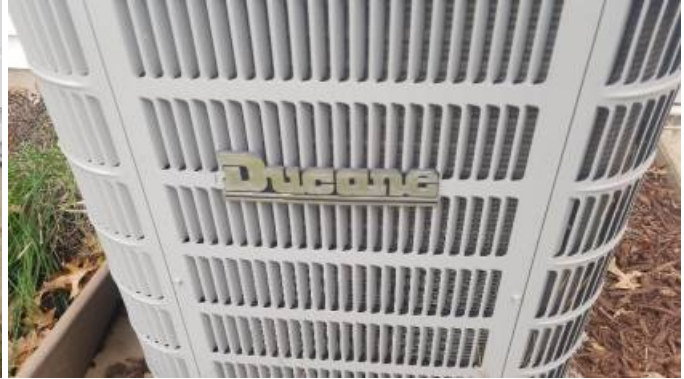
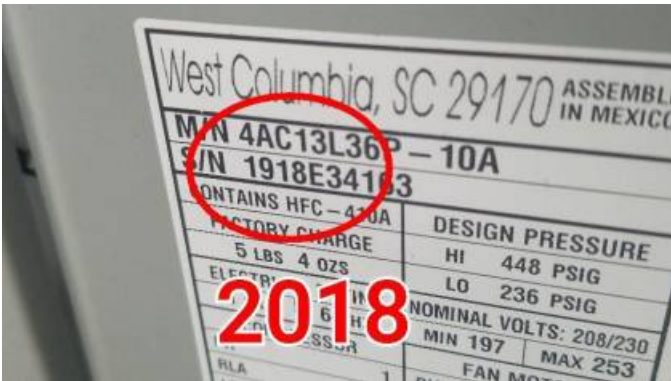
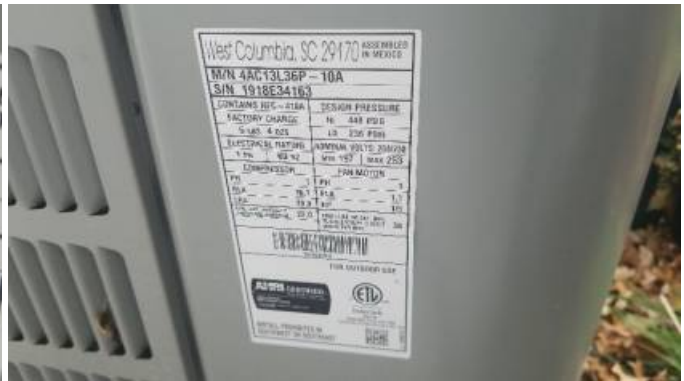
System is Ducane. Year is a 2018 and unit is 1 year old.

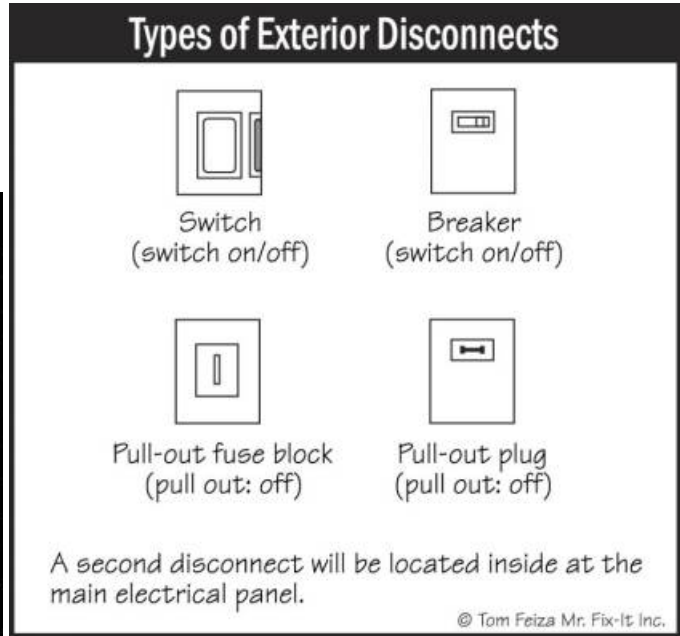
A004

Electric split system with disconnect was observed.

**Inspector observed disconnect box was rusted, recommend review for replacement as needed by a qualified electrician.**

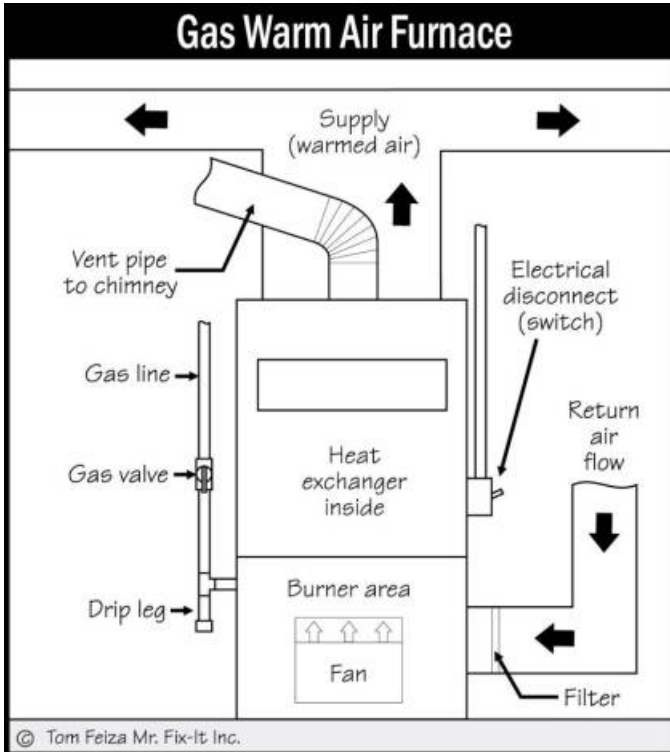
H001

The brand of the system is Trane brand. Unit is more than 30 years old and appears to be the original furnace.

**Rust, scale, and some debris was observed in this appliance. Recommend review by a**

**qualified HVAC contractor ensure proper and safe operation of this unit prior to close. Dismantling to inspect for holes and/or cracks in heat exchanger is not within the scope of this inspection.**

**We recommend this equipment be cleaned and evaluated by a qualified HVAC contractor for repair or replacement prior to close.**

**Although the furnace works, In the inspectors opinion the heating unit has exceeded its designed life expectancies and should be replaced. We make no warranty, guarantee or estimation as to the remaining useful life of this unit.**

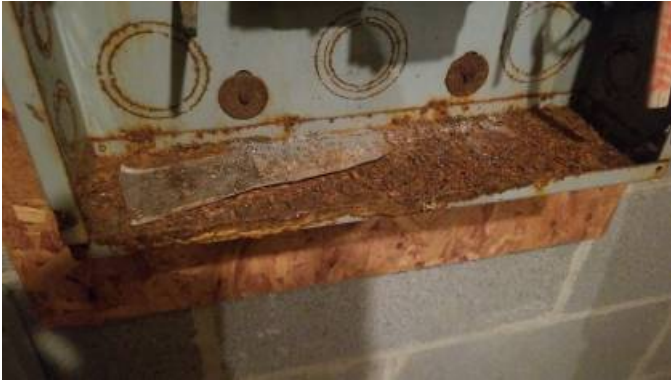
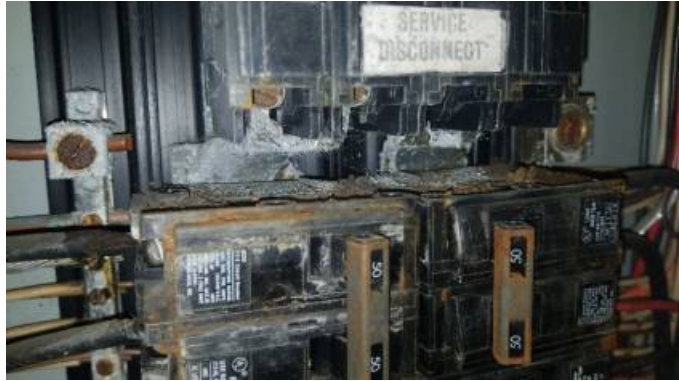
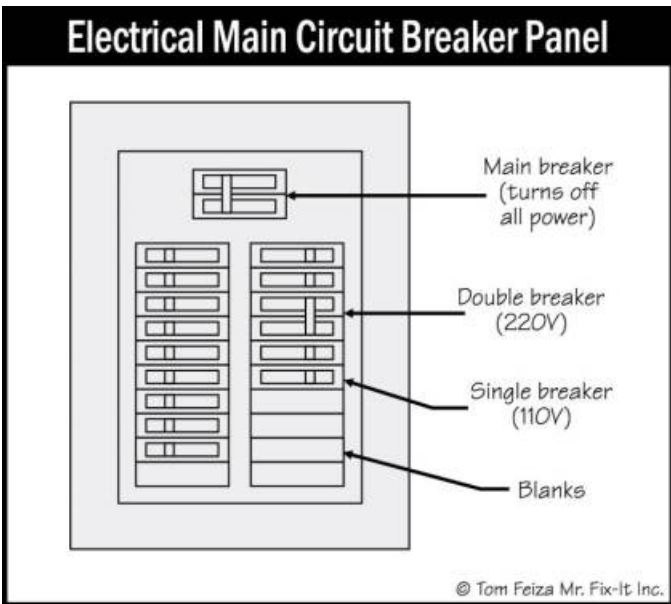
E002

**Double tapping observed in panel at neutral bus bars. Double tapping (i.e. 2 wires under a single screw), can cause possible overheating of the wire and is a safety concern. Recommend review by a qualified electrician for repair as needed.**

**Excessive rust or water was observed in the panel, this is a possible safety hazard. Recommend review by a qualified electrician for repair or replacement as needed.**

**In the inspector's opinion, the electrical panel has exceeded its designed life expectancies and may be a safety concern due to all the corrosion and moisture in the panel. We make no warranty, guarantee or estimation as to the remaining useful life of this panel. Recommend replacing the electrical panel with a licensed electrical contractor.**

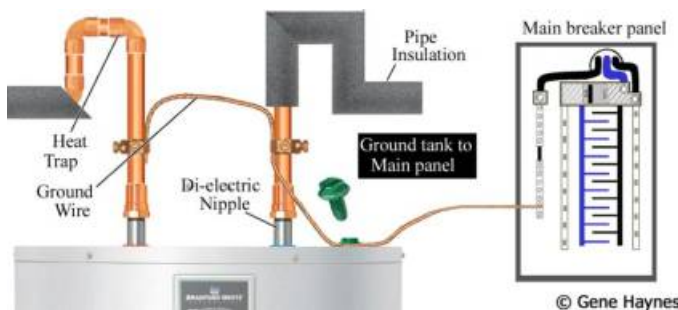
**Ground jumper cable not observed between hot and cold water lines, recommend qualified electrician install jumper cable to insure proper grounding and safety.**

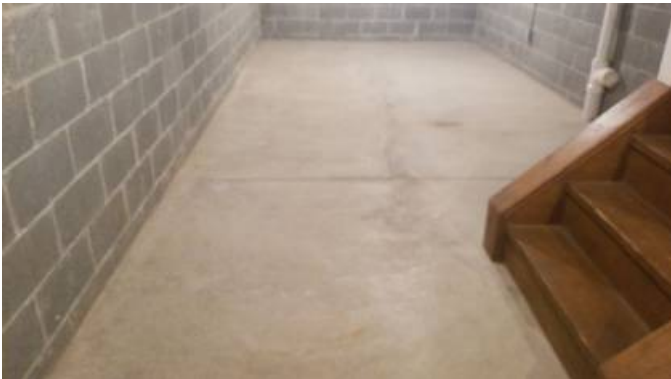
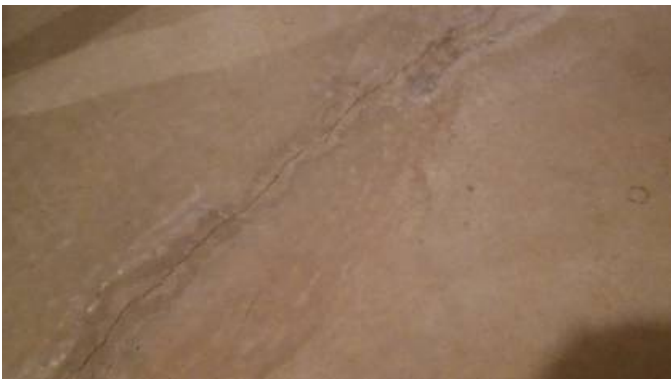
**Common cracks observed, primarily a cosmetic concern. Suggest sealing all joints as well as any cracks in surfaces to prevent water penetration as a routine maintenance effort.**

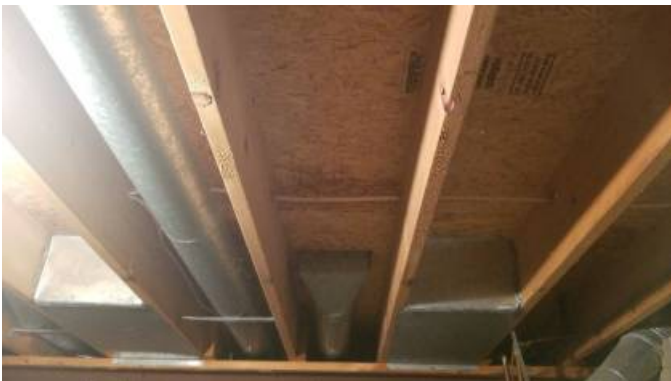
**Joists and Subfloor:**

Serviceable, Convention wood framing.

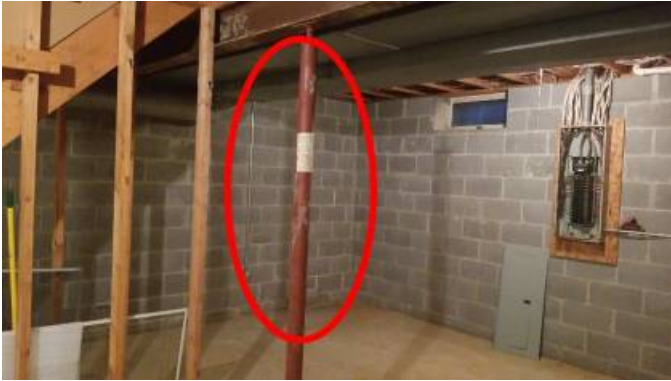
**Supports**

Serviceable, Metal Posts

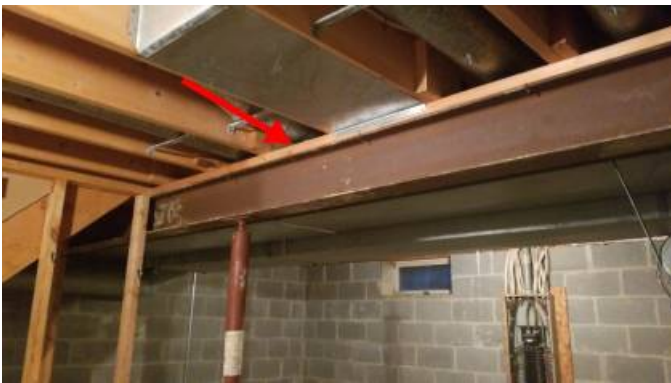
### **Beams**

Serviceable, Metal Beams

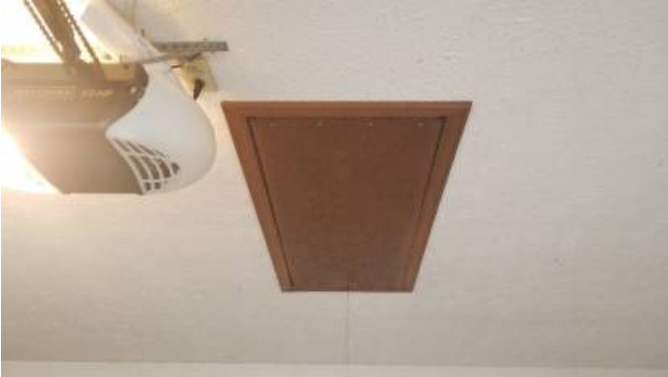
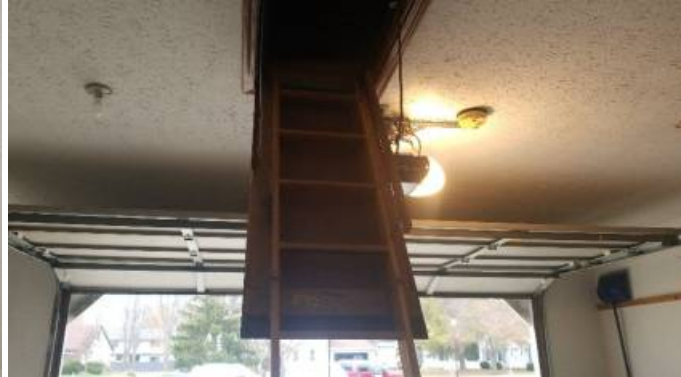
### Access Location:

The attic access is located in the garage and in a bedroom closet.

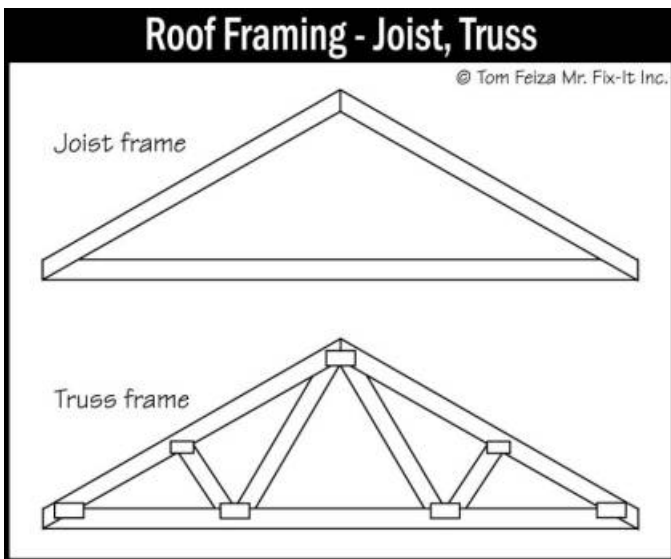
### Framing:

A truss system is installed in the attic cavity that is used to support the roof decking and transmit the roof load to the exterior walls.

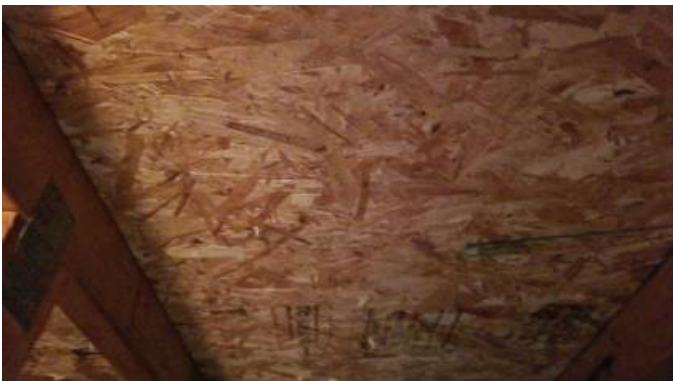
**Sheathing:**

Waferboard

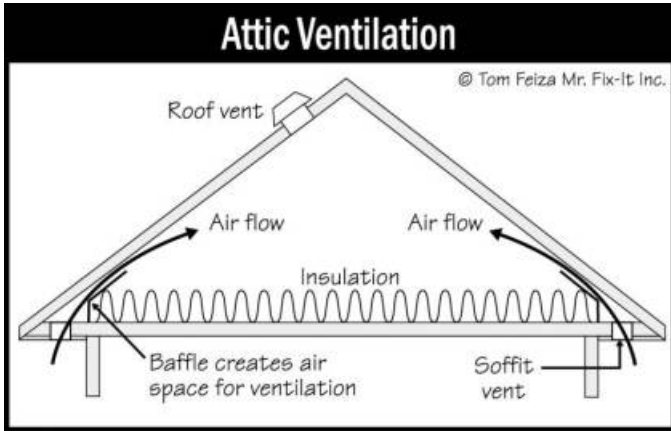
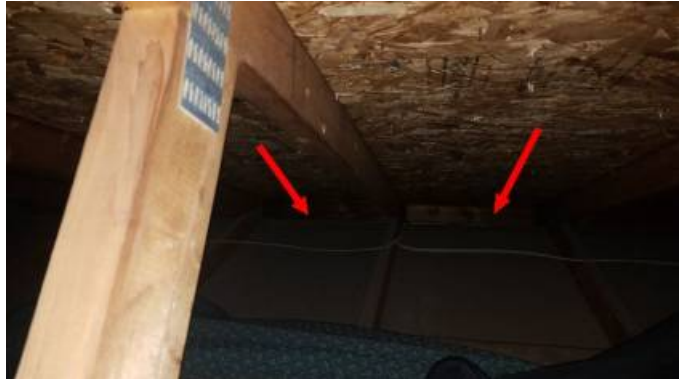
**Ventilation:**

Hooded Roof Vents

Ridge Vents

There are soffit vents installed.

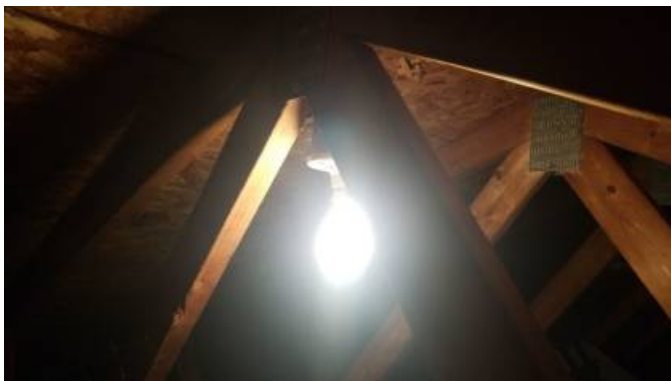
### **Switches/Fixtures/Outlets:**

A representative sampling of switches and outlets were tested. As a whole, switches and outlets throughout the attic are in serviceable condition.
