**Confidential Inspection Report**  
**3542 W 44th St**  
**Cleveland OH 44109**

**August 27, 2021**

Prepared for:  
**John Doe**  
**3542 W 44th St**  
**Cleveland OH 44109**

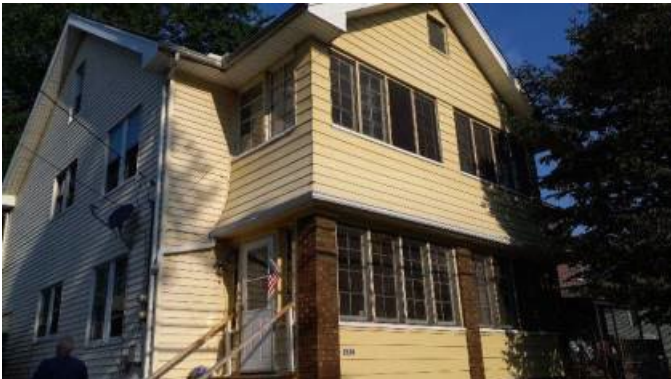
**Loose/missing siding observed at various areas. Recommend review for repair or replacement as needed.**

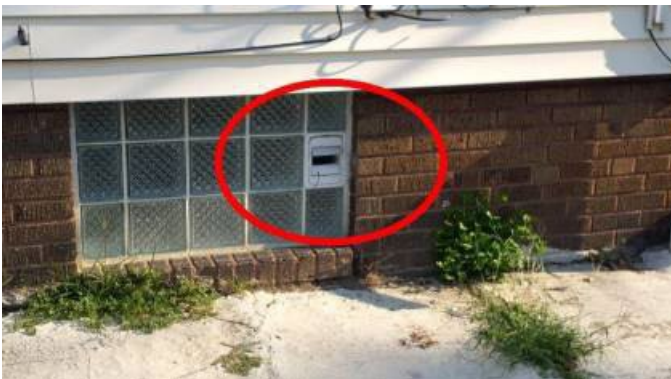
**Observed damaged vent. Recommend repairing or replacing vent cover to keep out birds and vermin.**

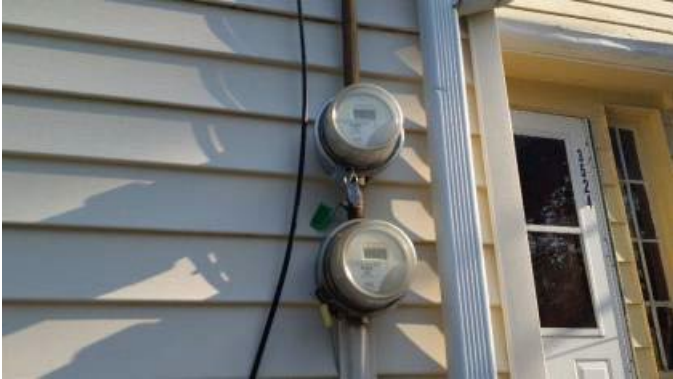
**Older style meter socket originally approved for 60 amp service only - Review recommended by a licensed electrician.**

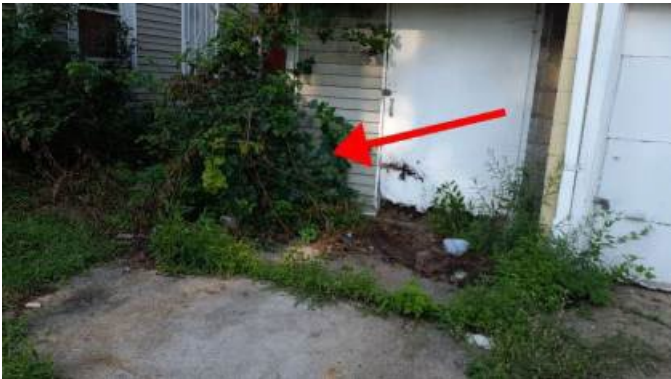
**Vegetation and overgrowth observed too close to structure. Bushes and shrubs need to be trimmed away from the structure at least 2 feet. This can promote moisture damage or direct access to the structure by insects which is not always visible to the inspector. This was a limited review of this area.**

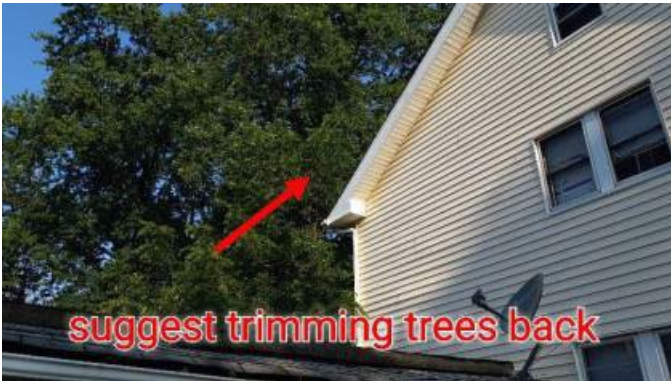
**Trees overhanging the structure need to be trimmed so that limbs, leaves, and rain will not drop off the tree onto the roof covering and clog the gutters, damage the roof, or promote moss growth. Trees that rub against the roof can cause severe damage and can drastically reduce the life of the roofing material. If concerned recommend contractor review for corrections as needed.**

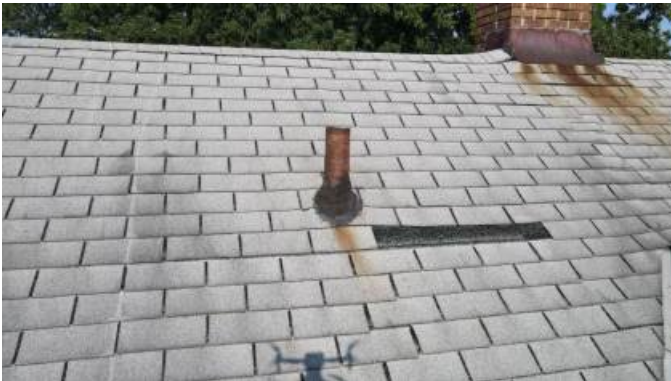
**Missing shingles observed. Recommend review by a qualified roofer for repair or replacement as needed prior to close.**

**Multiple layers of roofing observed on all or some parts of the roof. Typically two layers are considered the maximum in most jurisdictions.**

**Recommend a roof "tune-up" by a qualified roofing contractor to reseal any loose shingles, caulk around flashings and nail heads and review for any other issues.**

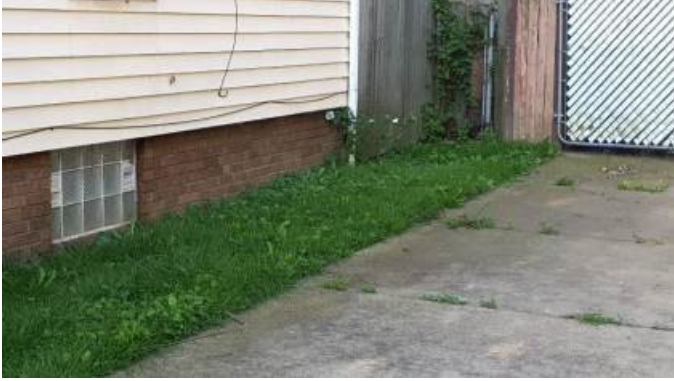
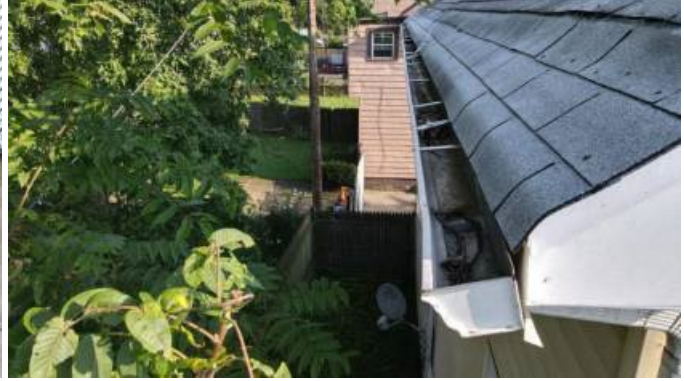
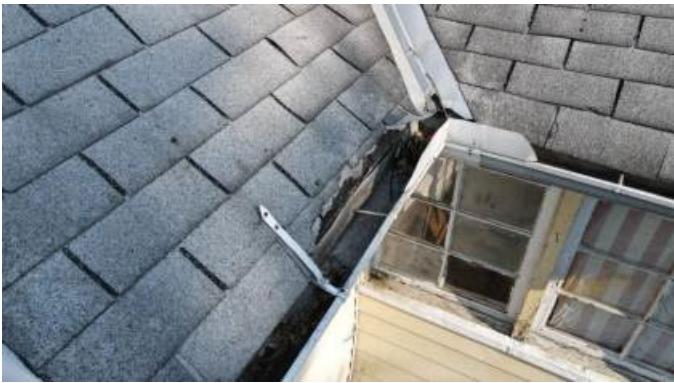
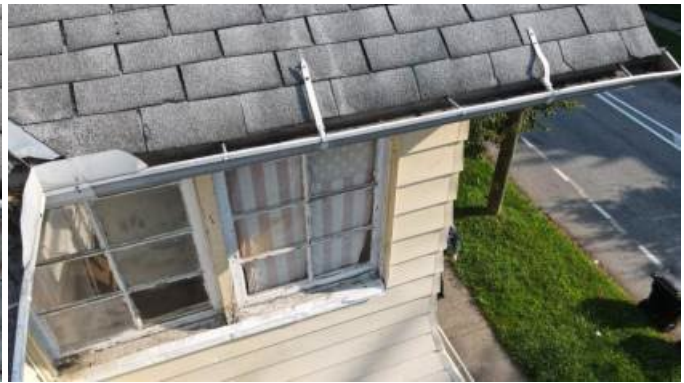
Fasteners are loose at one or more areas; suggest securing as needed for proper operation. Loose nails in fascia board may indicate that fascia board is deteriorated. Unable to view behind gutter. Recommend review by qualified contractor for repair or replacement as needed.

No gutter system is present on all or part of the roof, suggest client consider installing a full gutter system to more effectively divert roof runoff.

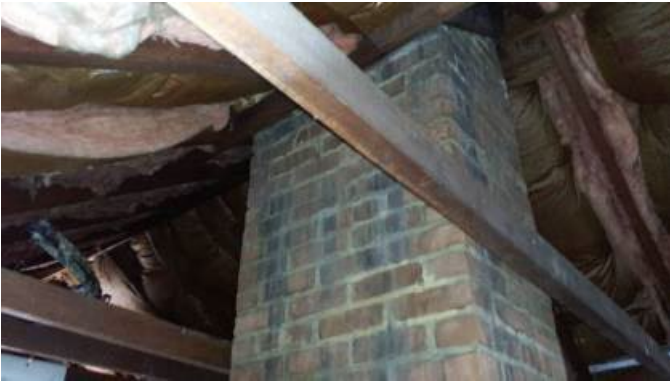
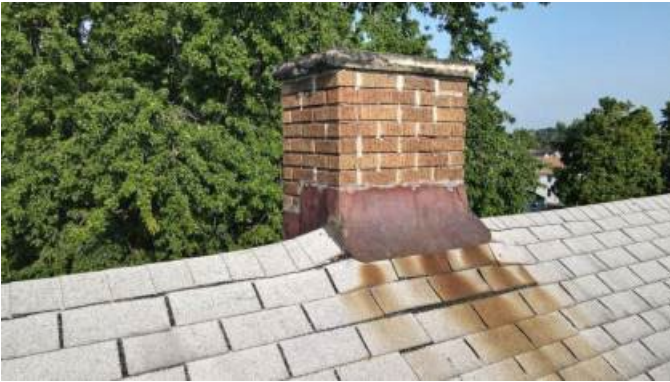
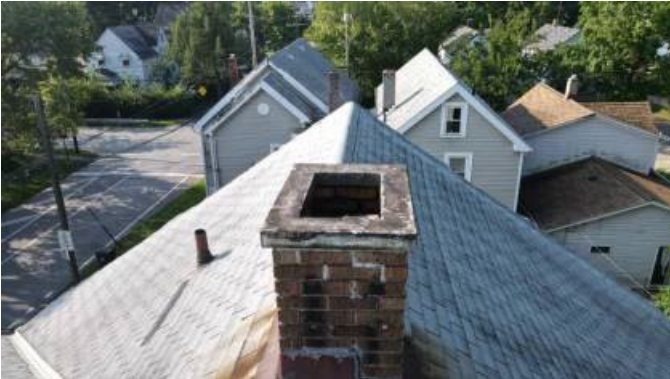
**Deteriorated mortar observed, suggest tuckpointing as needed to prevent further damage.**

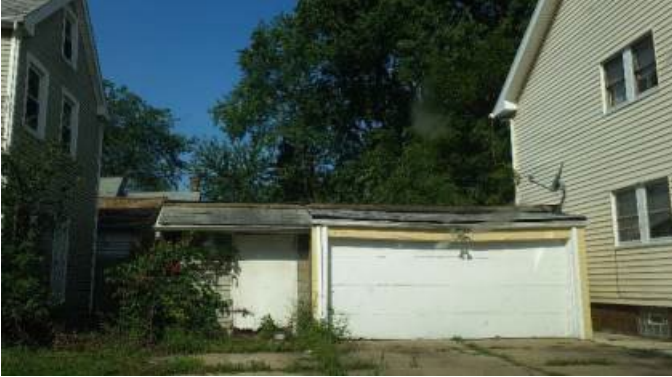
The garage exhibited severe general deterioration and appeared to be at or near the end of its long-term service life. The Inspector recommends that you consult with a qualified contractor to discuss options and costs for replacement or repair of garage.

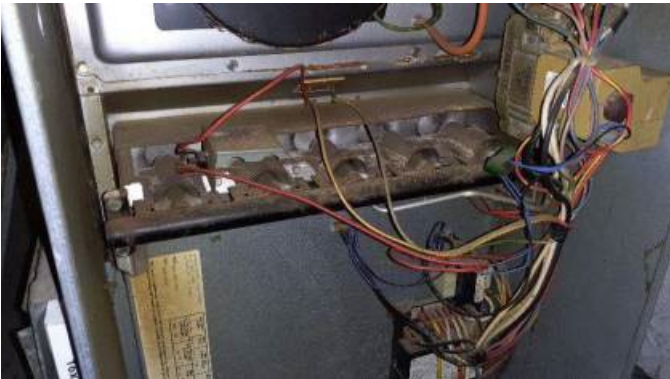
**Rust, scale, and some debris was observed in this appliance. Recommend review by a**

**qualified HVAC contractor ensure proper and safe operation of this unit prior to close. Dismantling to inspect for holes and/or cracks in heat exchanger is not within the scope of this inspection.**

**Partially visible. Unable to inspect the entire heat exchanger without dismantling. If concerned recommend review by a qualified HVAC contractor prior to close.**

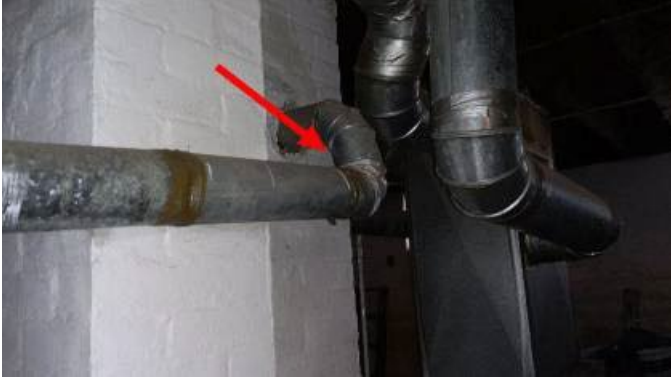
**Flue is leaking condensation and is rusted with corrosion Recommend the unit be serviceable by a qualified HVAC contractor.**

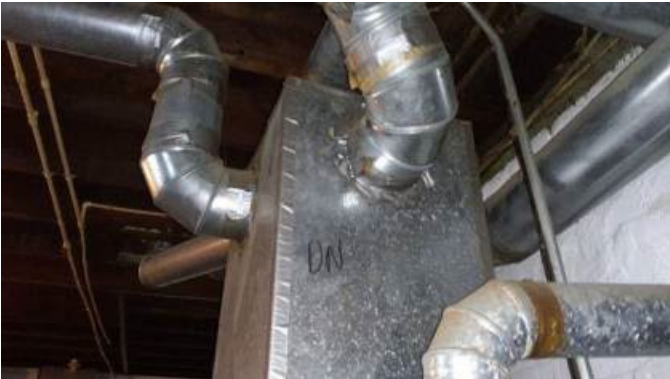
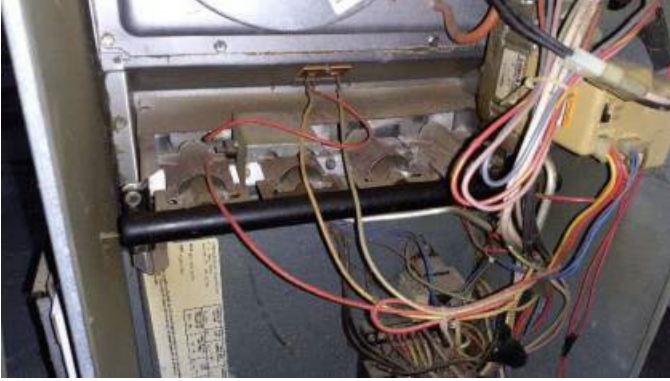
**No cold air return observed near unit, which may result in backdrafting and mixing of combustion by-products with interior circulation air. This is common with older homes more than 50 years old. Recommend review by a qualified HVAC contractor for prior to close if concerned about this.**

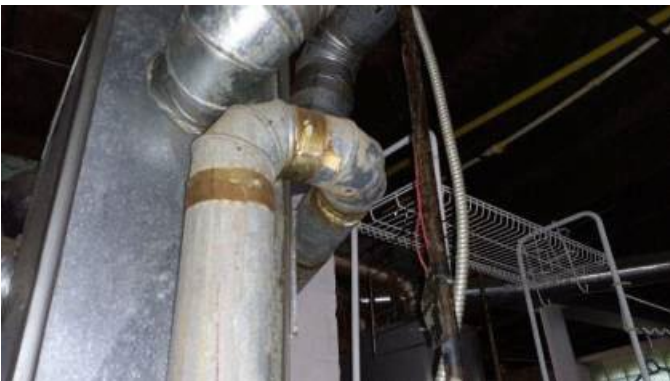
**Flue is leaking condensation and is rusted with corrosion Recommend the unit be serviceable by a qualified HVAC contractor.**

The flue pipe is metal.

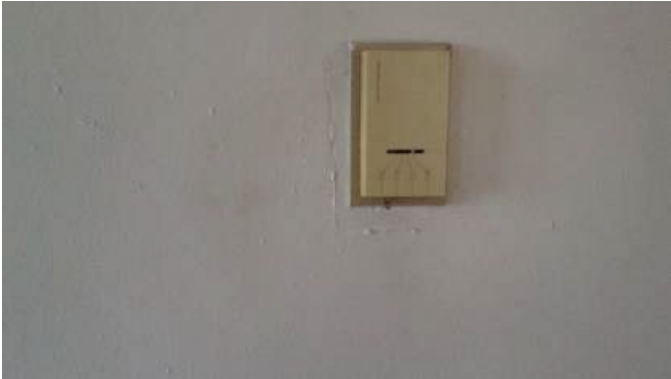
General conditions appears to be serviceable.

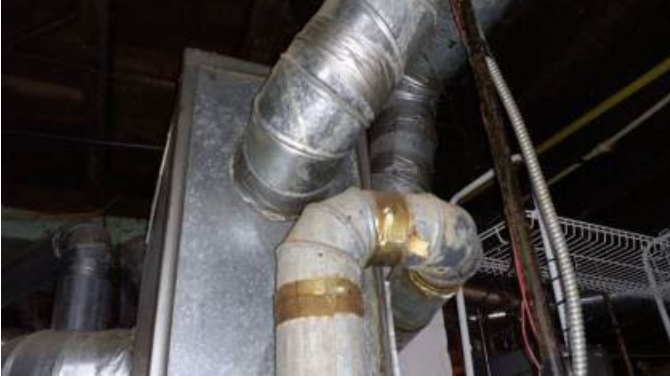
**No cold air return observed near unit, which may result in backdrafting and mixing of combustion by-products with interior circulation air. This is common with older homes more than 50 years old. Recommend review by a qualified HVAC contractor for prior to close if concerned about this.**

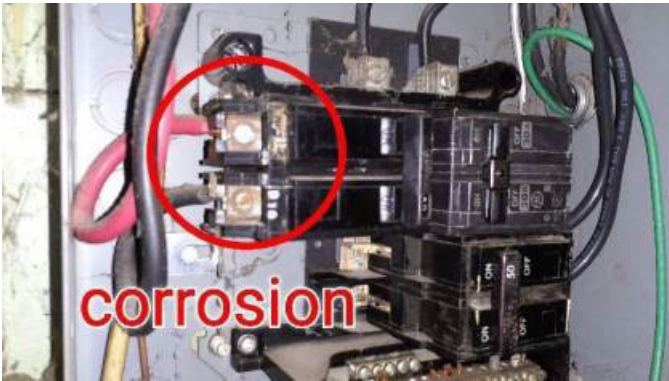
**The breakers are not marked as to the rooms, areas, or appliances controlled. It is recommended that they be noted for safety.**

**Rust and corrosion observed in the panel, which may be a possible safety hazard. Recommend review by a qualified electrician for repair or replacement as needed if concerned.**

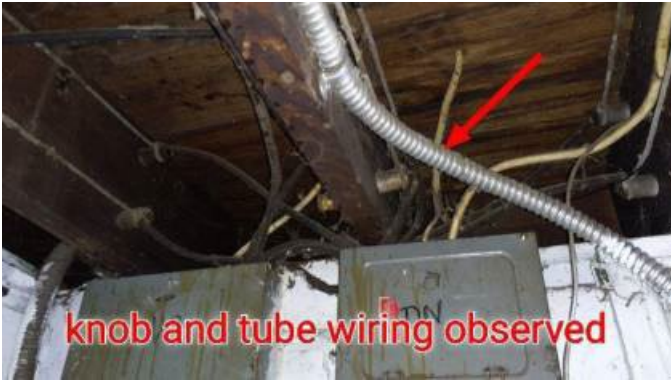
Part of the electrical system is an older non-grounded 2-wire system. This was common practice when this house was built. As repairs are made, it is suggested client upgrade to a new 3-wire grounded system to enhance electrical safety. If concerned we recommend review by a qualified electrician for addition information and repair as needed.

In the inspector's opinion, the electrical panel has exceeded its designed life expectancies. We make no warranty, guarantee or estimation as to the remaining useful life of this panel. Recommend review by a qualified electrician to determine the cost to replace breaker box.

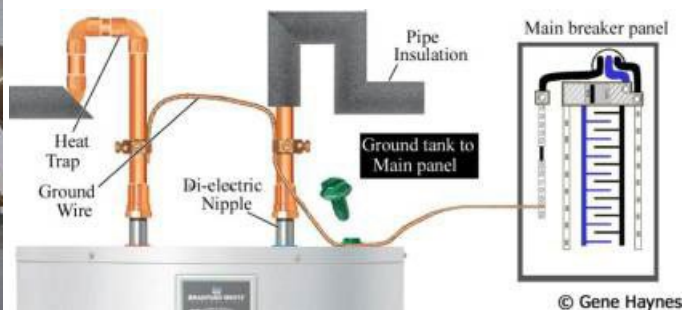
**Ground jumper cable not observed between hot and cold water lines, recommend installing jumper cable to insure proper grounding and safety.**

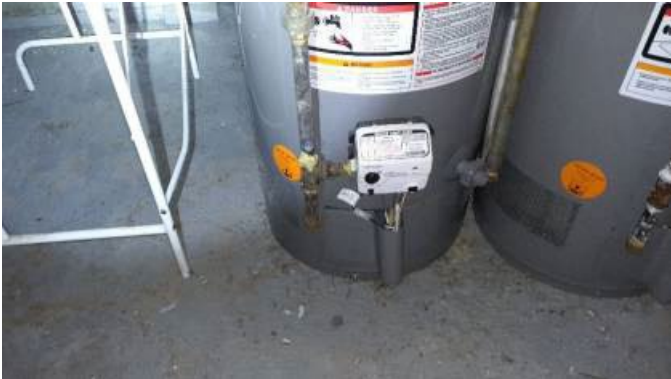
**Limited visual inspection only. Unable to inspect burner chamber due to closed system.**

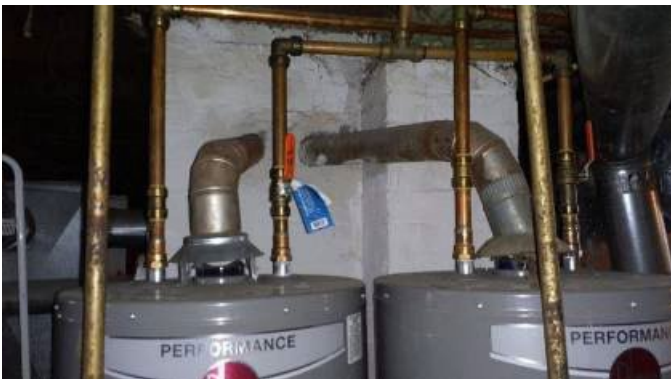
The visible portions of the flue/vent system appear to be installed correctly and appear to be serviceable.

The flue pipe is metal.

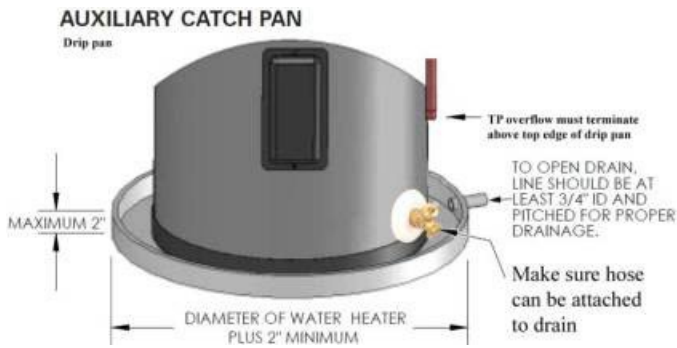
Water heater is located indoors without an overflow pan/drain line. This may not have been required when the home was built or may be impossible due to interior location. Recommend review by a qualified plumber for additional information.

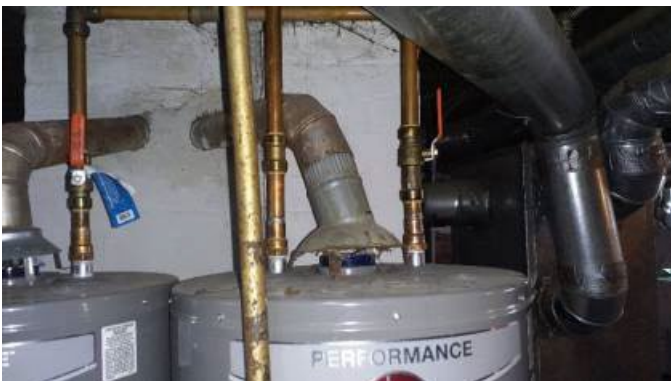
**Ground jumper cable not observed between hot and cold water lines, recommend installing jumper cable to insure proper grounding and safety.**

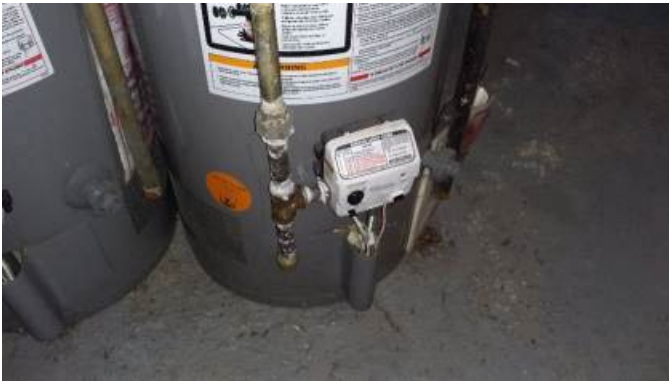
**Limited visual inspection only. Unable to inspect burner chamber due to closed system.**

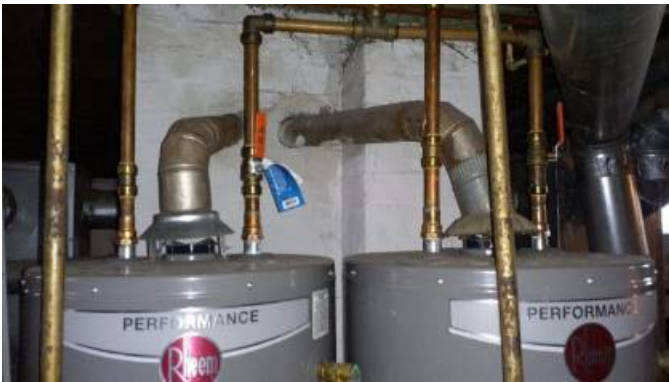
The visible portions of the flue/vent system appear to be installed correctly and appear to be serviceable.

The flue pipe is metal.

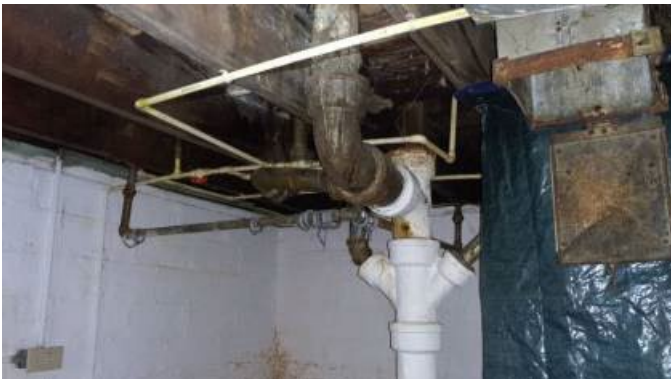
Drain lines are mostly original & will likely need ongoing maintenance and replacement. Older drains are more likely to be of poor material, have hidden damage, root problems or other blockage, which can affect drainage or increase risk of sewer gas escape. We suggest you obtain the maintenance history for the home's plumbing and obtain receipts for any recent work or for anything for which a warranty may apply.

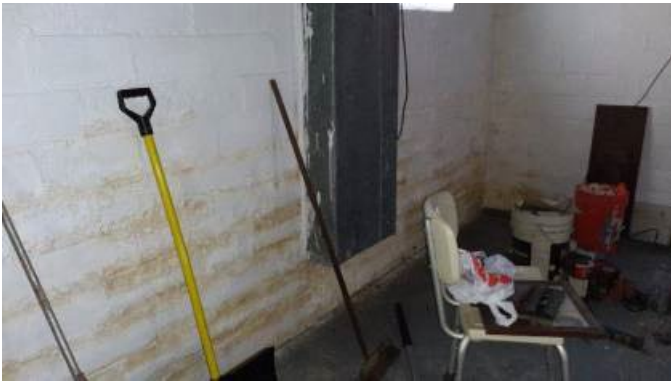
**Common cracks observed, primarily a cosmetic concern. Recommend monitoring cracks for future/further movement. Suggest sealing all cracks in concrete/asphalt/brick surfaces to prevent water penetration as a routine maintenance effort.**

**Efflorescence was visible at some of the interior surfaces of the foundation walls. Efflorescence is a white, powdery residue left by moisture seeping through the foundation wall and its presence indicates high moisture levels in soil near the foundation. This may only be cosmetic in nature. However, excessively high moisture levels in soil supporting the foundation can cause various structural problems related to soil movement. The source of moisture should be identified and the condition corrected. Recommend review by qualified contractor as needed.**

**Moisture stains observed. An elevated level of moisture was detected using an electronic moisture meter. Whenever there is water damage, there is the possibility of hidden mold growth and pest infestation. Because certain types of mold may be toxic and result in adverse health effects, or if you have concerns regarding mold, we suggest review by a qualified professional. Anytime there is a mold or mildew condition we suggest clean up be performed per EPA guidelines to correct the condition and that corrective measures be taken to limit moisture in the home.**

**Moisture intrusion was observed and can damage materials and encourage the growth of microbes such as mold. The source of moisture should be located and corrected to avoid future moisture intrusion. Recommend consulting a licensed contractor or basement waterproofing company for review and repair of the wall.**

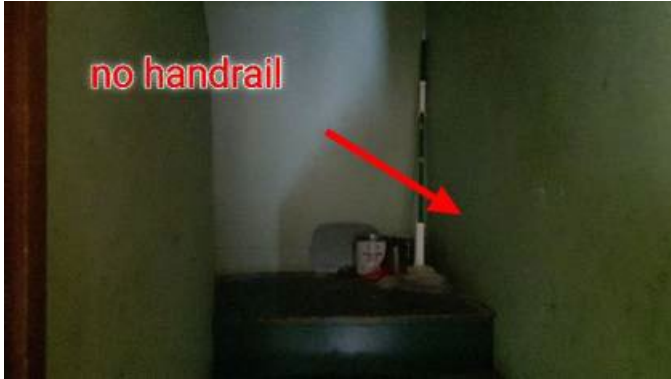
**Recommend installing a handrail/guardrail for safety. Whenever a stairway is three or more risers high a handrail and/or guardrail is usually required for safety.**

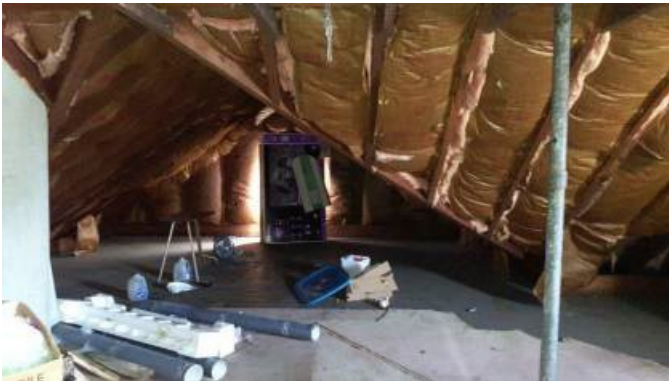
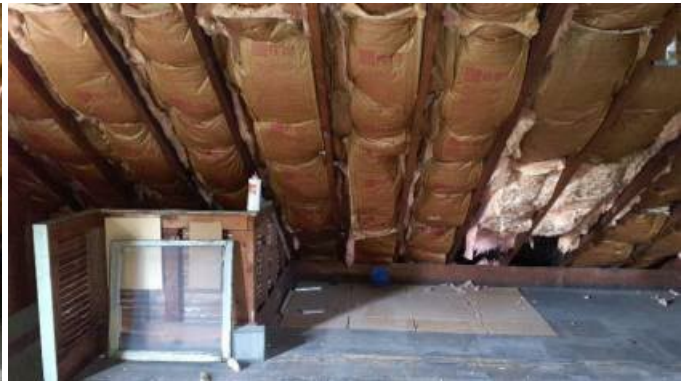
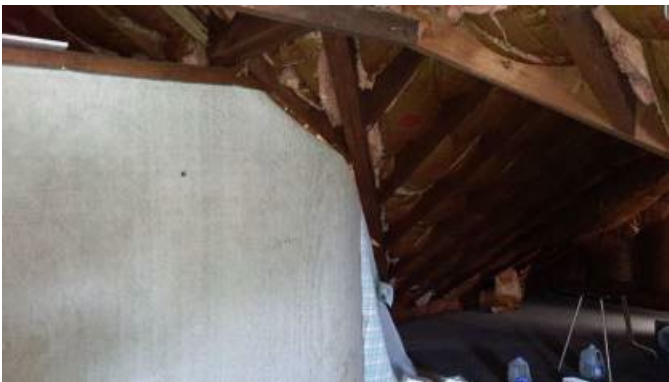
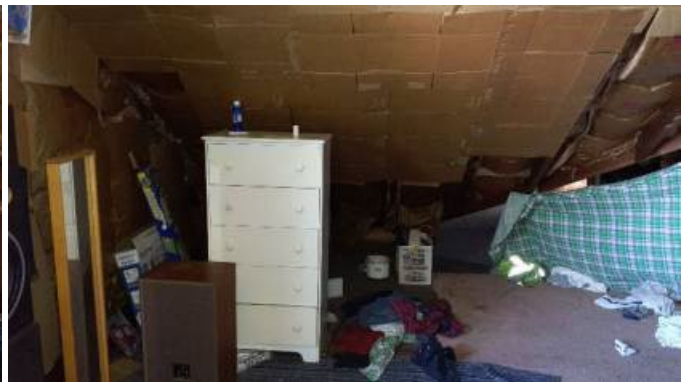
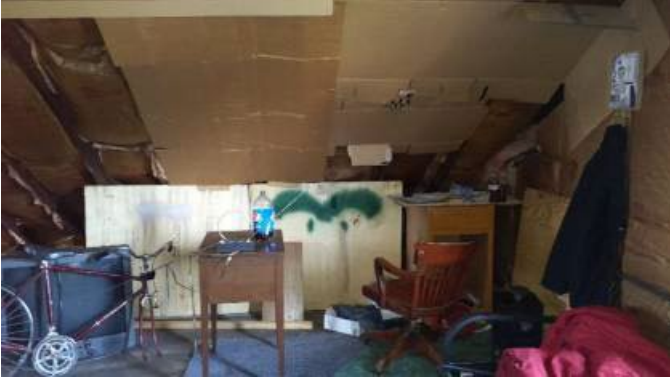
A rafter system is installed in the attic cavity to support the roof decking.

2x6

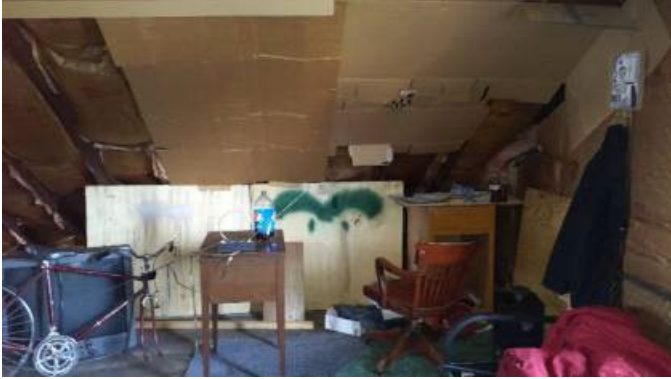
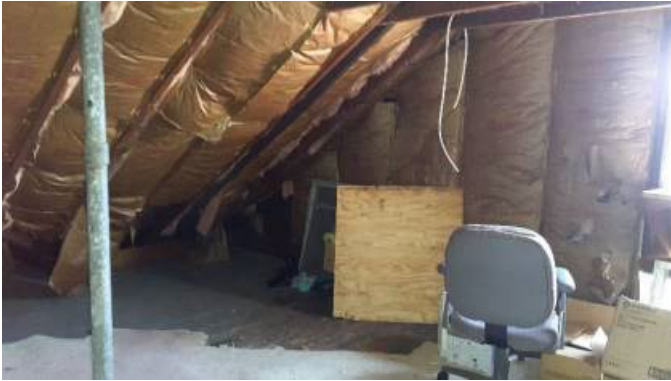
Finished areas observed in attic. Complete access to original attic walls, floors, and ceilings is limited due to the additional construction that is present such as framed-out walls, covered ceilings, and added floor coverings. Suggest consult sellers for additional information.
