Tri-County Inspections LLC
440-653-1947 (mobile/text)
mike@tri-countyinspections.com | https://tri-countyinspections.com/
Inspection reference: [REDACTED]
Mentor, OH 44060

Confidential Inspection Report

March 12, 2024

Inspection: 031224MV - [REDACTED] Address: [REDACTED]

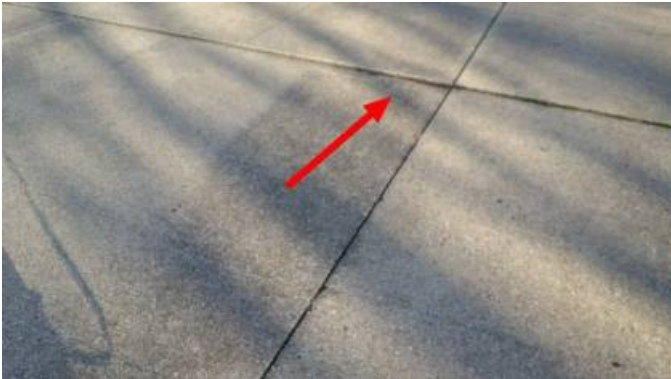
2.2 Driveway Condition:

Possible trip hazard noted at various locations. This is a safety concern. Suggest repair/replacement as needed to ensure safety.

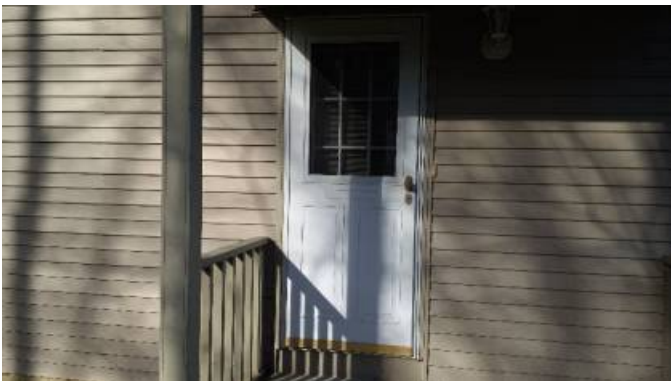
2.12 Exterior Door #3 Condition:

1. **Peeling paint observed at doors, suggest scraping and painting as needed as part of normal maintenance.**

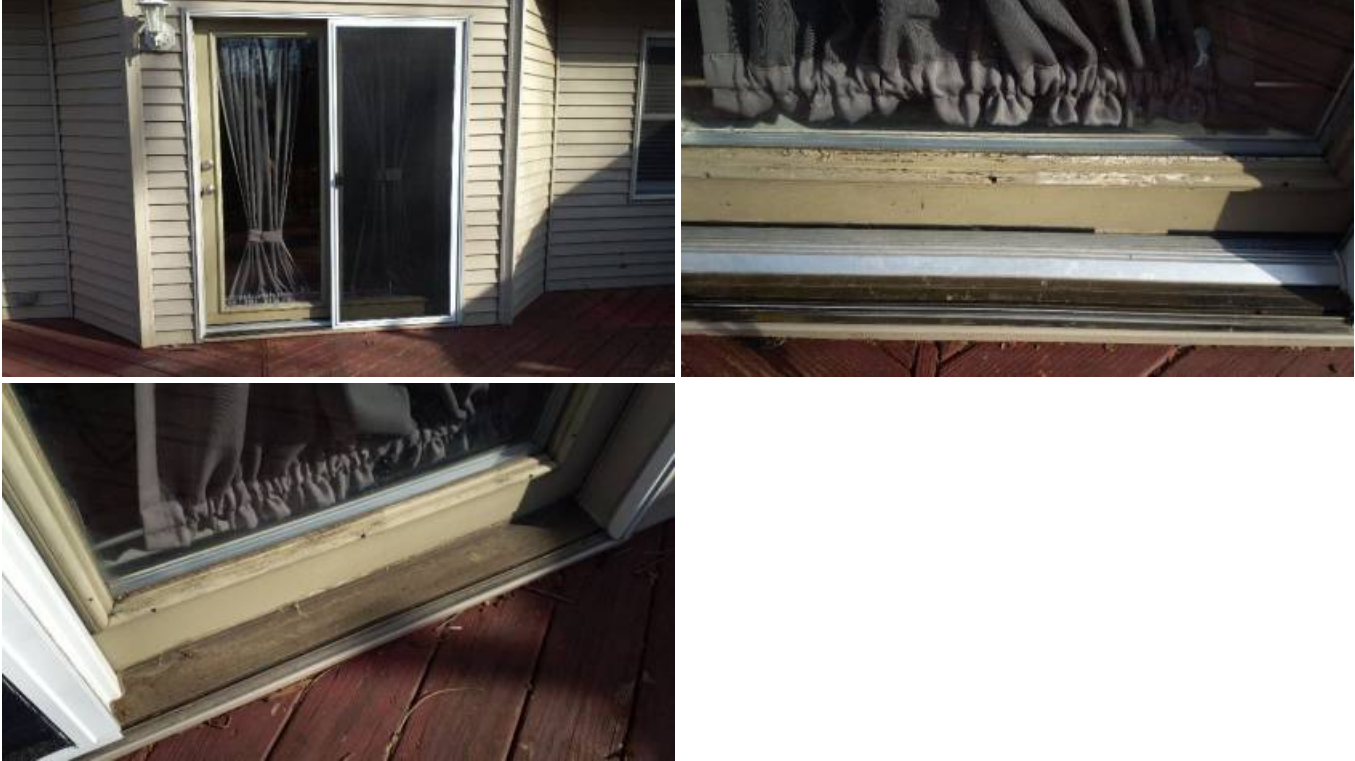
2.13 General Window Condition:

Damaged screens observed at various locations, suggest corrections for proper use and operation of windows.

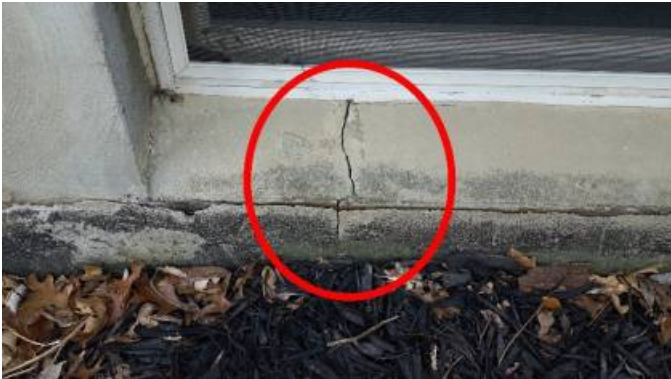
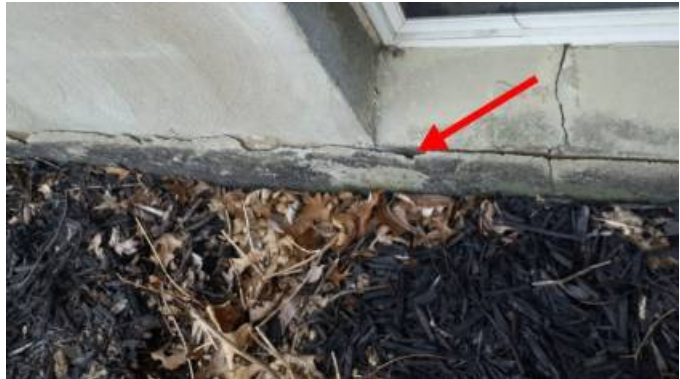
2.15 Location of Wall Cracks and Description:

3. **Common cracks observed. Suggest sealing any cracks in concrete/brick/block surfaces to prevent water penetration as a routine maintenance effort.**

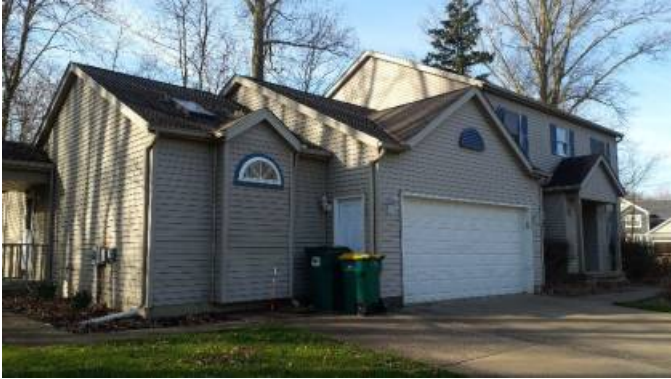
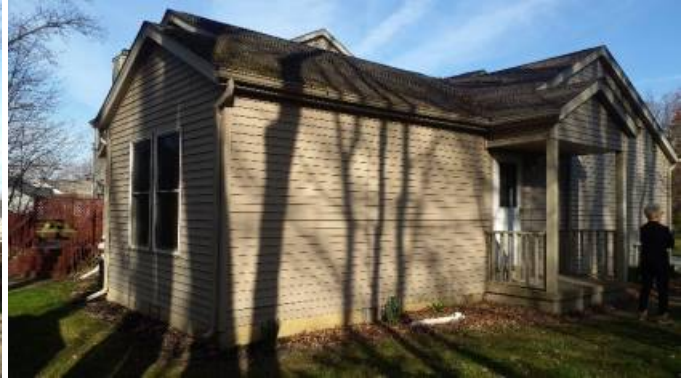
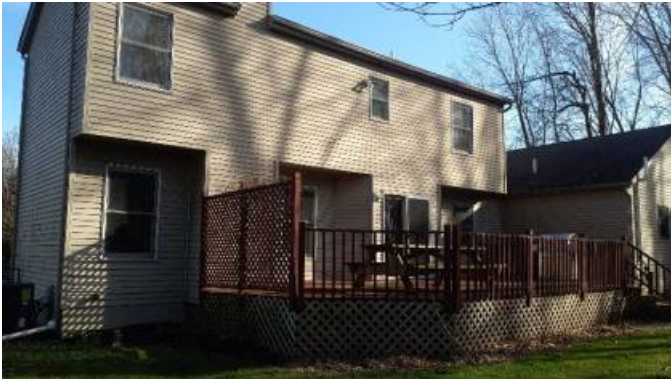
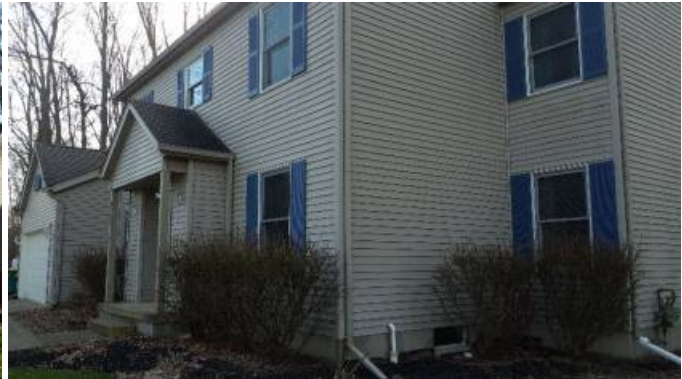
2.19 Trim Condition:

4. **Peeling paint observed at various areas; suggest scraping and painting as needed as part of normal maintenance.**

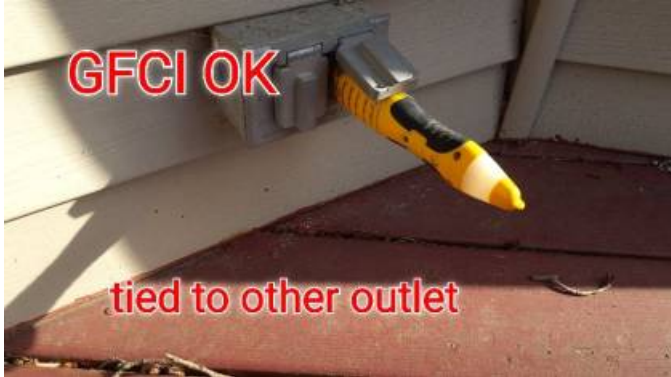
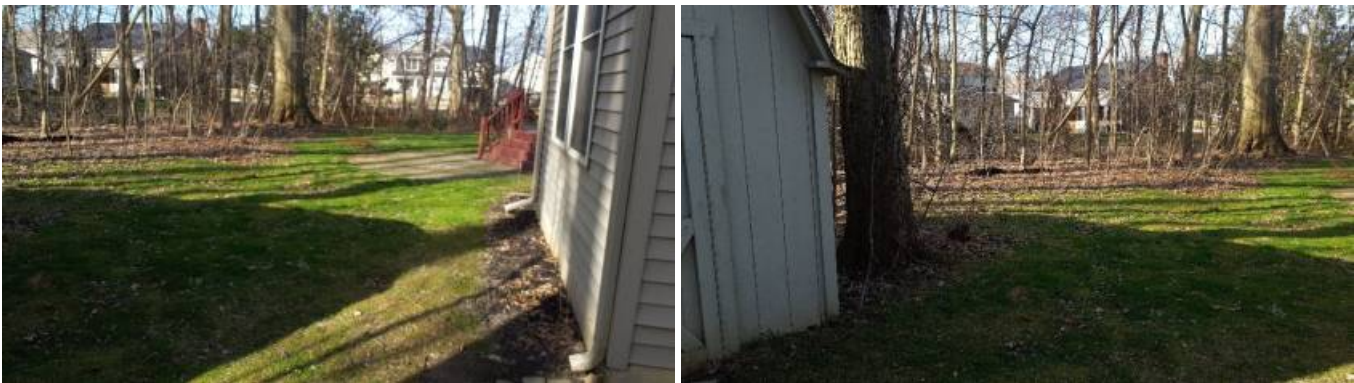
2.29 Lot/Grade/Drainage:

Evidence of ponding observed. Grade improvements, landscape alterations, or the installation of surface drains may be needed if water ponding is an ongoing concern. Ponding near foundation may result in basement/crawlspace seepage or foundation damage. This inspection does not include determining if the property is above the 100 year flood plain. For further information regarding elevation of the lot, check with your survey and appraiser.

Evidence of low spots observed near foundation. Grade improvements, landscape alterations, or the installation of surface drains may be needed to prevent water ponding from occurring. Low spots near foundation may result in basement/crawlspace seepage or foundation damage from rainfall or flooding. This inspection does not include determining if the property is above the 100 year flood plain. For further information regarding elevation of the lot, check with your survey and appraiser.

Flat lot. Grading and/or adding dirt backfill to any low lying areas located around the foundation is recommended to ensure proper drainage away from the foundation at all times. The ground immediately adjacent to the foundation should slope away from the house a minimum of 6" in the first 6'.

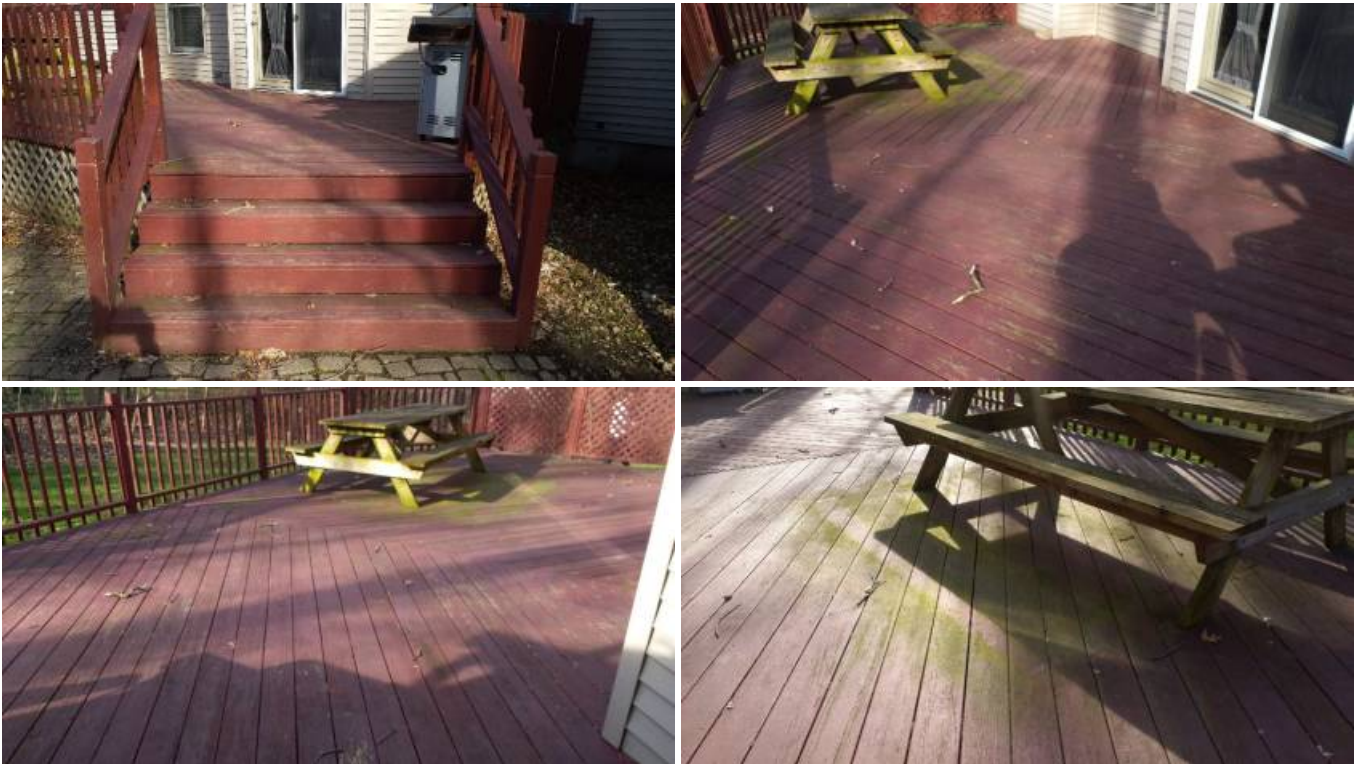
2.32 Condition of Materials:

Deck is weathered: suggest cleaning, staining or sealing as needed to preserve the remaining life of the deck.

Peeling paint observed at various areas, suggest scraping and painting as needed as part of normal maintenance.

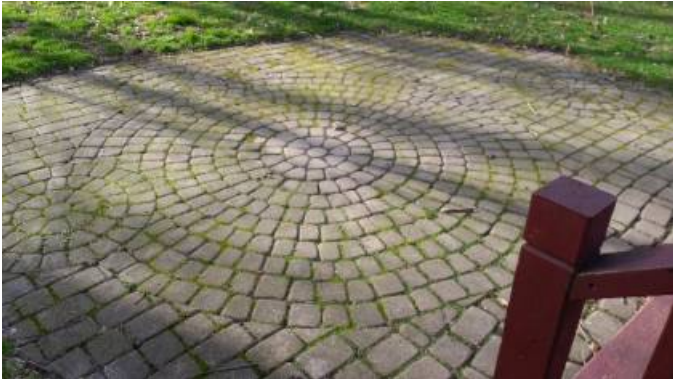
2.34 Patio Condition:

Recommend cleaning moss and/or algae from the patio block.

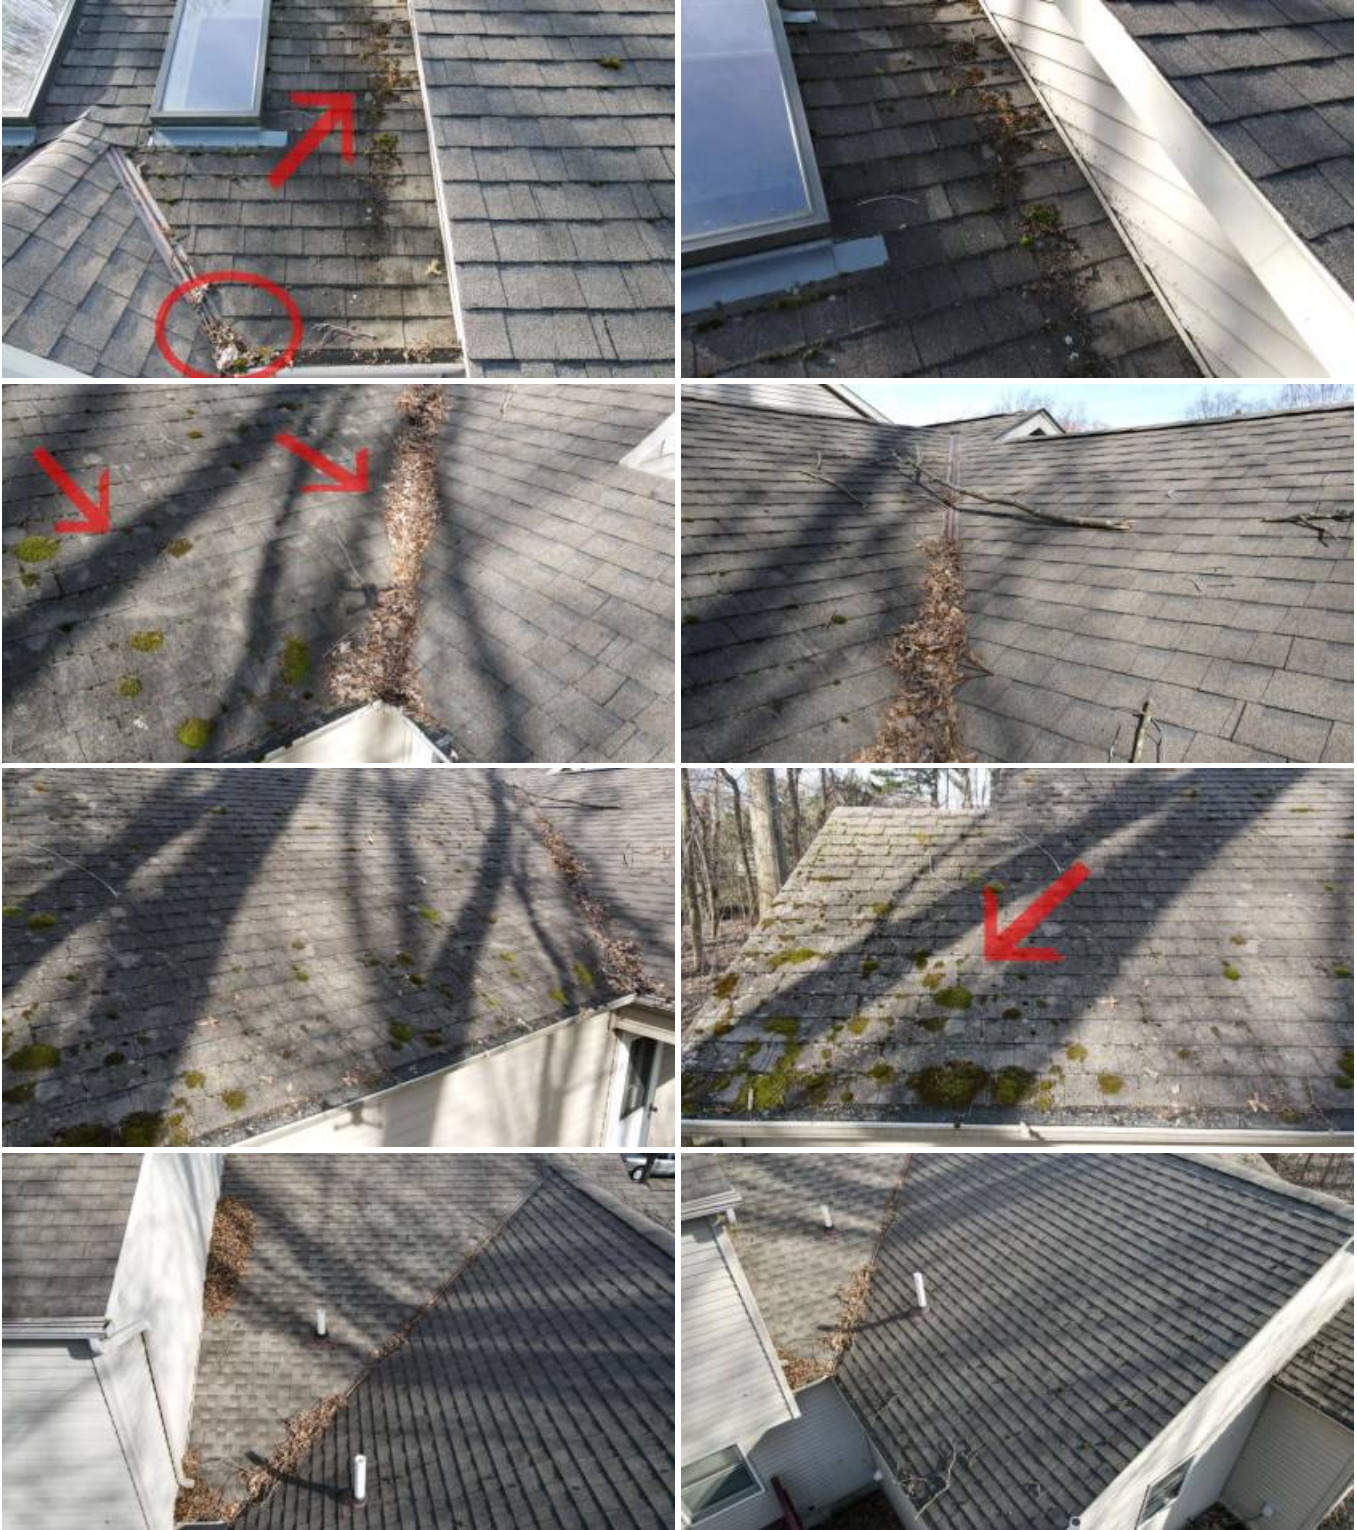
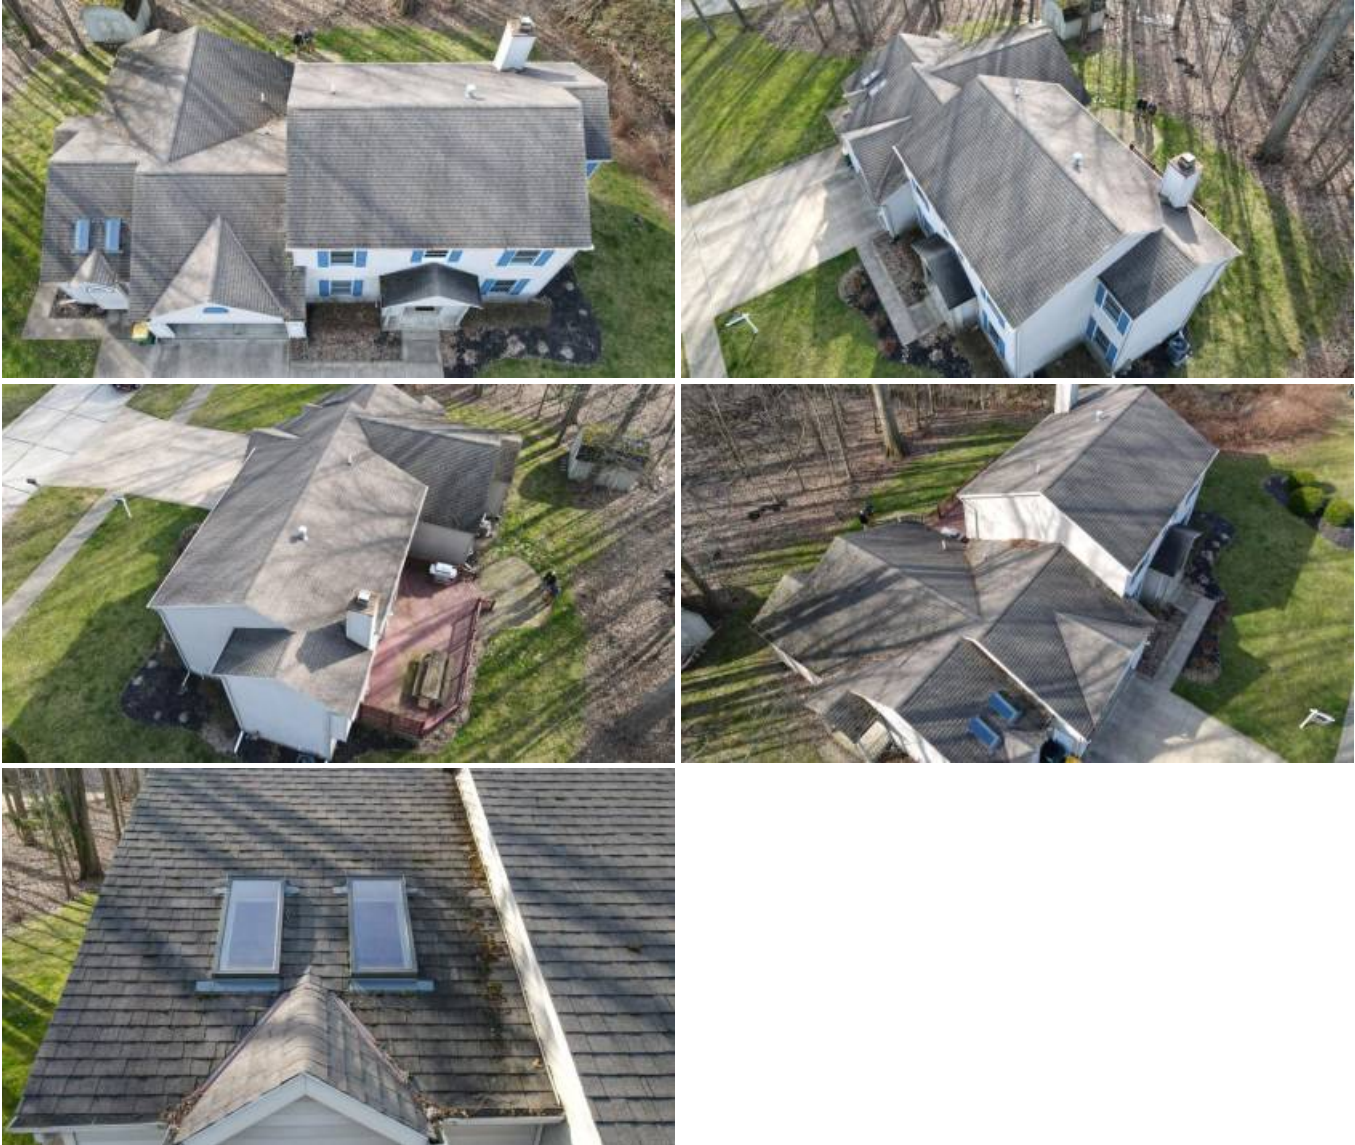
3.3 Condition of Roof Covering Material:

Moss observed on roof covering at various locations. Moss tends to hold water and cause moisture related deterioration problems to roof covering. Suggest having moss removed and take steps to prevent re-growth.

Recommend removing debris to allow for proper drainage and to prevent deterioration of roofing materials.

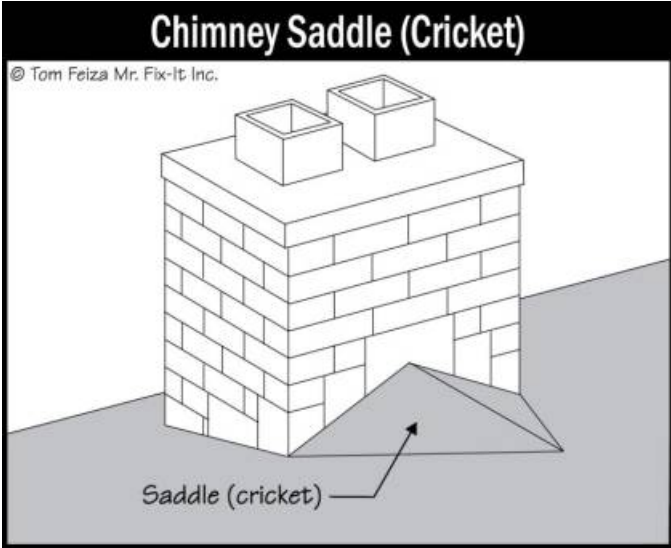
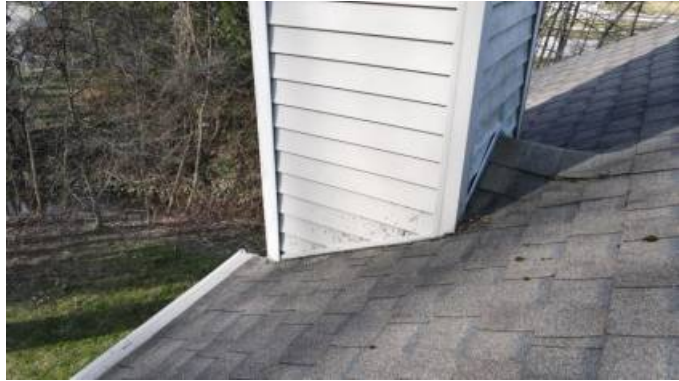
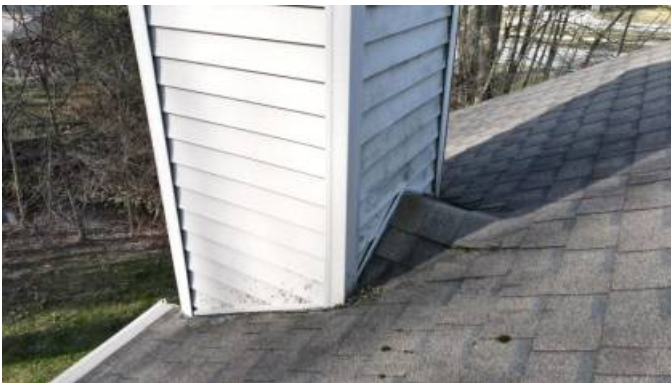
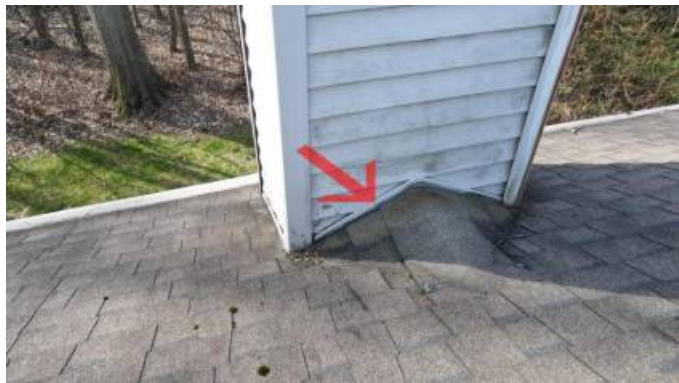
There is a chimney cricket/saddle installed. It appears to be serviceable.

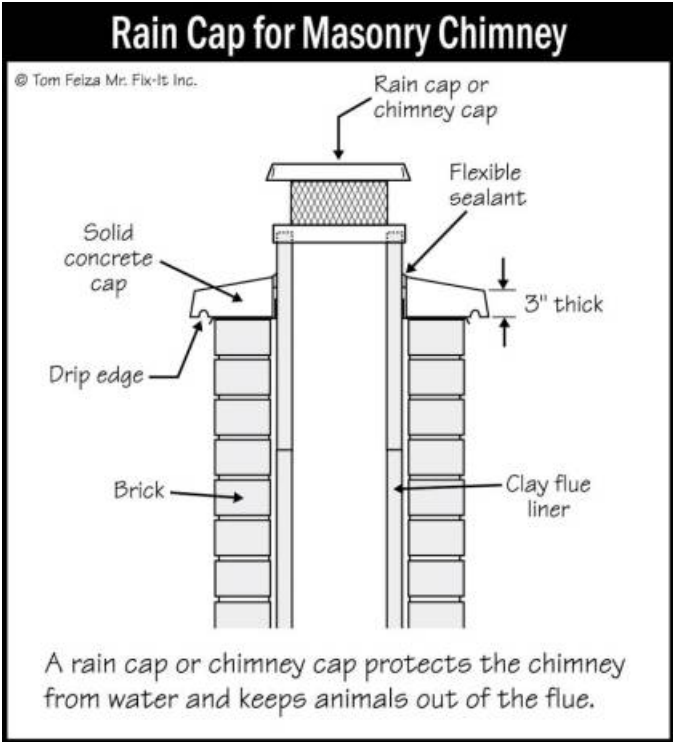
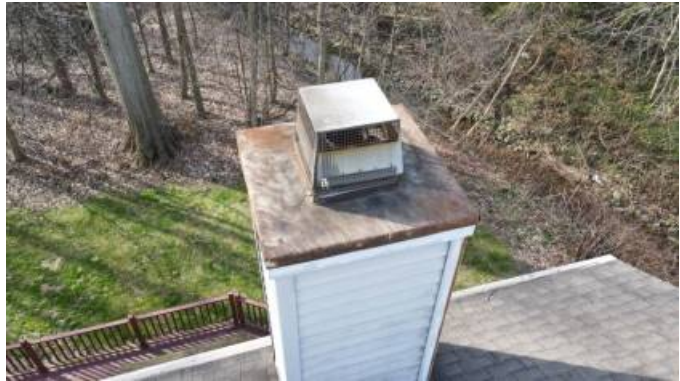
Rain cap observed. Rain caps will help keep water and critters out of chimney.

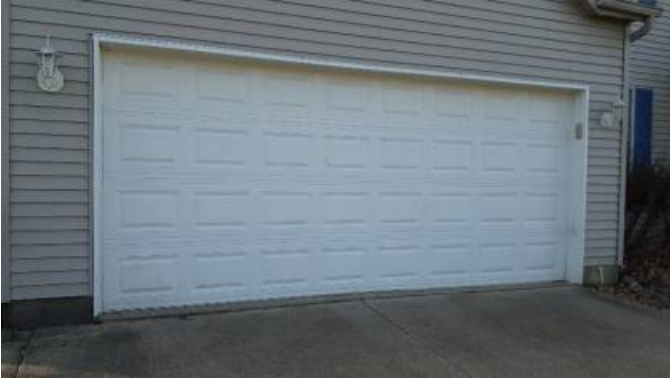
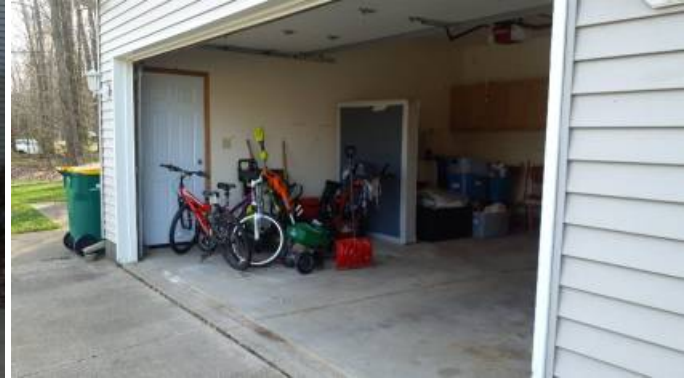
The garage is attached.

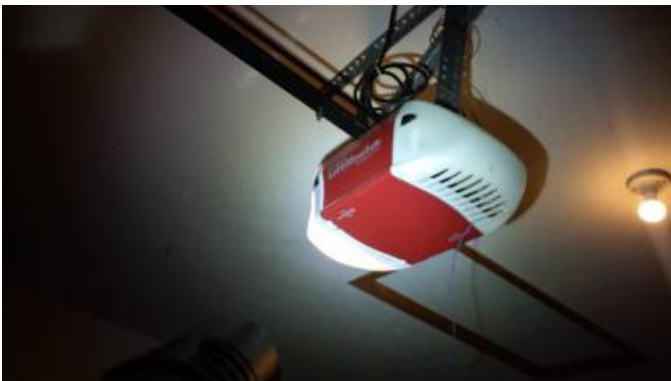
This garage door opener is equipped with a safety reverse device, which operated when tested at the time of our inspection. The U.S. Product Safety Commission recommends these devices be checked monthly for proper operation and safety.

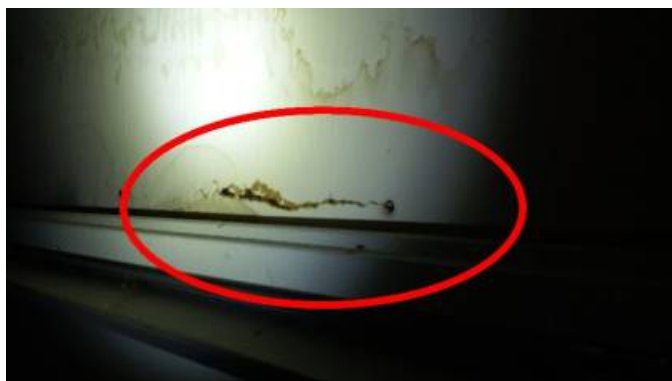
Stains observed. The inspector probed stains with a moisture detector, which showed normal moisture present at time of inspection. Client is advised to consult seller to determine the source of staining and verify that corrections have been made.

Walls are damaged in various areas recommend review by a qualified contractor for repair as needed.

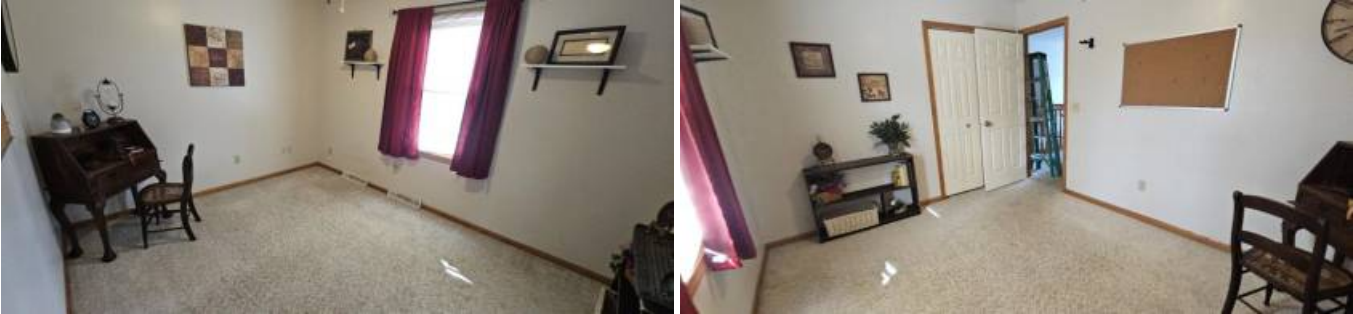
2nd Floor

The entry doors to these rooms are serviceable.

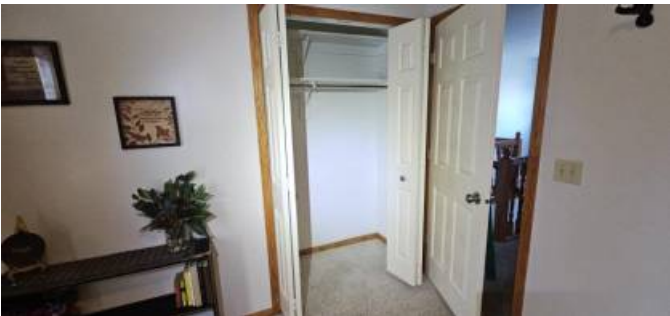
The floors are in serviceable condition.

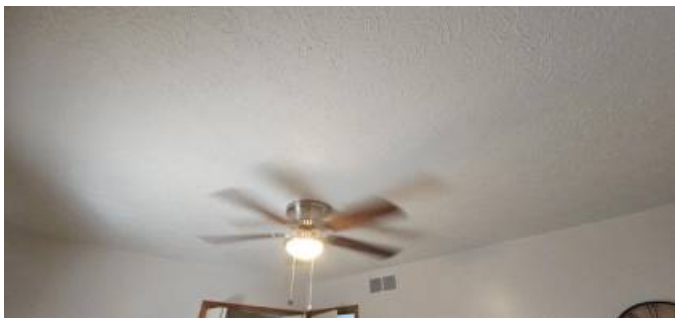
There is a ceiling fan installed in this room. It appears to be serviceable.

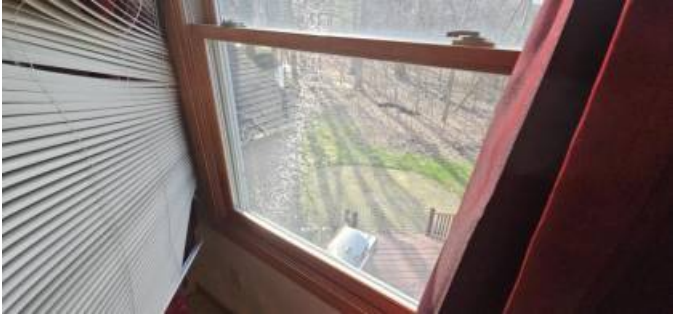
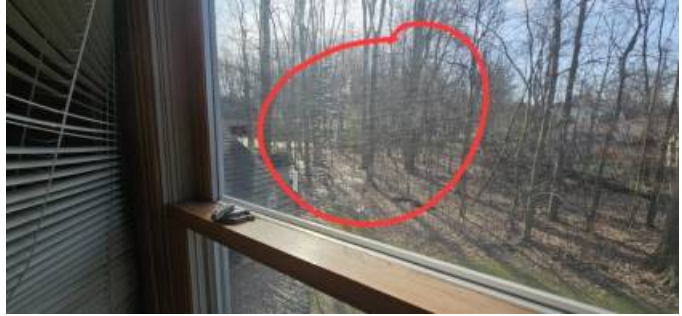
Damaged/missing screens observed at various locations, suggest corrections for proper use and operation of windows.

Suggest windows and frames be kept caulked, sealed/painted to prevent moisture penetration. Failure to keep windows and frames sealed can cause deterioration and extensive moisture damage to the interior walls and surrounding sub-flooring. This damage is not always visible or accessible to the inspector at the time of inspection.

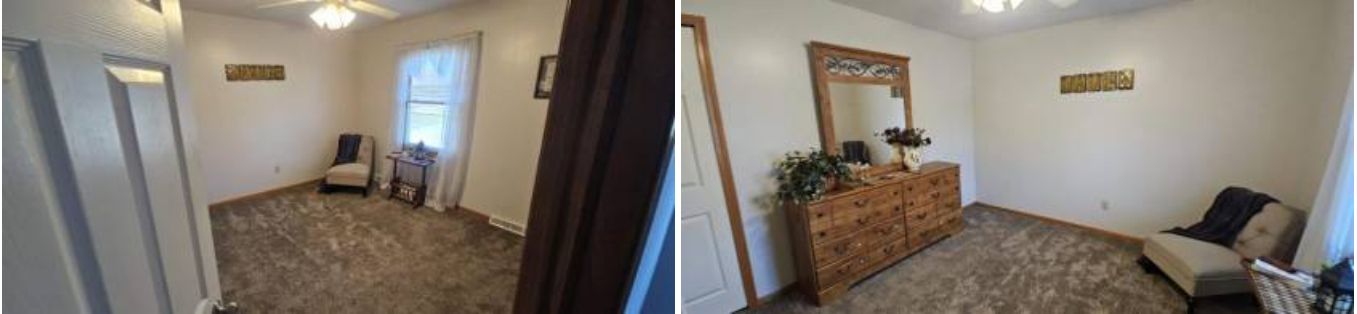
2nd Floor

The entry doors to these rooms are serviceable.

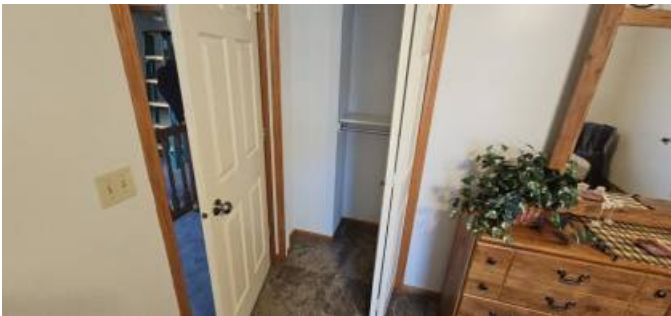
The floors are in serviceable condition.

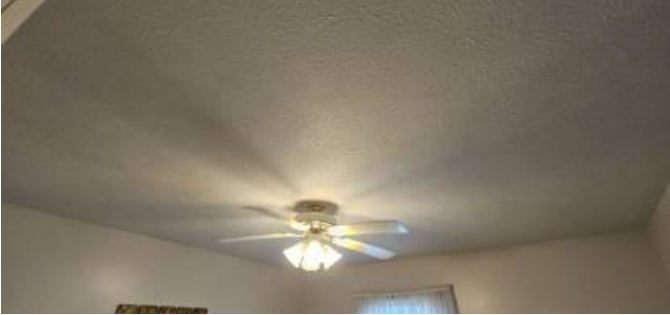
There is a ceiling fan installed in this room. It appears to be serviceable.

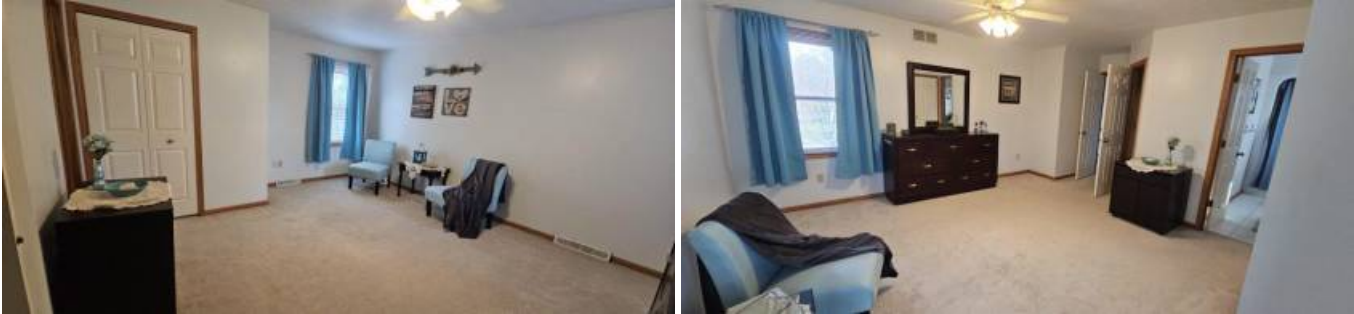
2nd Floor

The entry doors to these rooms are serviceable.

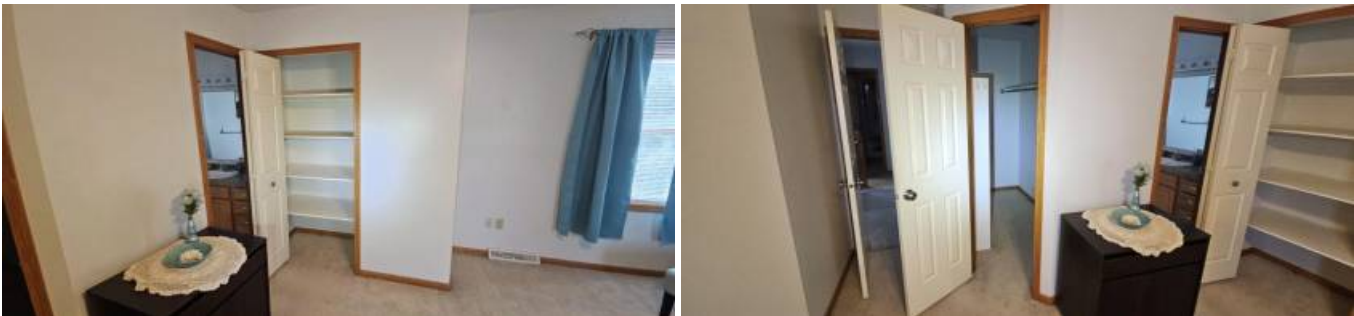
The floors are in serviceable condition.

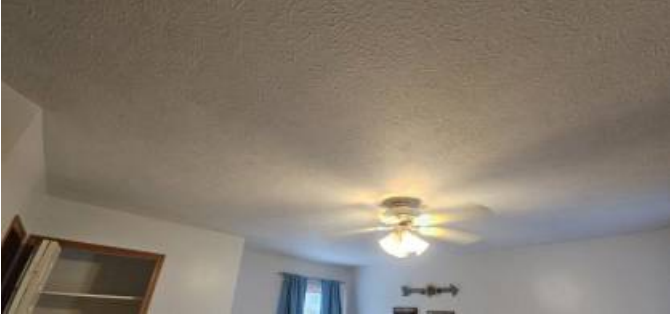
There is a ceiling fan installed in this room. It appears to be serviceable.

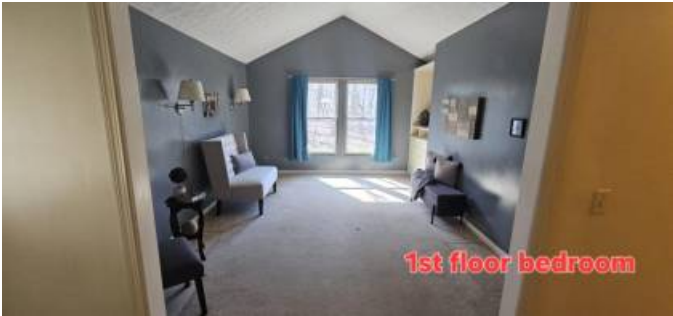
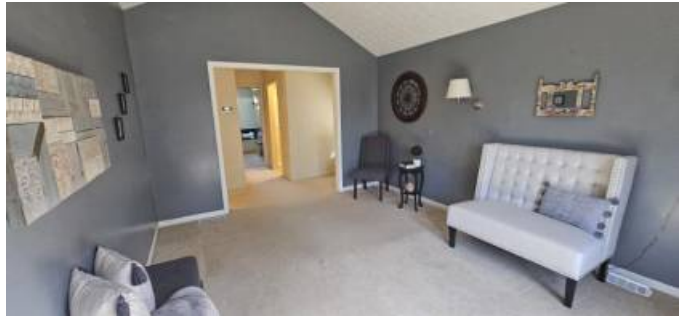
1st Floor, In-law suite

The entry doors to these rooms are serviceable.

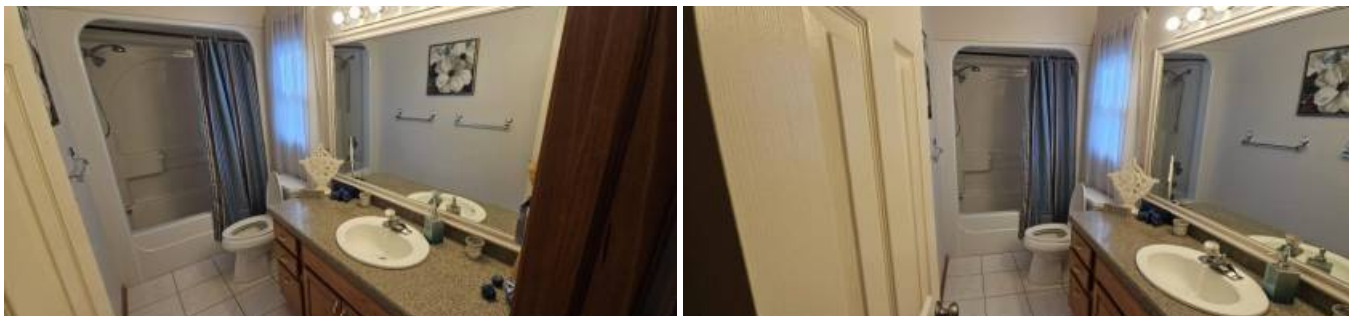
2nd Floor

The entry door to this room is serviceable.

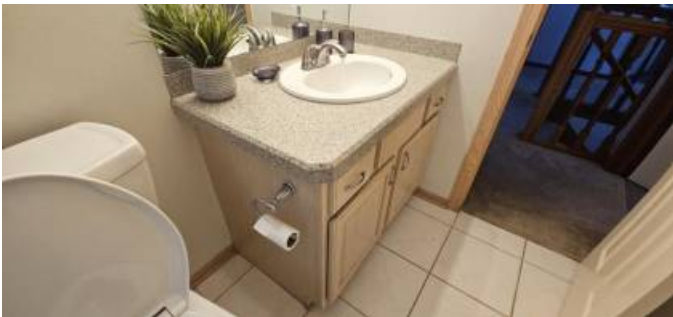
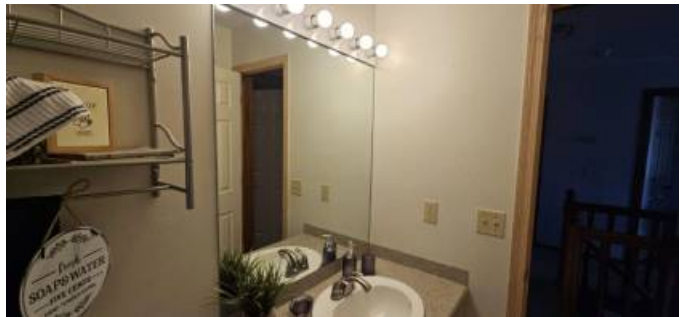
7.29 Ground Fault Protected Outlets:
GFCI outlets are provided for safety.

Note: Outlet is tied to GFCI outlet in basement.

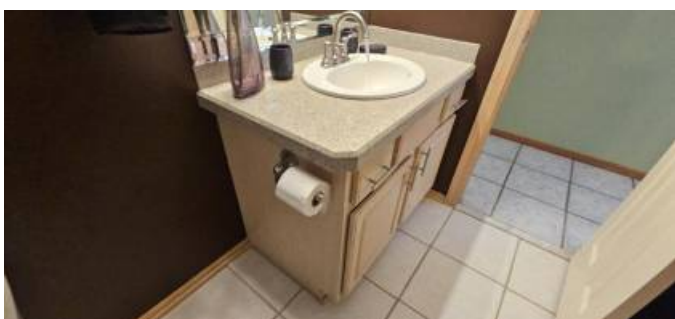
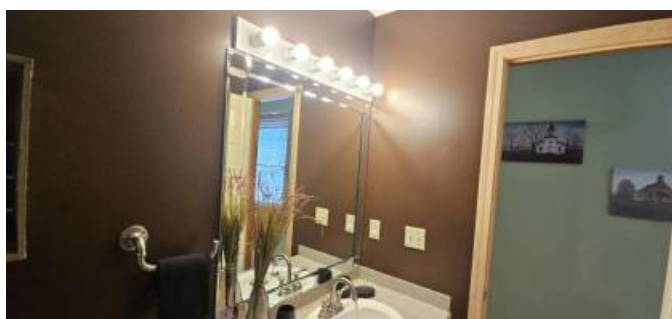
7.40 Ground Fault Protected Outlets:

GFCI outlets are provided for safety.

Note: Outlet is tied to GFCI outlet in basement.

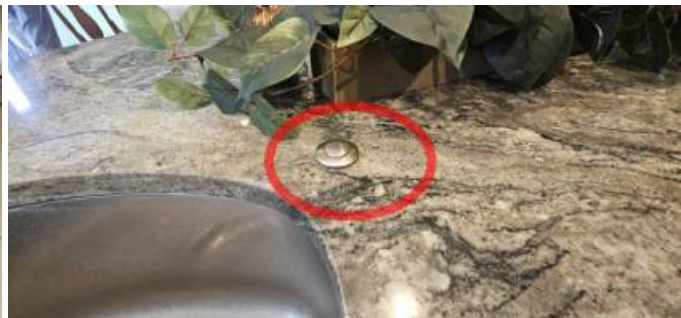
8.11 Dishwasher:

System is Samsung. Dishwasher was operational at the time of inspection. Dishwashers most commonly fail internally at the pump, motor or seals. We do not disassemble these units to inspect these components. Our inspection is limited to operating the unit on the 'normal wash' cycle only.

Loose hardware observed. Recommend repairs and corrections be made as needed by

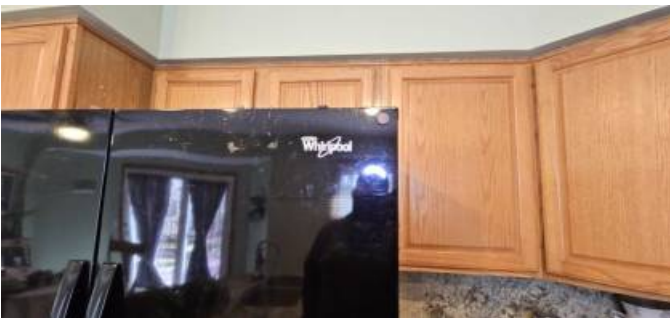
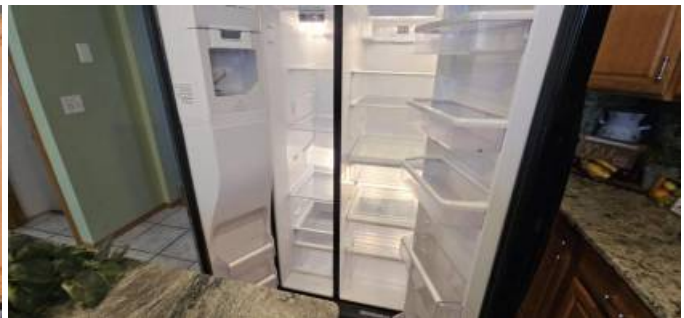
8.14 Refrigerators:

Refrigerator System is Whirlpool brand. The refrigerator is tested to verify that unit is cooling at time of inspection. Freon levels, icemaker operation and other specialty items are beyond the scope of this inspection.

The ice maker and/or water dispenser located on refrigerator door is not working properly or has no water line connected. Recommend consulting sellers or have a qualified appliance contractor review and repair appliance as needed.

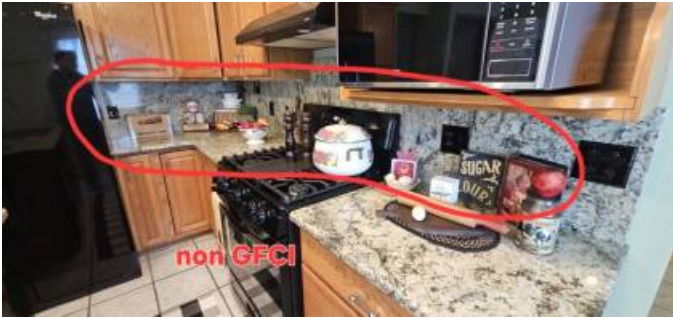
8.15 Ground Fault Protected Outlets:

Ground Fault Circuit Interrupters (GFCI) may not have been required when the home was built. GFCI's should be at all receptacles that service a counter in the kitchen, the bathrooms, the garage, the laundry room and exterior receptacles as an upgrade to safety. Upgrades should be performed by a qualified electrician.

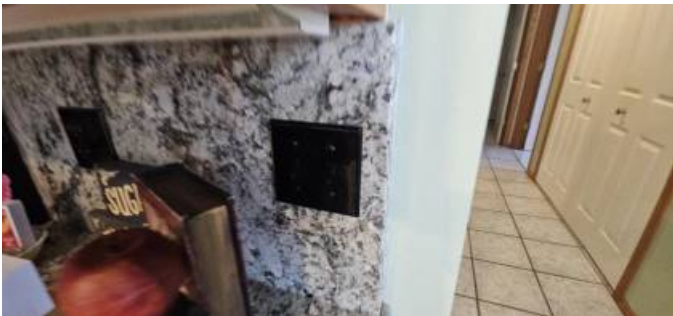
8.16 Switches/Outlets/Fixtures:

A representative sampling of switches and outlets were tested. As a whole, outlets throughout the room are in serviceable condition.

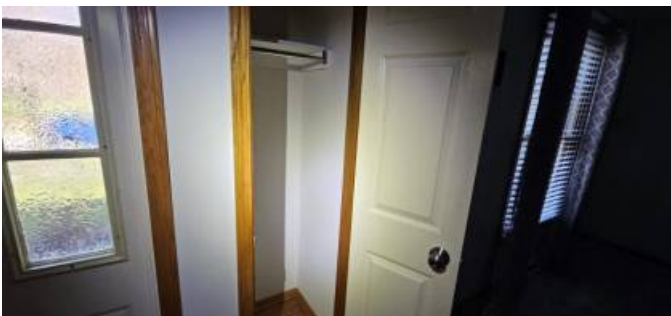
9.2 Entry Closet Door:

Serviceable

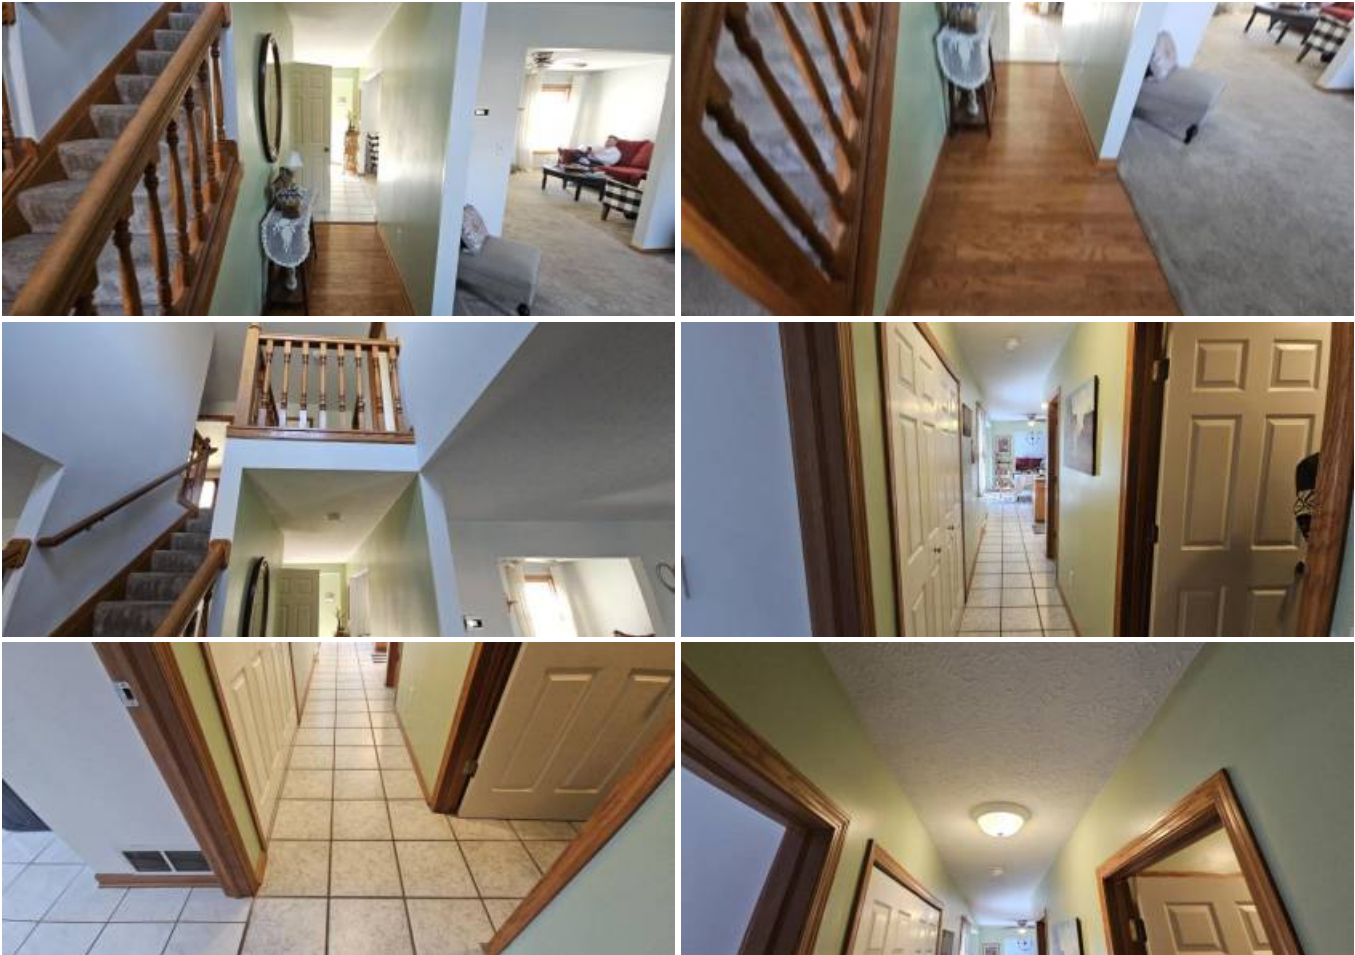
9.3 Main Hallway Walls:

Drywall and/or plaster walls and ceilings are present in this home. Cracks in drywall and/or plaster walls and ceilings are common and are considered cosmetic unless otherwise noted.

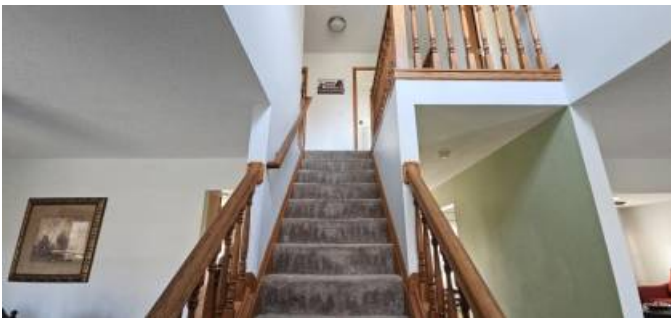
9.4 Stairs:

The main staircase appears to be installed correctly.

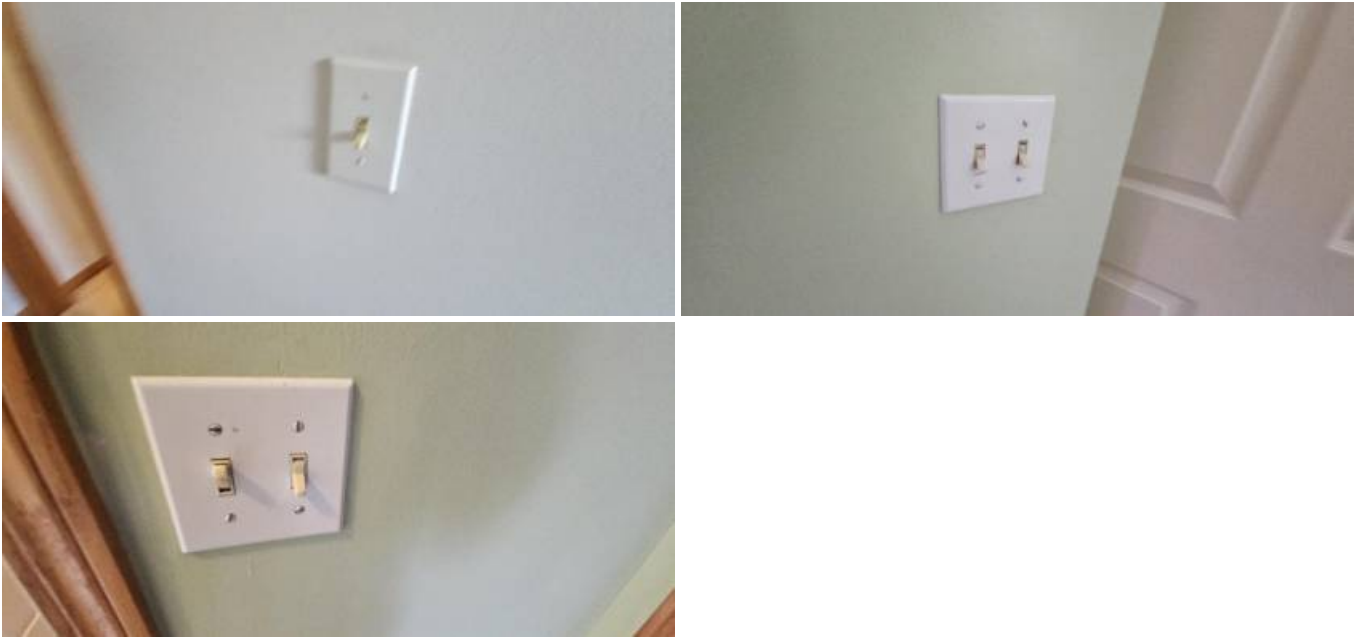
9.5 Switches/Fixtures/Outlets:

A representative sampling of switches and outlets were tested. As a whole, switches and outlets throughout the room are in serviceable condition.

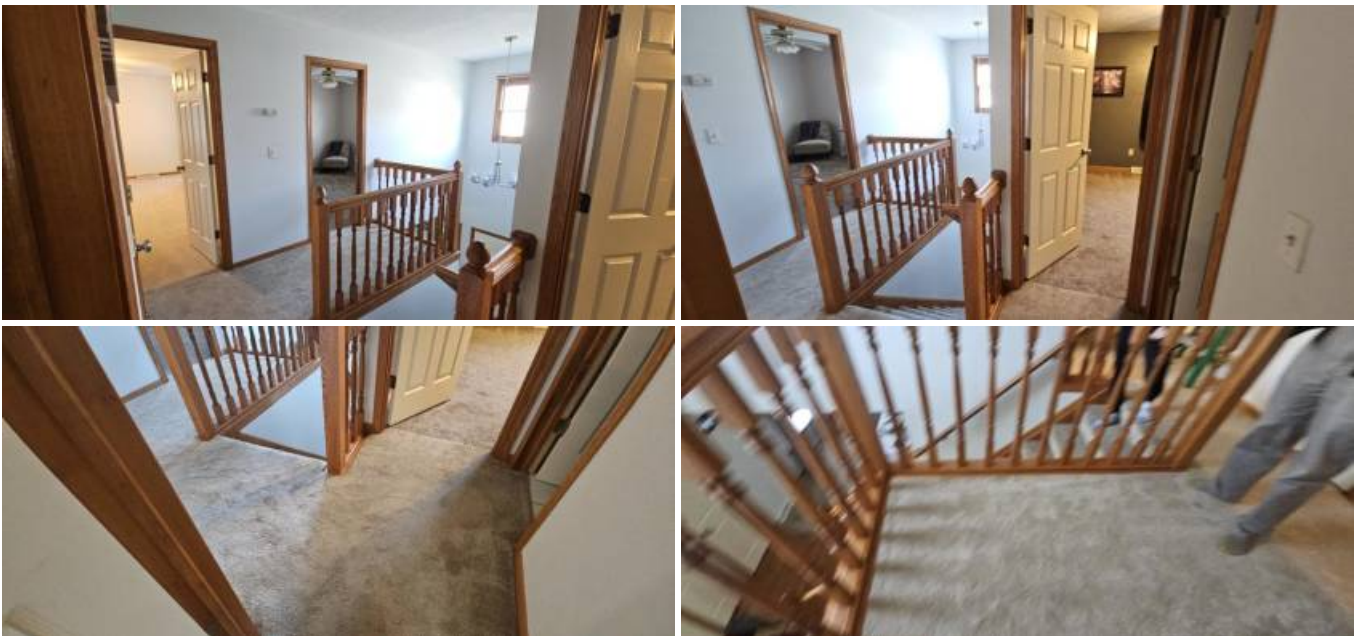
9.6 Upper Level Hallway:

Drywall and/or plaster walls and ceilings are present in this home. Cracks in drywall and/or plaster walls and ceilings are quite common and are considered cosmetic unless otherwise noted.
