Tri-County Inspections LLC
440-653-1947 (mobile/text)
mike@tri-countyinspections.com | https://tri-countyinspections.com/
Inspection reference: [REDACTED]
Mentor, OH 44060

Confidential Inspection Report

March 12, 2024

Inspection: 031224MV - [REDACTED] Address: [REDACTED]

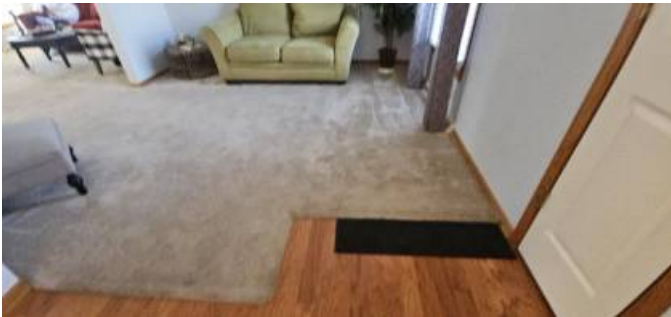
9.9 Floor:

The floors are in serviceable condition.

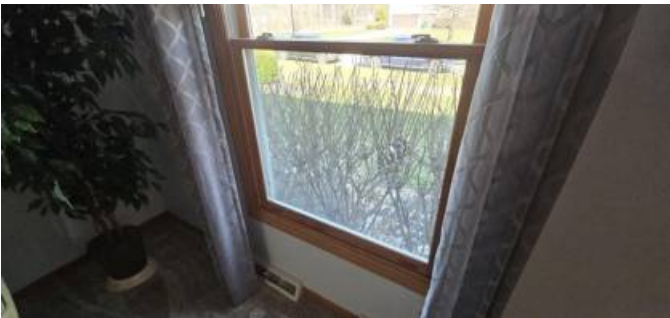
9.12 Windows Type:

The windows and associated hardware in this room are all serviceable.

Suggest windows and frames be kept caulked, sealed/painted to prevent moisture penetration. Failure to keep windows and frames sealed can cause deterioration and extensive moisture damage to the interior walls and surrounding sub-flooring. This damage is not always visible or accessible to the inspector at the time of inspection.

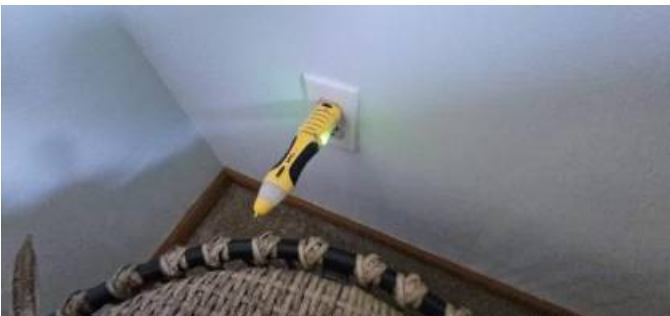
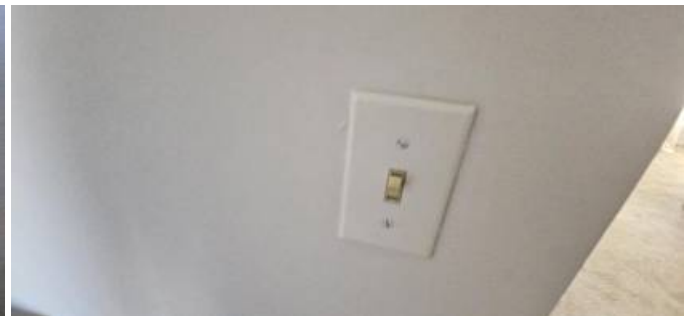
9.14 Switches/Fixtures/Outlets:

A representative sampling of switches and outlets were tested. As a whole, switches and outlets throughout the room are in serviceable condition.

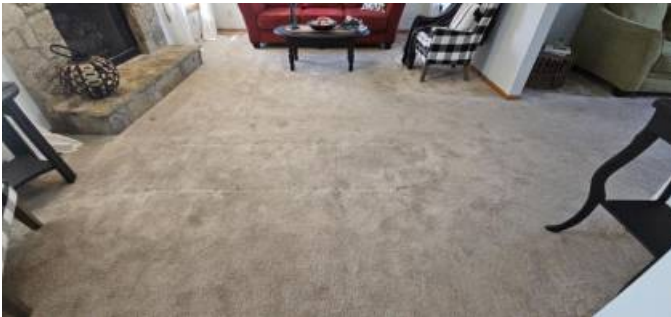
9.16 Floor:

The floors are in serviceable condition.

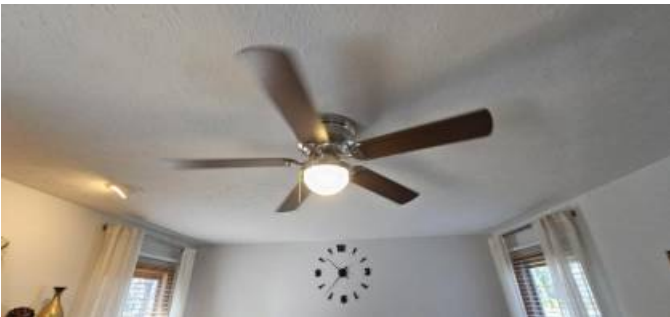
**9.19 Ceiling Fan:**

There is a ceiling fan installed in this room. It appears to be serviceable.

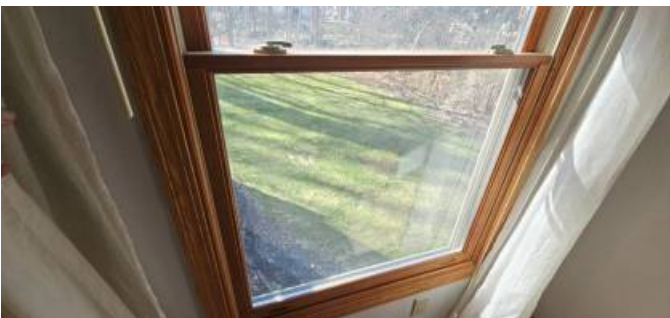
**9.20 Windows Type:**

The windows and associated hardware in this room are all serviceable.

Suggest windows and frames be kept caulked, sealed/painted to prevent moisture penetration. Failure to keep windows and frames sealed can cause deterioration and extensive moisture damage to the interior walls and surrounding sub-flooring. This damage is not always visible or accessible to the inspector at the time of inspection.

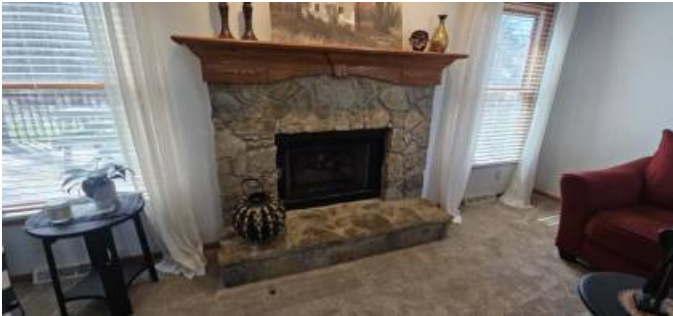
9.23 Type of Fireplace:

Gas logs are present. We recommend using caution when gas logs are used in this fireplace. Always operate per manufactures recommendations and with damper open to allow products of combustion to vent to exterior.

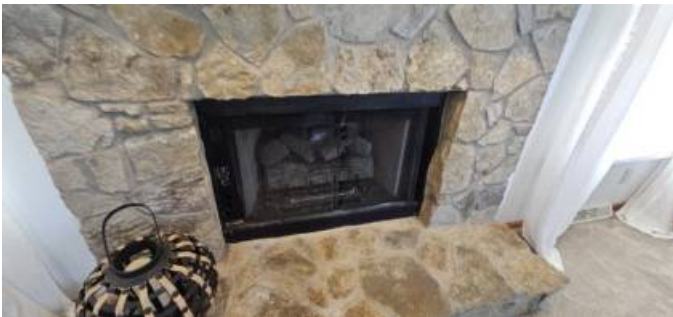
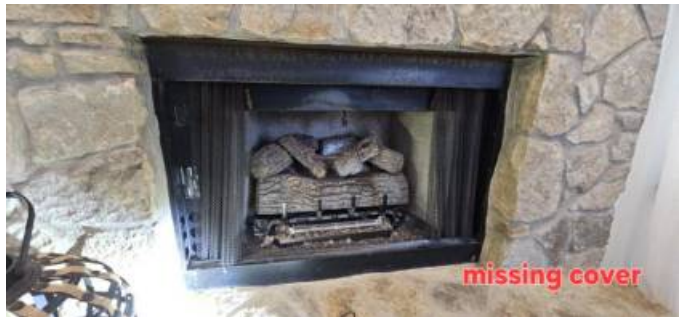
9.24 Firebox Condition:

Serviceable.

Glass cover or doors appear to be missing. Recommend adding the proper glass doors as needed.

The National Fire Protection Association, document NFPA 211, recommends all wood burning fireplaces be reviewed annually for damage. The fireplaces should be reviewed by a chimney sweep according to this standard.

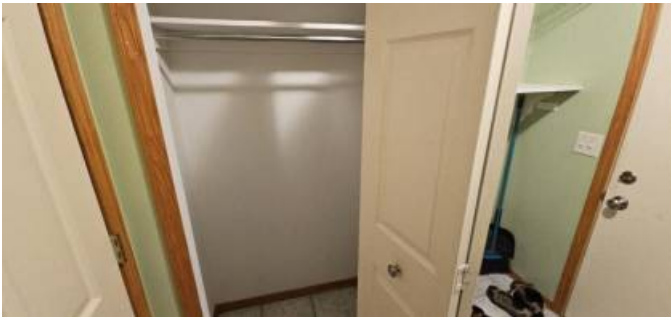
9.26 Closet Door:

The closet door to this room is functional.

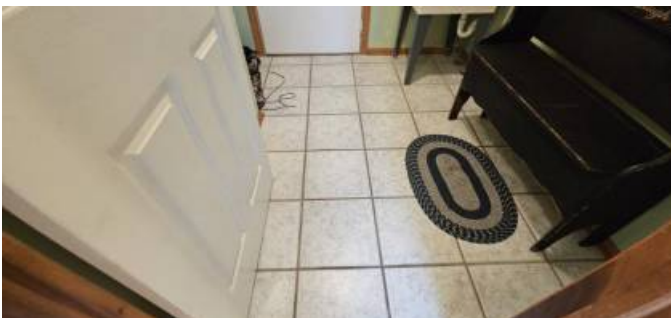
9.27 Floor:

The floors are in serviceable condition.

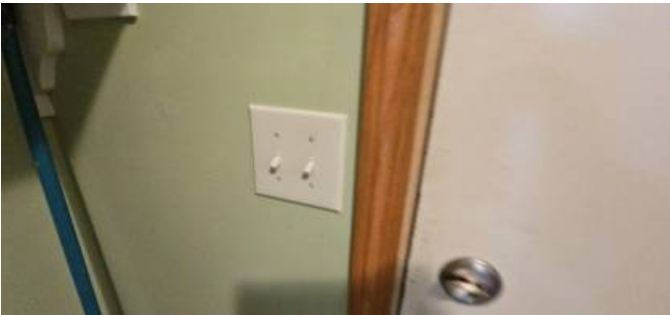
9.30 Switches/Fixtures/Outlets:

A representative sampling of switches and outlets were tested. As a whole, switches and outlets throughout the room are in serviceable condition.

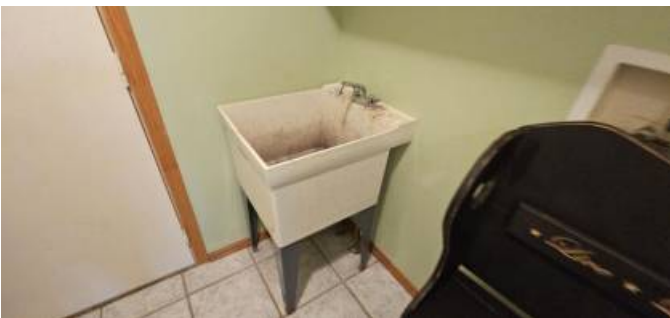
9.31 Sink:

Sink, Serviceable

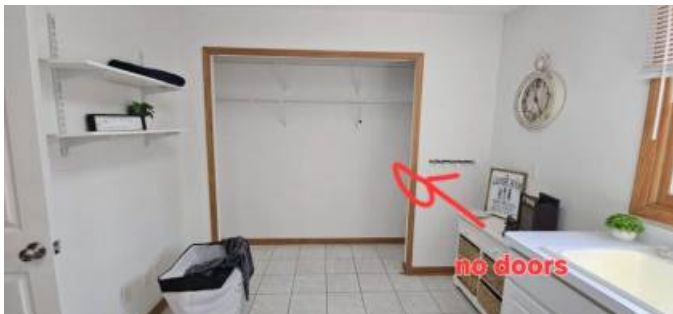
10.2 Closet Door:

Door missing. Recommend repairs and corrections be made as needed by qualified contractor.

Note: Closet doors were observed in the crawlspace.

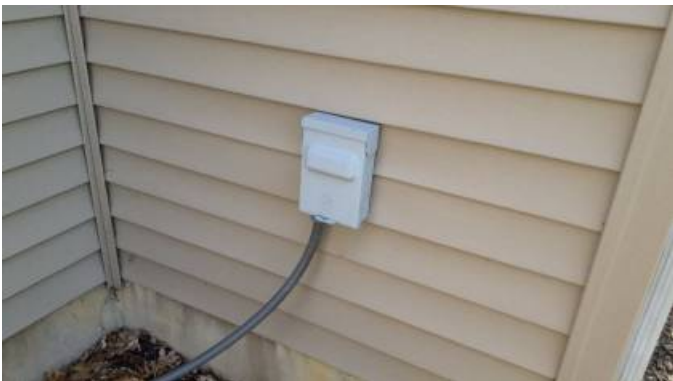
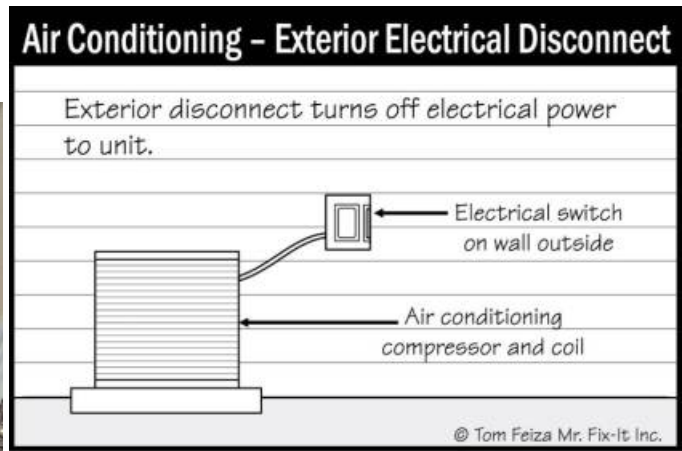
11.3 AC Design:

The air conditioner was activated to check the operation of the motor and the compressor, both of which appear to be in serviceable condition. As a detailed review of the cooling capacity of this unit is beyond the scope of this inspection, we make no warranty as to the system's adequacy.

In the inspectors opinion the air conditioning unit has exceeded its designed life expectancies. Typical life cycle of an A/C unit is 15-20 years, however it can reach 20-25 years with good routine maintenance. We make no warranty, guarantee or estimation as to the remaining useful life of this unit.

Suggest sealing gap around refrigerant line entrance to plenum to prevent loss of conditioned air and moisture intrusion.

We recommend this equipment be cleaned and evaluated by a qualified HVAC contractor for repair or replacement prior to close.

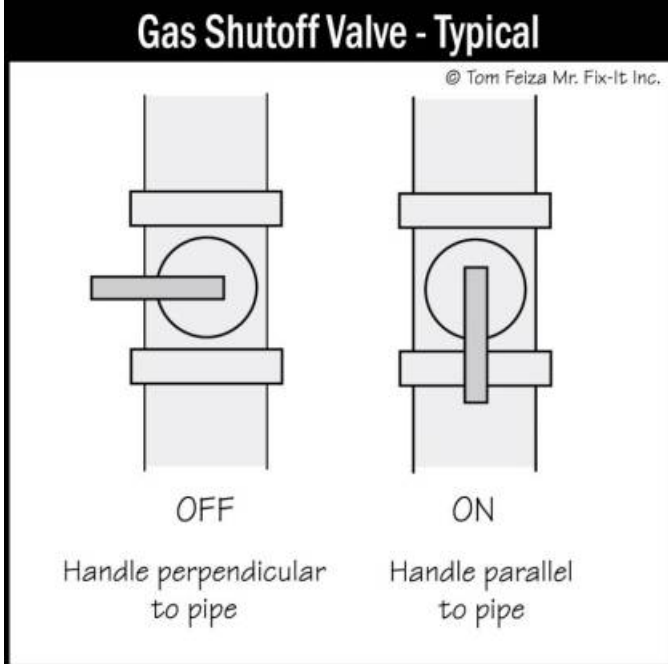
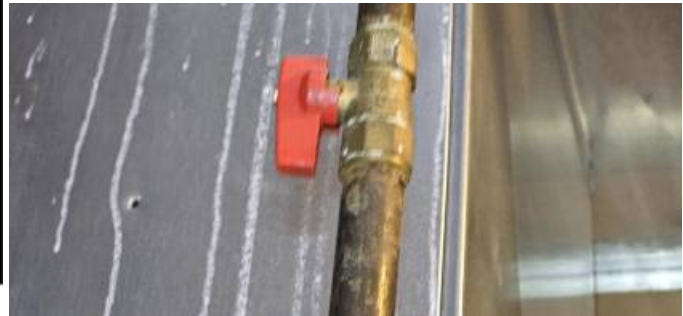
12.4 Burners Chamber:

Rust was observed in this appliance. Recommend review by a qualified HVAC contractor ensure proper and safe operation of this unit prior to close. Dismantling to inspect for holes and/or cracks in heat exchanger is not within the scope of this inspection.

We recommend this equipment be cleaned and evaluated by a qualified HVAC contractor for repair or replacement prior to close.

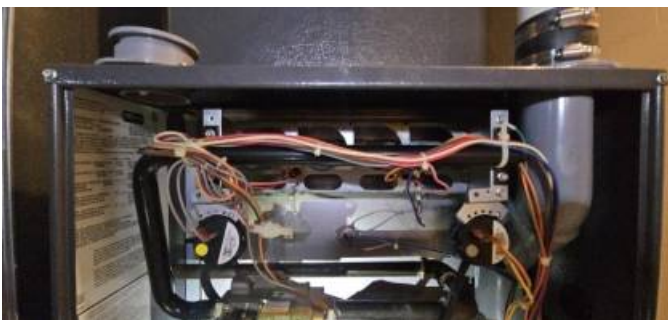
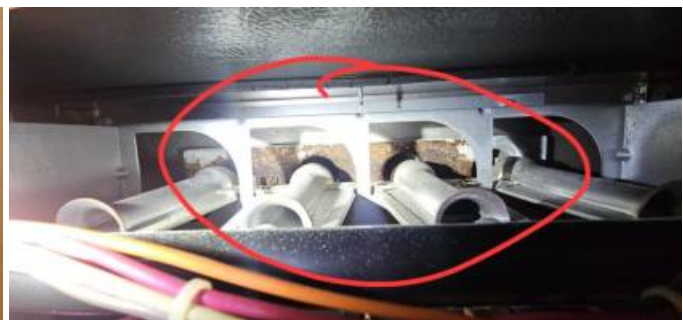
12.5 General Conditions:

The furnace had moisture visible in the cabinet and on the floor that appeared to be caused by improper handling of condensation. The Inspector recommends service by a qualified HVAC contractor.

We recommend this equipment be cleaned and evaluated by a qualified HVAC contractor for repair or replacement prior to close.

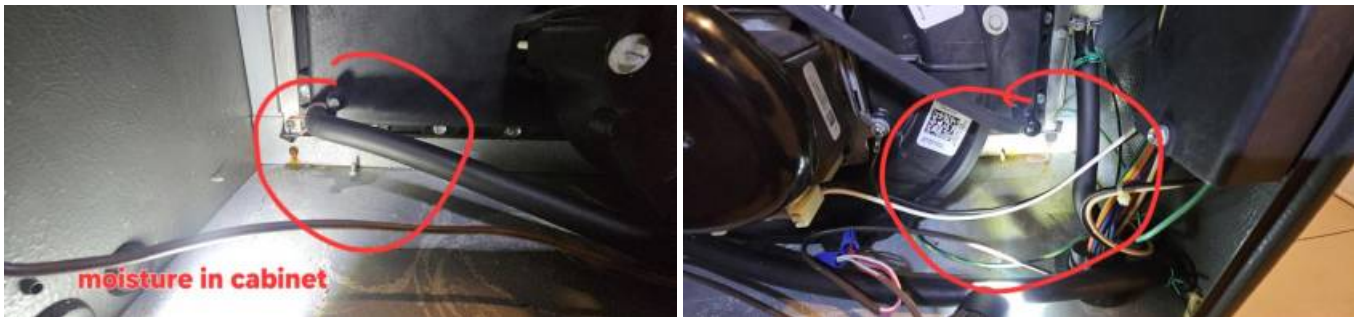
Active leaks observed on condensate line. Recommend review and repair by a qualified plumber.

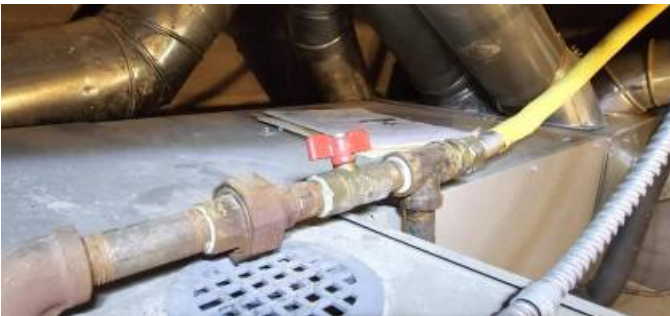
12.14 Energy Source:

Natural Gas w/Shutoff

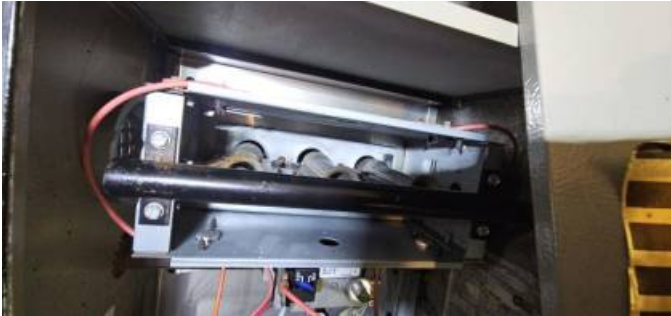
12.15 Burners Chamber:

Serviceable

Partially visible. Unable to inspect the entire heat exchanger without dismantling. If concerned recommend review by a qualified HVAC contractor prior to close.

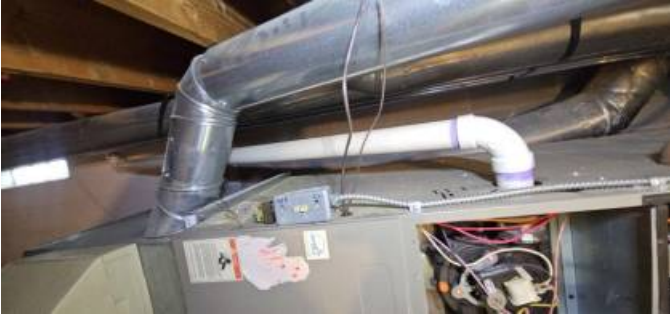
**12.18 Condensate Line:**

The condensate drain line appears to be adequately installed. Periodic checking to make sure that the line is clear will help to maintain the system.

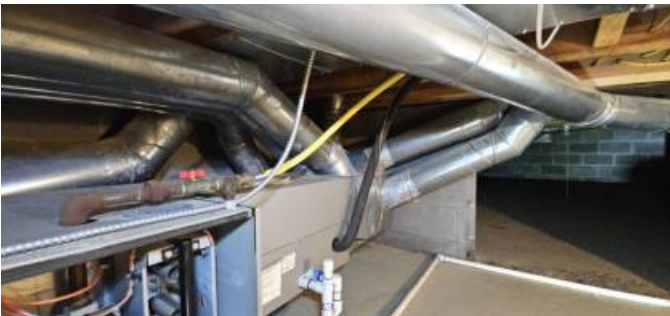
12.22 Humidifier Installed:

The filter is dirty and should be replaced.

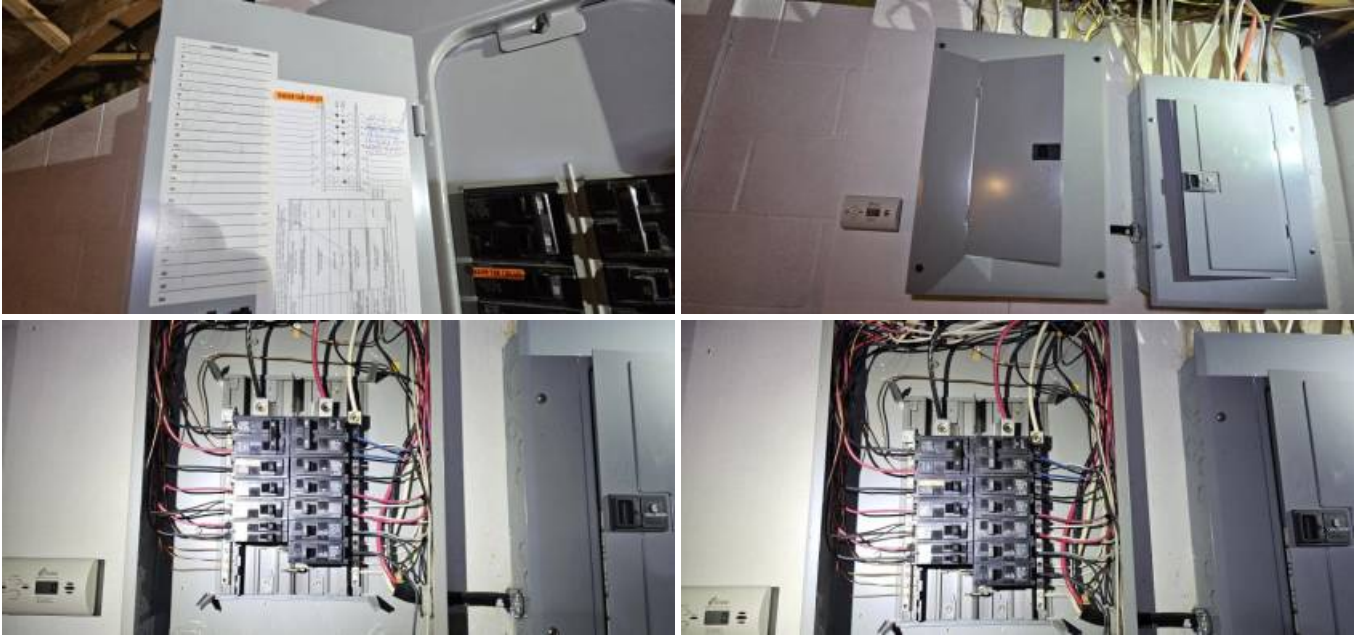
13.2 Main Panel #2:

Open knockouts observed in service panel cover; suggest installing knockout plugs, as needed for safety.

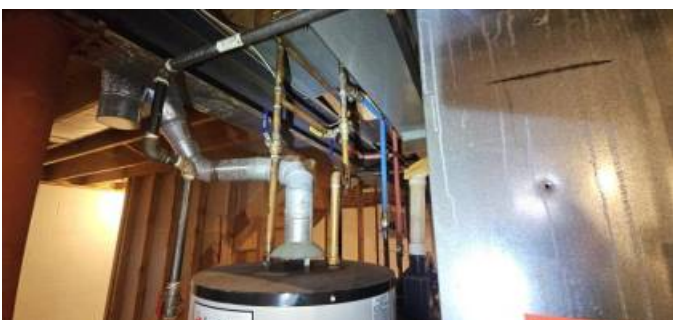
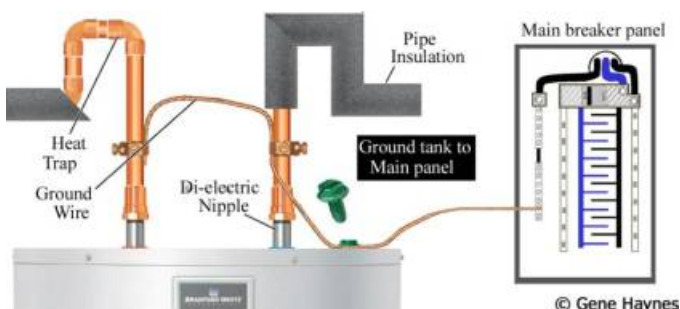
Ground jumper cable not observed between hot and cold water lines, recommend installing jumper cable to insure proper grounding and safety.

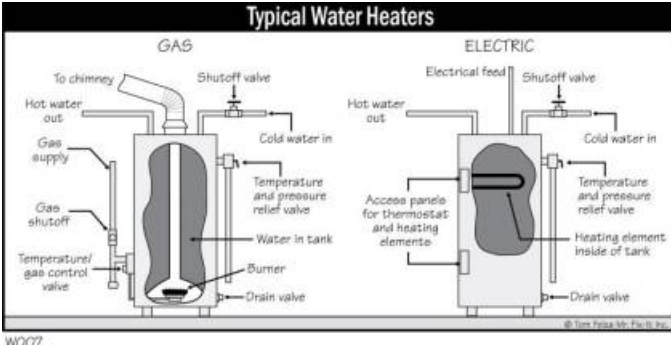
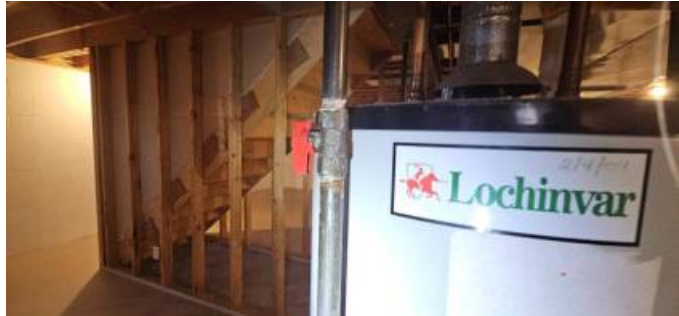
14.5 Energy Source:

Gas shut-off valve was observed near this appliance.

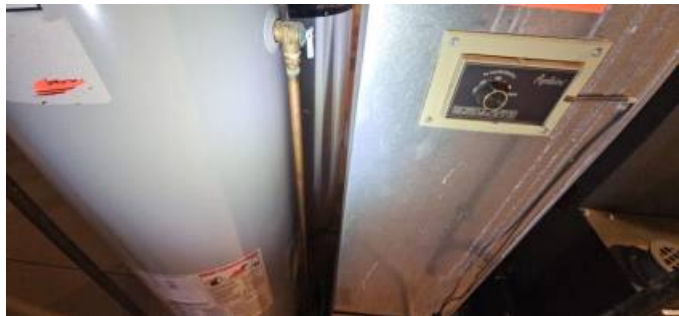
14.7 Burner:

Serviceable

Limited visual inspection only. Unable to inspect burner chamber due to closed system.

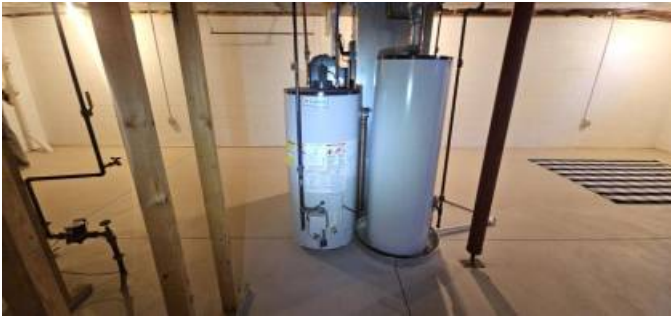
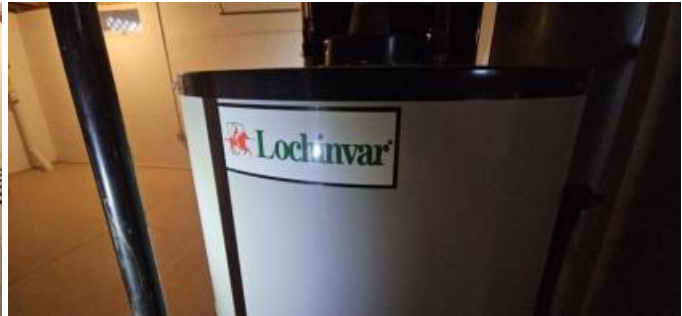
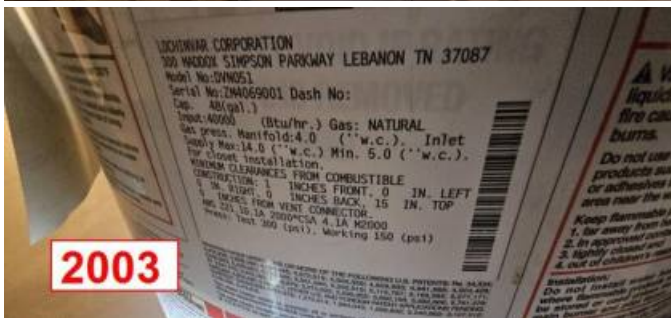
14.12 Brand:

Water heater is manufactured by Lochinvar Corp. The unit is a 2003 and is 21 years old.

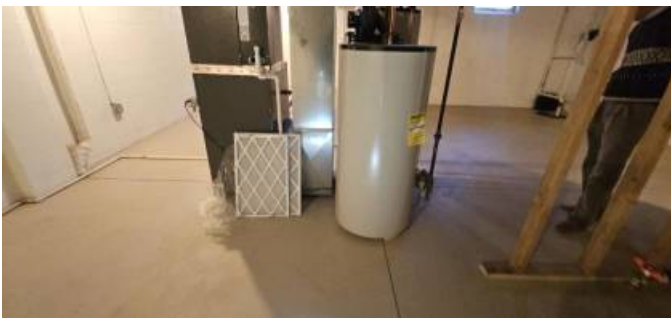
14.22 Overflow Pan/Drain Line:

Water heater is located indoors without an overflow pan/drain line. This may not have been required when the home was built or may be impossible due to interior location. Recommend review by a qualified plumber for additional information.

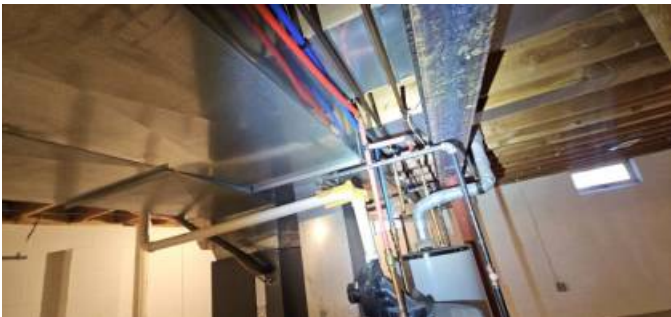
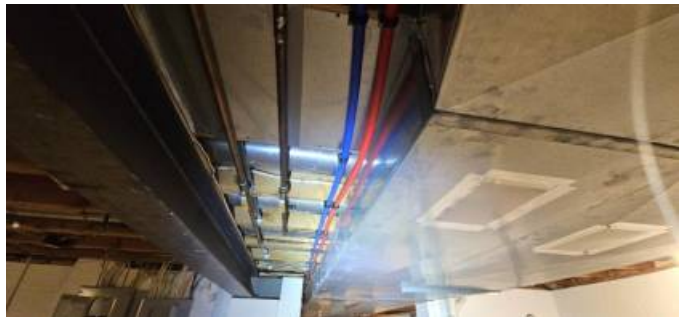
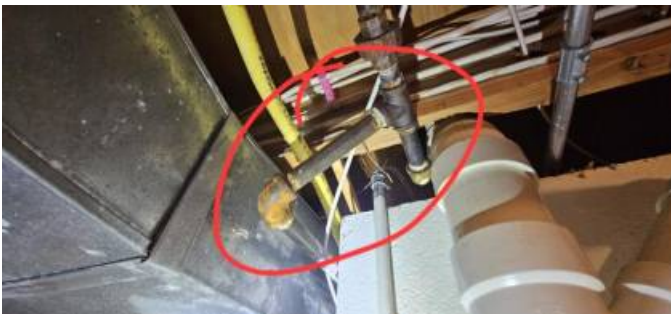
15.2 Supply Lines:

Corrosion observed at one or more valves and fittings; no leaks visible at time of inspection. Recommend review by a qualified plumber for repair or replacement as needed.

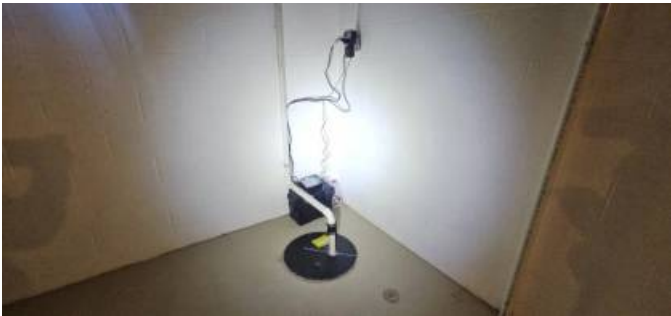
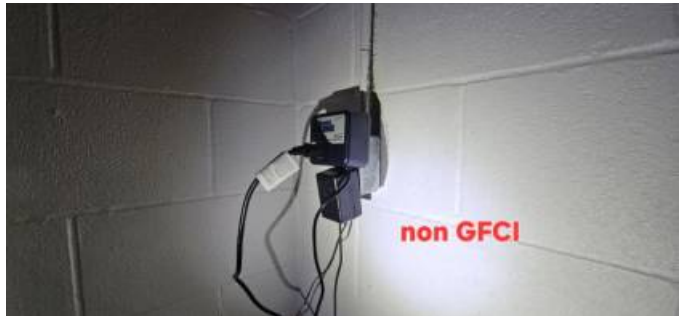
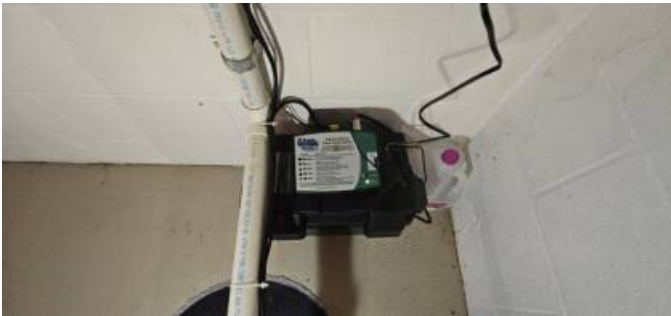
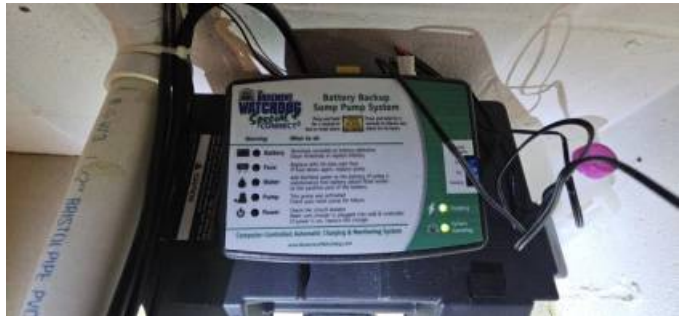
Ground Fault Circuit Interrupters (GFCI) may not have been required when the home was built. GFCI's should be installed to power the sump pump. Recommend review and repair by a qualified electrician.

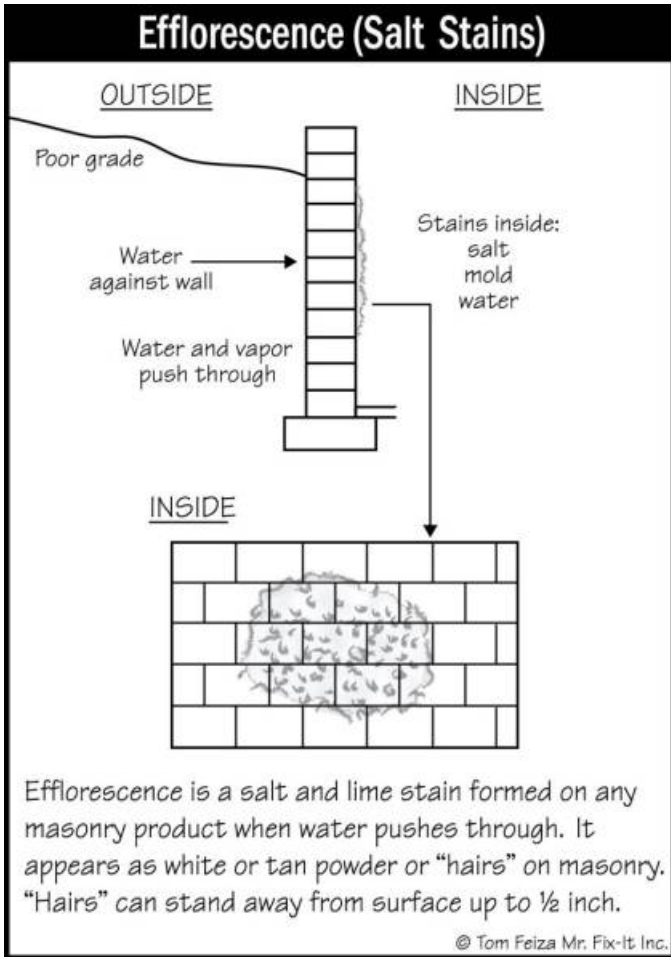
16.4 Walls:

Efflorescence was visible at some of the interior surfaces of the foundation walls.

Efflorescence is a white, powdery residue left by moisture seeping through the foundation wall and its presence indicates high moisture levels in soil near the foundation. This may only be cosmetic in nature. However, excessively high moisture levels in soil supporting the foundation can cause various structural problems related to soil movement. The source of moisture should be identified and the condition corrected. Recommend review by qualified contractor as needed.

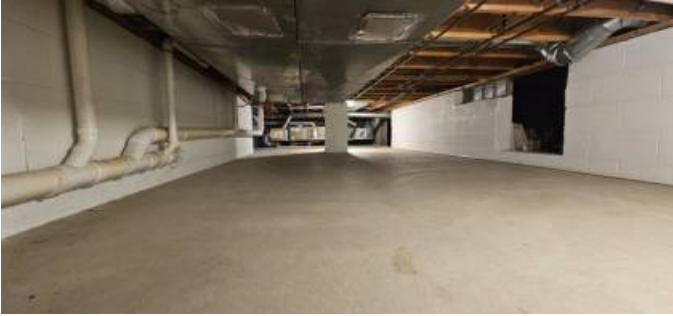
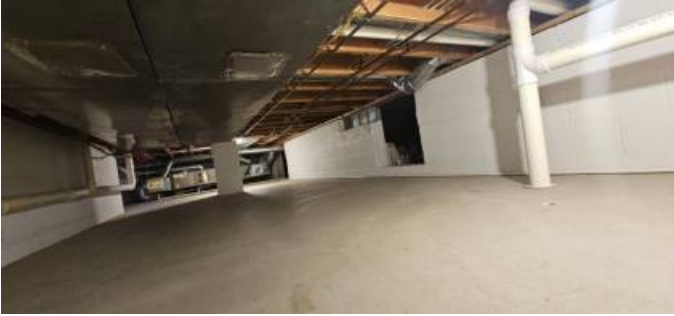
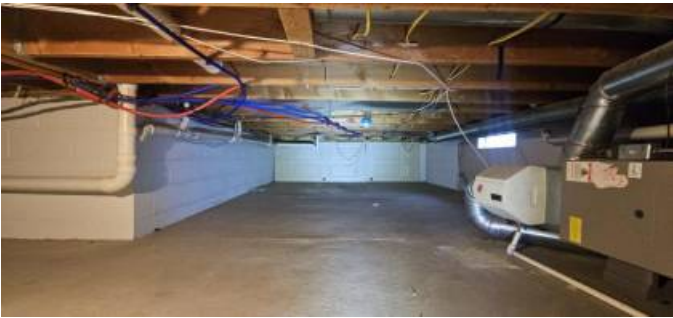
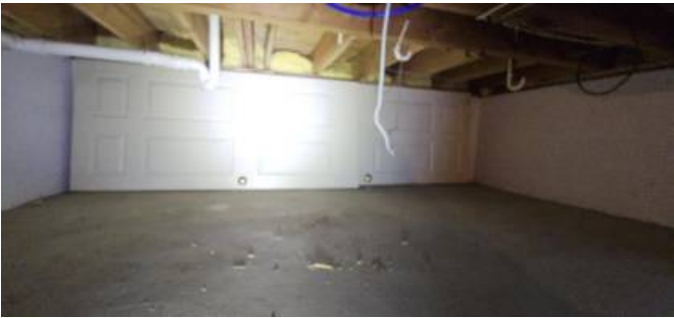
17.1 Access:

Location of Entrance is the Basement..

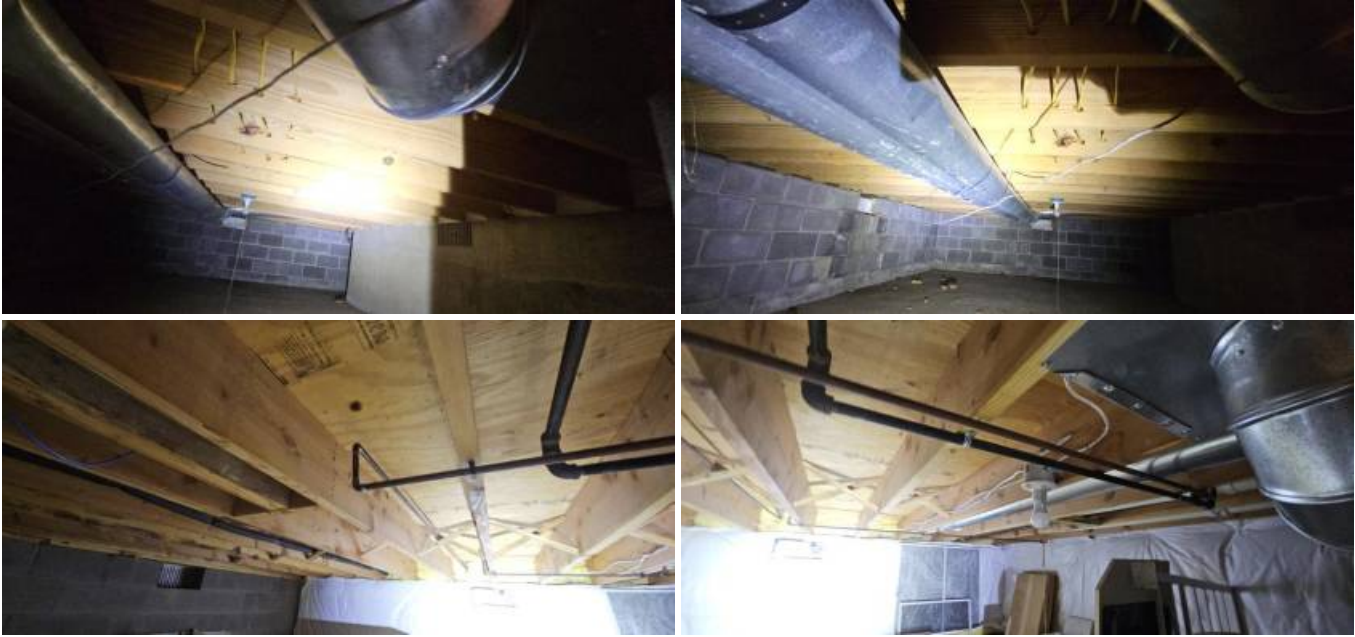
Efflorescence was visible at some of the interior surfaces of the foundation walls. Efflorescence is a white, powdery residue left by moisture seeping through the foundation wall and its presence indicates high moisture levels in soil near the foundation. This may only be cosmetic in nature. However, excessively high moisture levels in soil supporting the foundation can cause various structural problems related to soil movement. The source of moisture should be identified and the condition corrected. Recommend review by qualified contractor as needed.

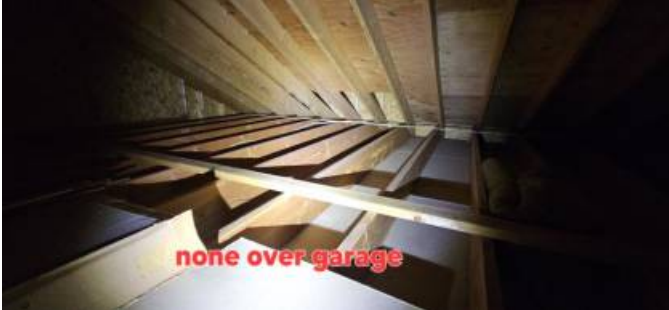
18.4 Insulation:

No insulation is installed over the garage. Recommend adding insulation as needed.

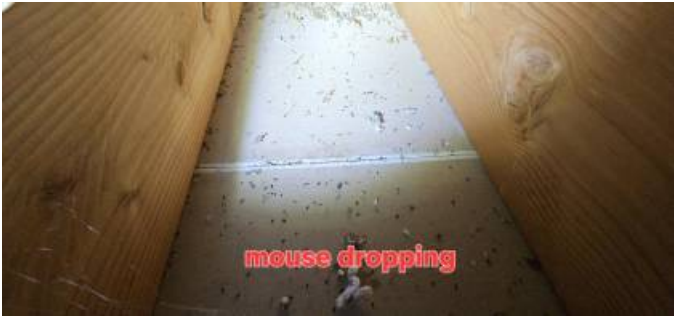
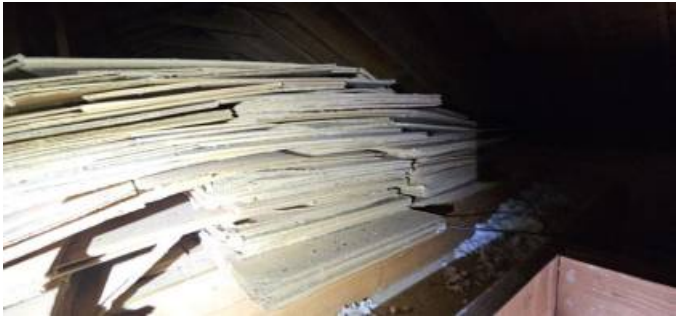
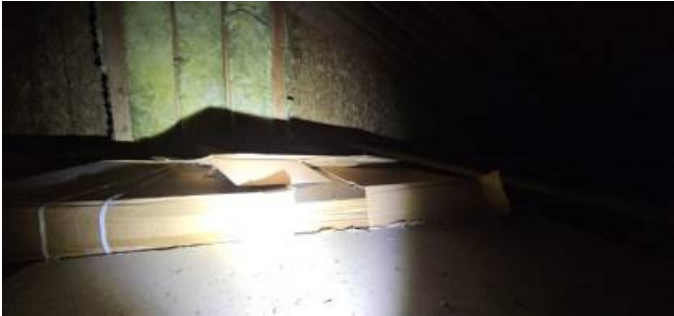
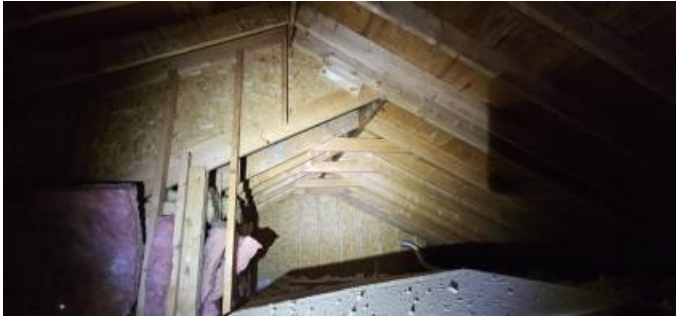
18.6 Attic Comments:

Rodent droppings or evidence of rodents observed. Suggest review by qualified pest control specialist for corrections as needed.

Recommend removing the cardboard boxes from attic to prevent rodent infestations.
