**Mixed Use Store
Front/Apts
Sample Report**

13375 Madison
Lakewood OH 44107

September 16, 2022

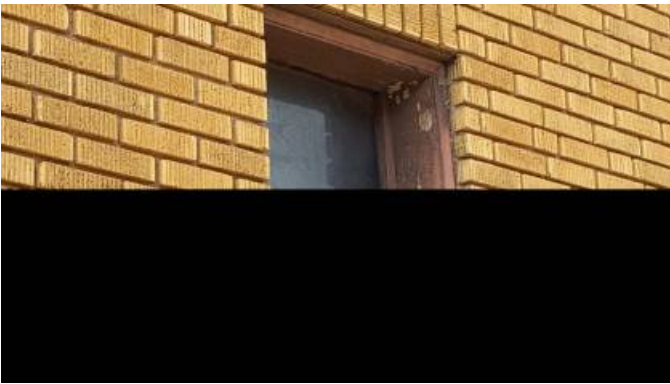
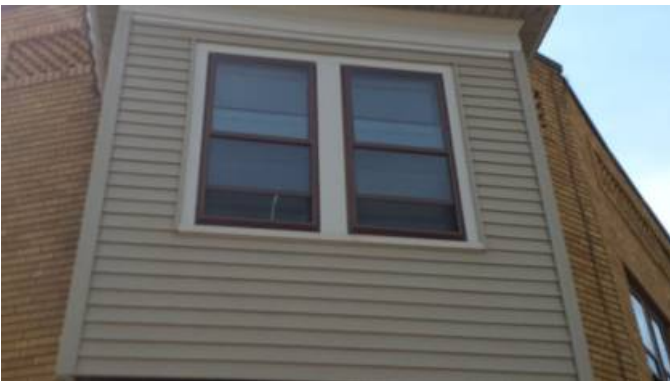
In the inspectors opinion many of the windows/frames are near the end of their useful life due to age and poor condition. Recommend review by a qualified professional for repair or replacement, as needed, prior to close.

Suggest windows and frames be kept caulked, sealed/painted to prevent moisture penetration. Failure to keep windows and frames sealed can cause deterioration and extensive moisture damage to the interior walls and surrounding sub-flooring. This damage is not always visible or accessible to the inspector at the time of inspection.

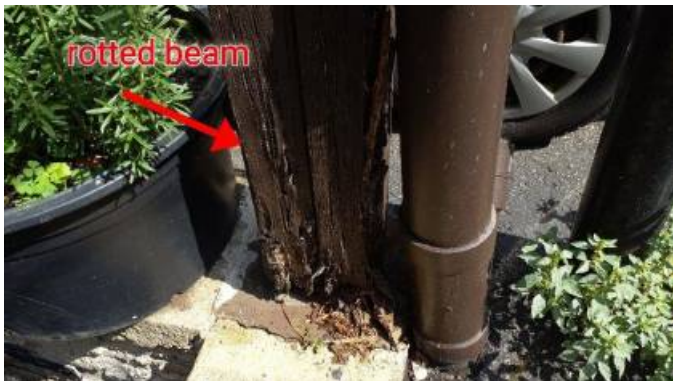
Moisture damaged trim observed at various areas; The extent of damage could not be determined without destructive analysis (maintenance and/or repairs should be performed). Whenever there is water damage, there is the possibility of hidden mold growth and pest infestation. If you have concerns regarding mold, we suggest review by a qualified professional. Anytime there is a mold or mildew condition we suggest clean-up be performed per EPA guidelines to correct the condition and that corrective measures be taken to limit moisture in the home.

Peeling paint observed at various areas; suggest scraping and painting as needed as part of normal maintenance.

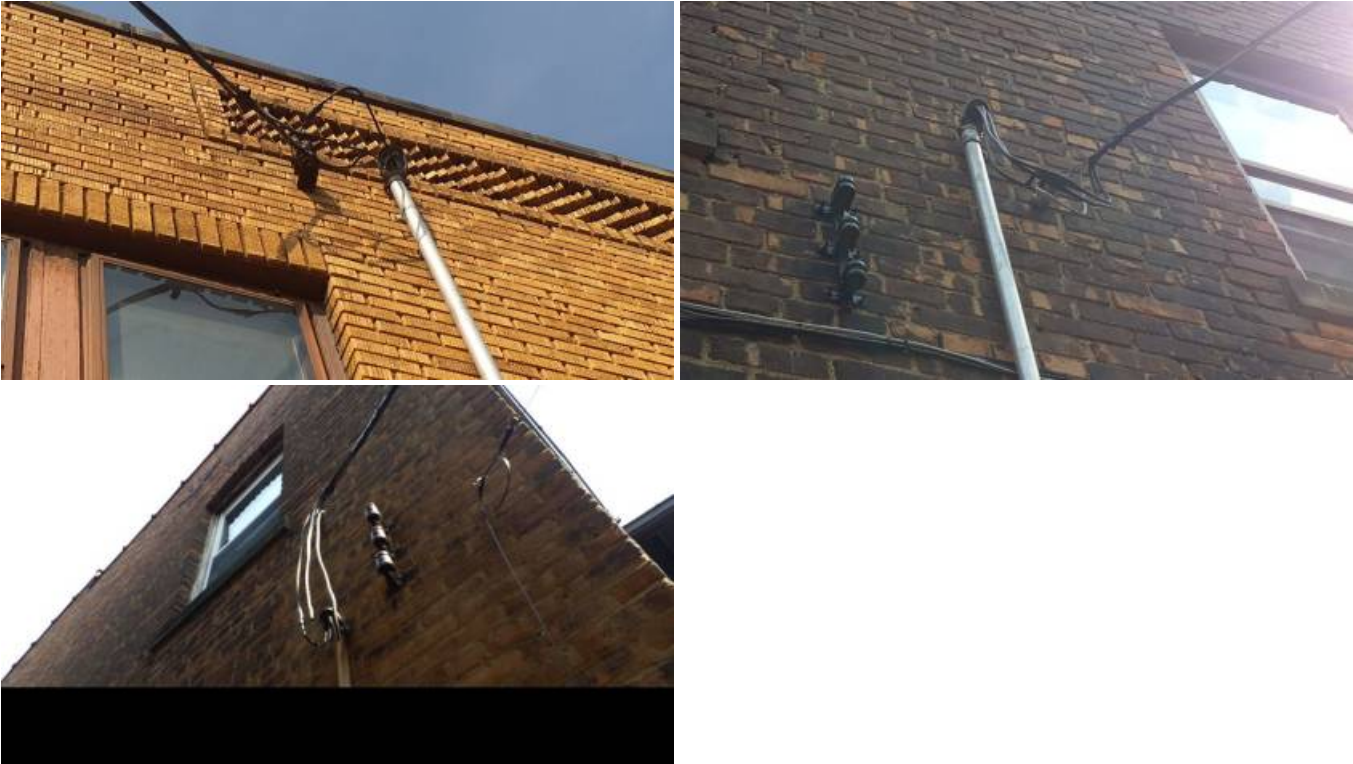
Appears serviceable

Overhead

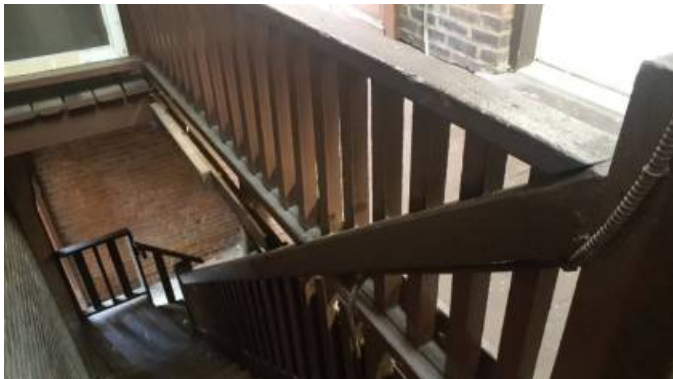
The porch deck is very springy, poorly framed, inadequately supported or severely overspanned. Recommend review by a qualified professional for repair or replacement as needed.

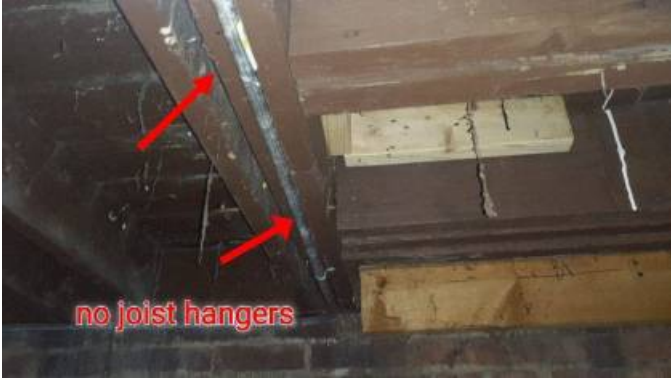
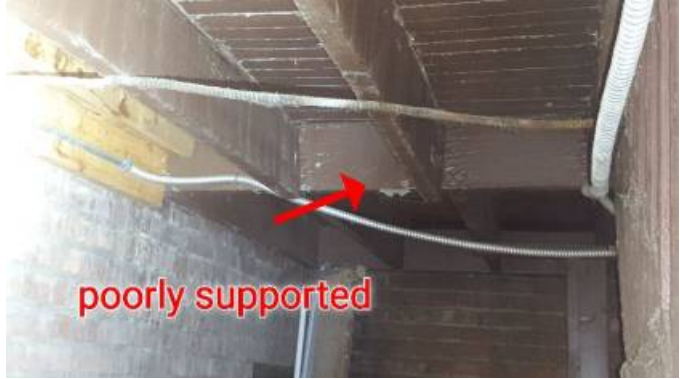
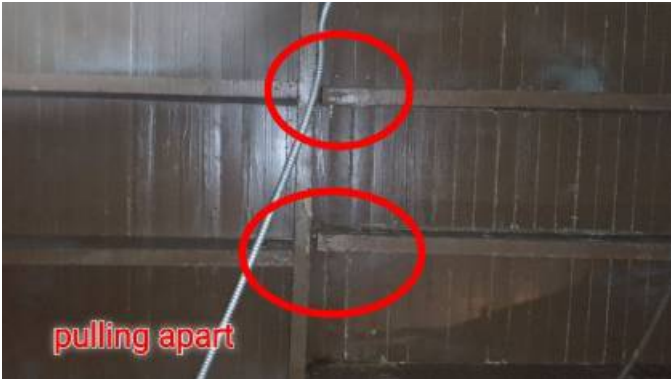
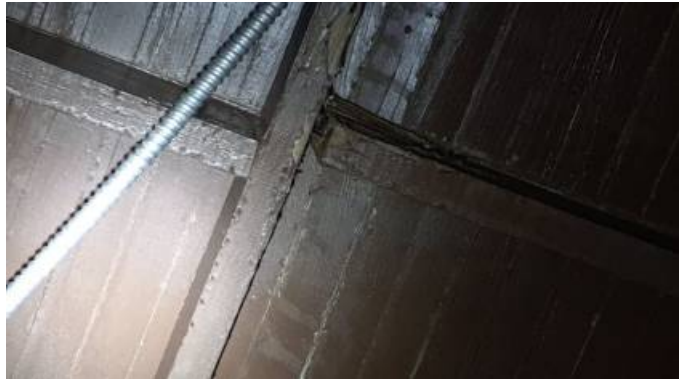
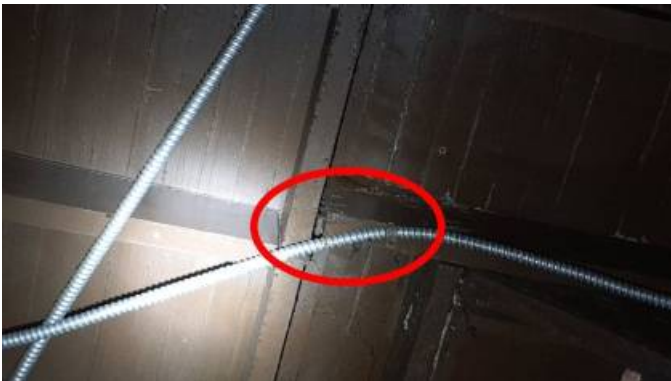
The support used in supporting the porch appeared to be inadequate. This condition is potentially dangerous. The Inspector recommends that an evaluation and any necessary work be performed by a qualified contractor.

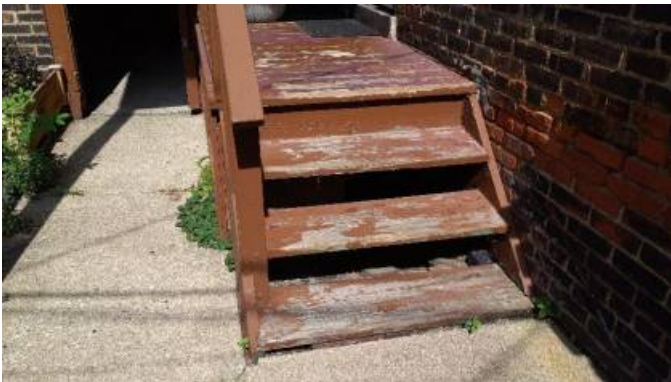
The porch is deteriorated, recommend review by a qualified contractor for repair or replacement needed.

Peeling paint observed at various areas, suggest scraping and painting as needed as part of normal maintenance.

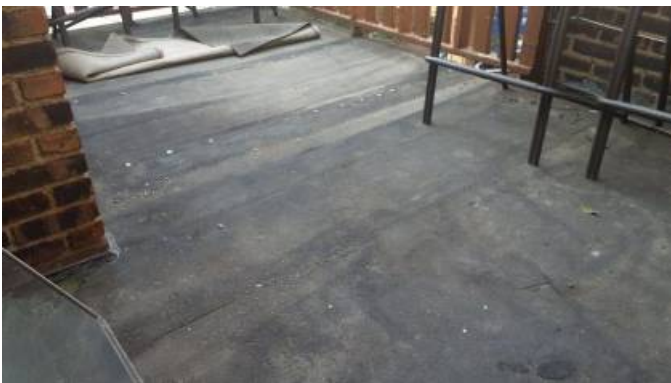
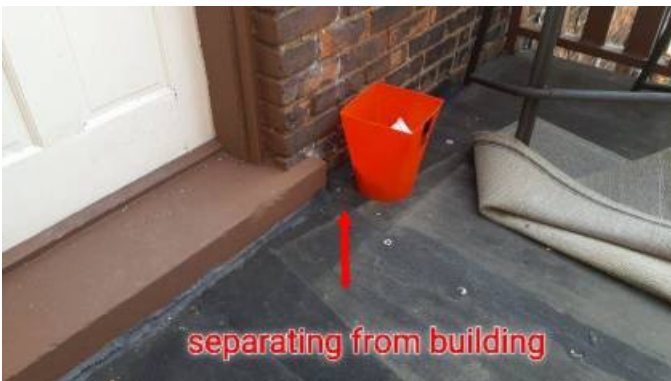
Settling observed. Recommend review by a qualified contractor for repair or replacement as needed.

Peeling paint observed at various areas, suggest scraping and painting as needed as part of normal maintenance.

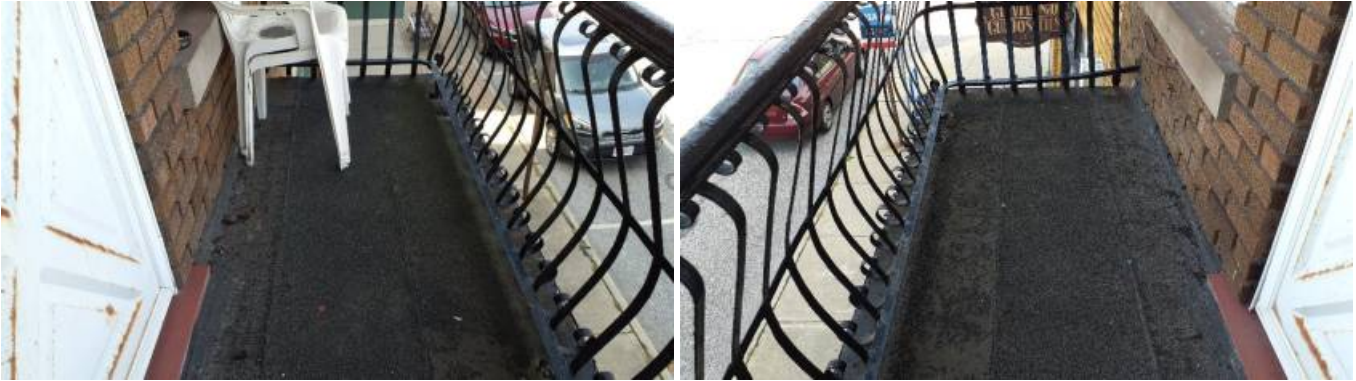
Rolled Roofing observed on balcony floor.

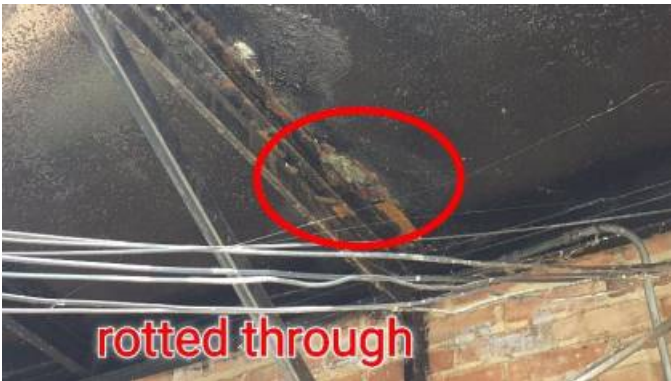
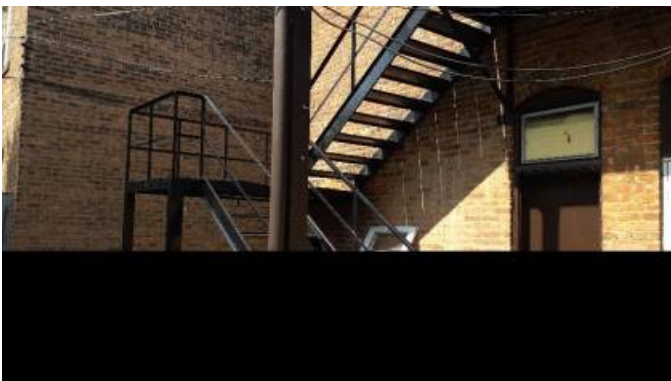
Damaged material observed recommend repair or replacement as needed..

Excessive load may result in structural failure. Recommend review by a qualified contractor for repair or replacement as needed.

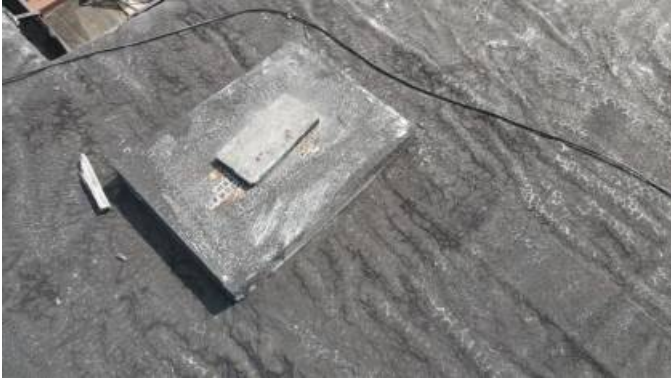
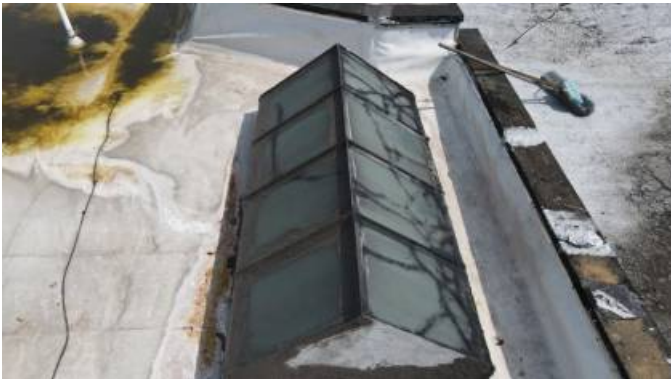
3.4 Roof Comments:

Flat roof observed. Flat roofs deteriorate at a faster rate than sloped roofs.

The skylight shows signs of leakage. Recommend review by a qualified roofer for repair or replacement as needed.

In the inspectors opinion the skylight has exceeded its designed life expectancies. We make no warranty, guarantee or estimation as to the remaining useful life of this window.

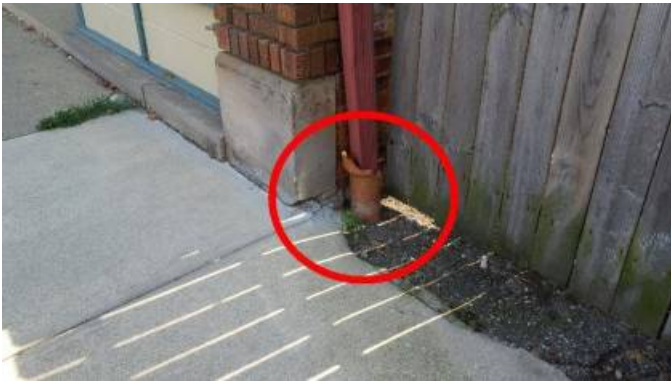
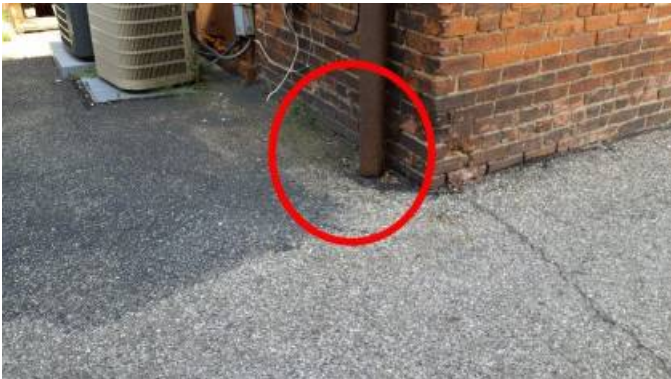
3.6 Roof Gutter System:

Damage observed. Recommend review for repair or replacement as needed.

One or more downspouts exit into an underground drainage pipe. Underground drainage systems are not within the scope of this inspection and a functional water flow test is not performed. If concerned about underground drainage, recommend having a sewer/storm drain scope from a qualified plumber.

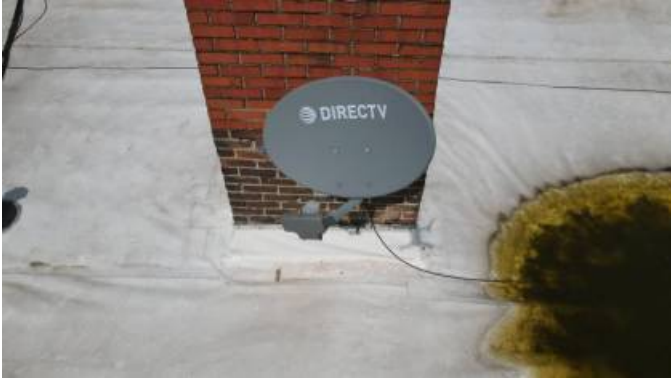
The areas at which the chimney penetrated the roof-covering material were dependent upon a sealant alone to prevent moisture intrusion of the roof structure. Sealant will eventually dry, shrink and crack, allowing moisture intrusion with the potential to cause decay of the roof sheathing or framing, microbial growth, or damage to other home materials. The condition of the sealant should be checked annually and an appropriate sealant reapplied as necessary by a qualified roofing contractor. The Inspector recommends installation of proper flashing and counter-flashing by a qualified contractor.

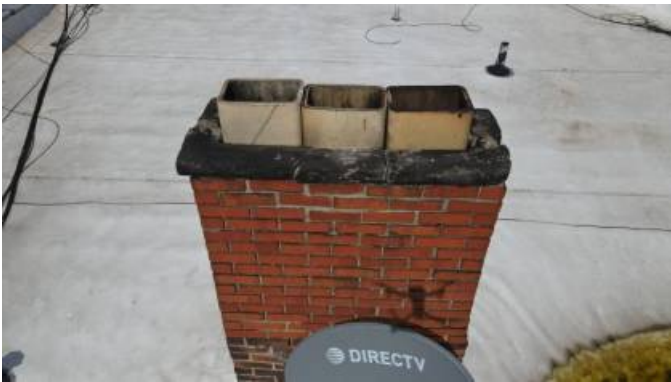
4.5 Rain Cap:

No chimney rain cap observed, suggest installing a screened chimney raincap to prevent the entrance of the elements, local wildlife, and to preserve the life of the chimney as well as minimize maintenance.

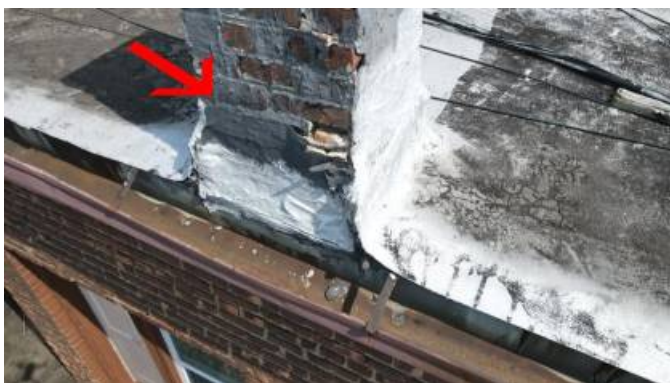
Flashings are covered with roofing cement, which may indicate previous water penetration into the structure at this location. Suggest client consult with sellers for additional information or review by qualified roofer for repair as needed.

In the inspectors opinion the flashings are near the end of their useful life due to deterioration. Recommend review by qualified roofer for corrections as needed.

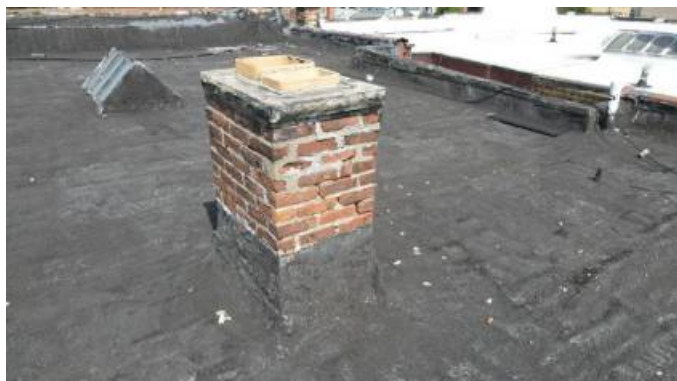
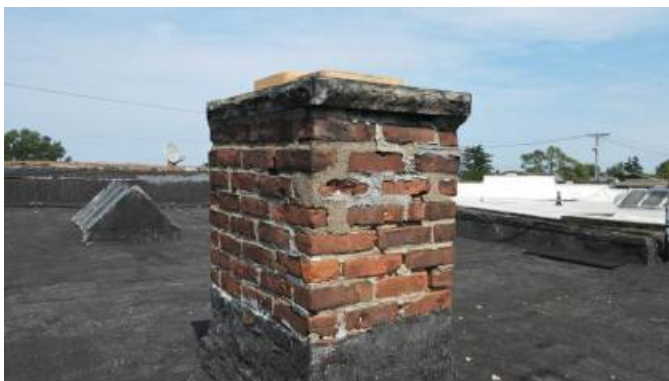
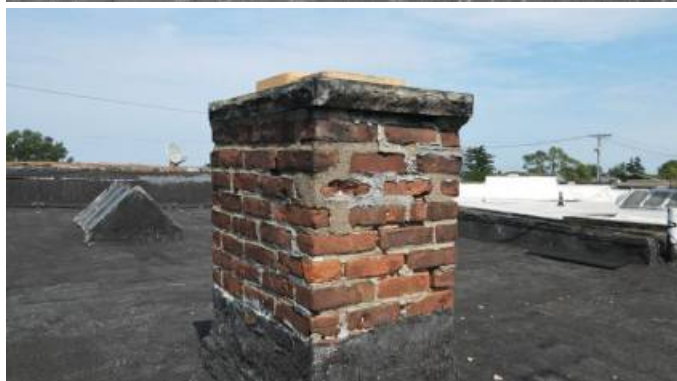
4.12 Visible Condition:

Deteriorated mortar observed, suggest tuckpointing as needed to prevent further damage.

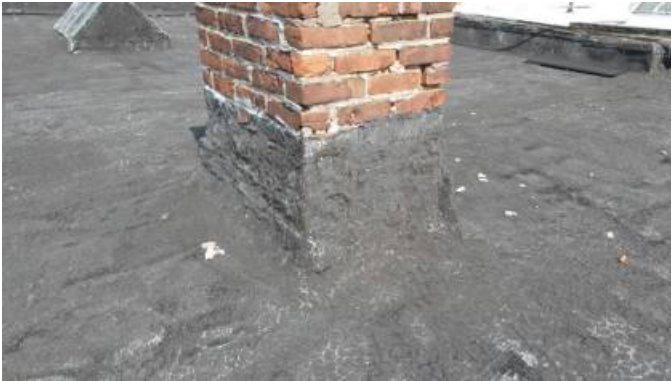
Flashings are covered with roofing cement, which may indicate previous water penetration into the structure at this location. Suggest client consult with sellers for additional information or review by qualified roofer for repair as needed.

In the inspectors opinion the flashings are near the end of their useful life due to deterioration. Recommend review by qualified roofer for corrections as needed.

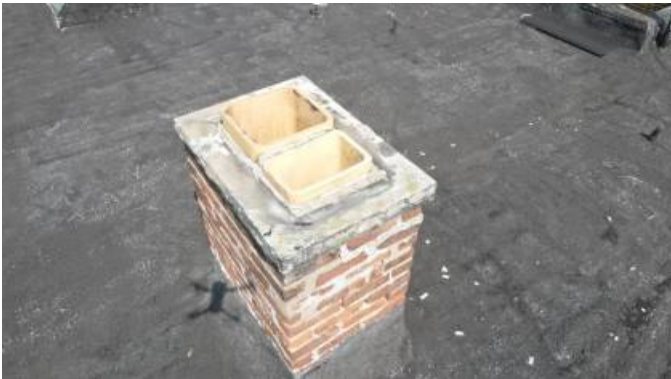
4.15 Rain Cap:

No chimney rain cap observed, suggest installing a screened chimney raincap to prevent the entrance of the elements, local wildlife, and to preserve the life of the chimney as well as minimize maintenance.

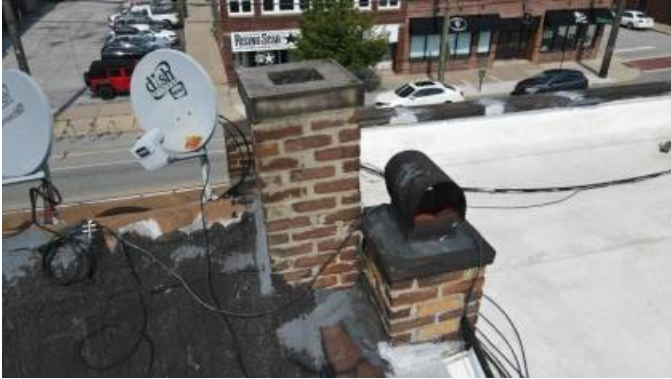
Flashings are covered with roofing cement, which may indicate previous water penetration into the structure at this location. Suggest client consult with sellers for additional information or review by qualified roofer for repair as needed.

In the inspectors opinion the flashings are near the end of their useful life due to deterioration. Recommend review by qualified roofer for corrections as needed.

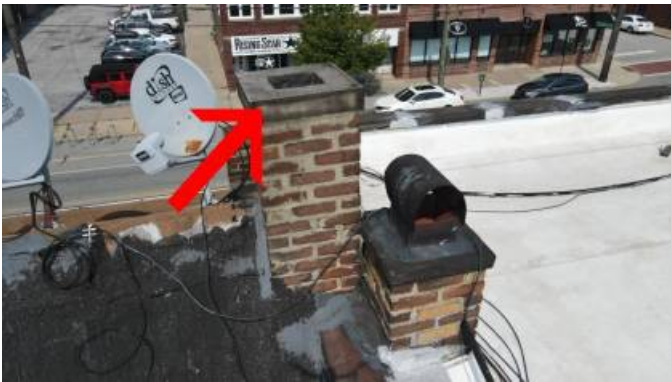
4.20 Rain Cap:

No chimney rain cap observed, suggest installing a screened chimney raincap to prevent the entrance of the elements, local wildlife, and to preserve the life of the chimney as well as minimize maintenance.

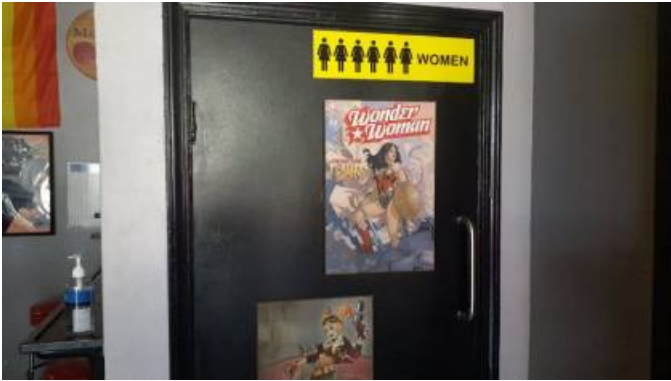
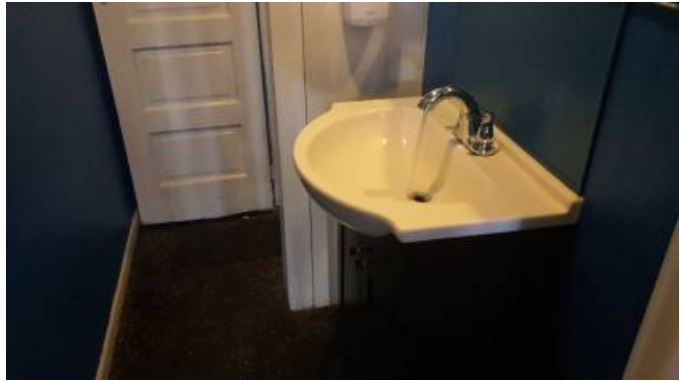
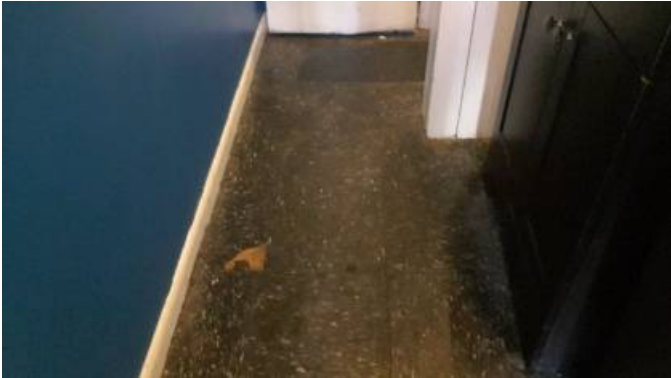
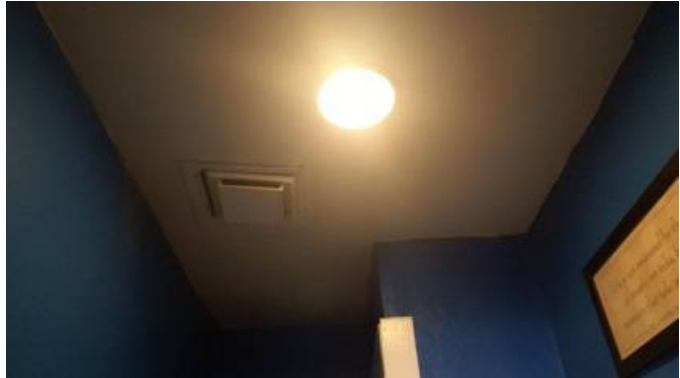
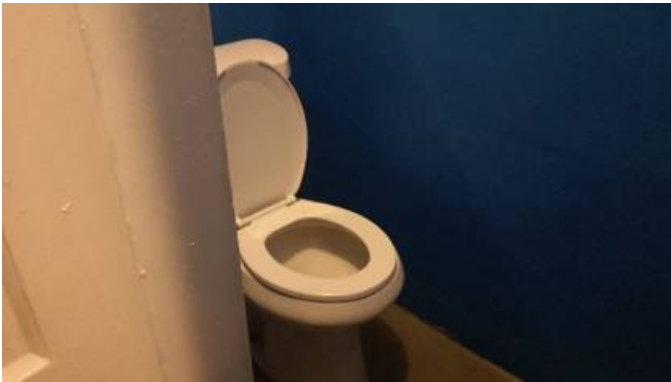
7.5 Location:

1st floor bar ladies room.

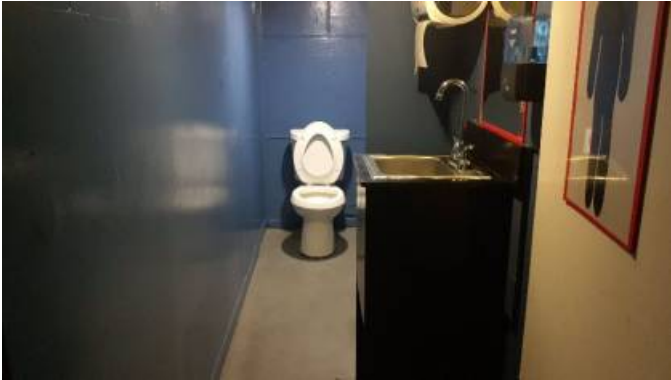
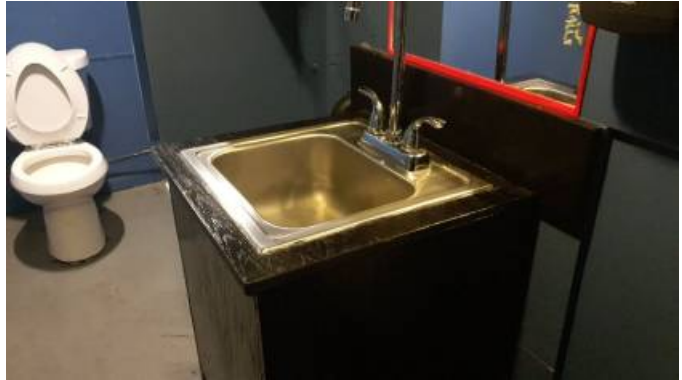
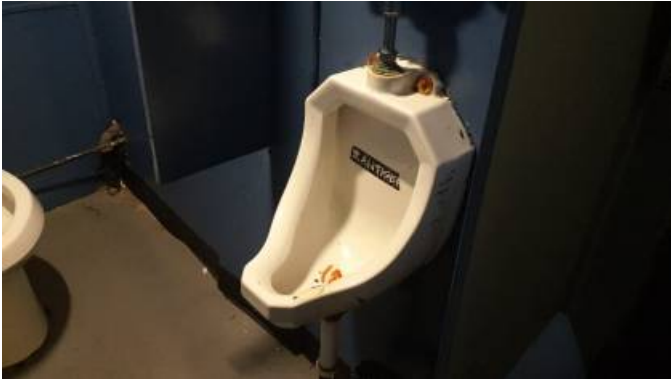
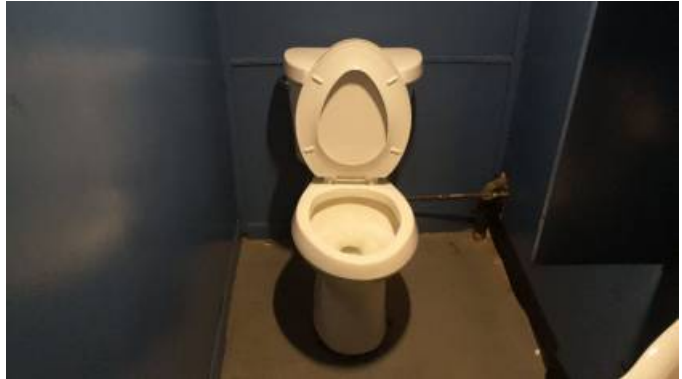
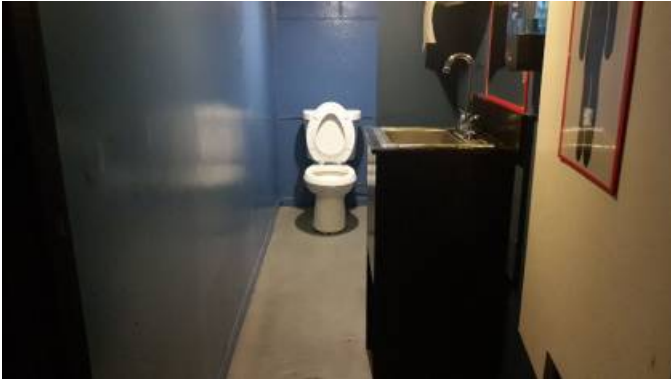
Bathroom #5:

Men's room bar.

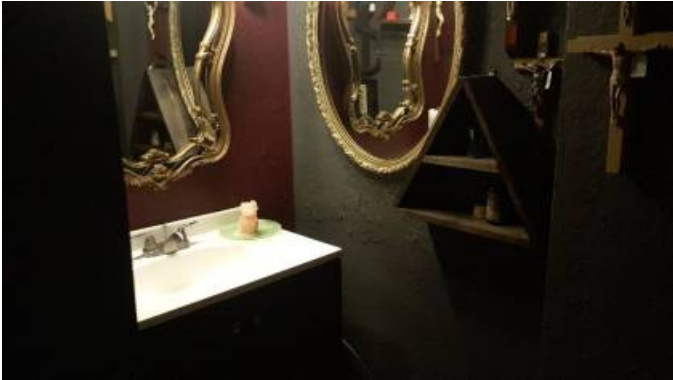
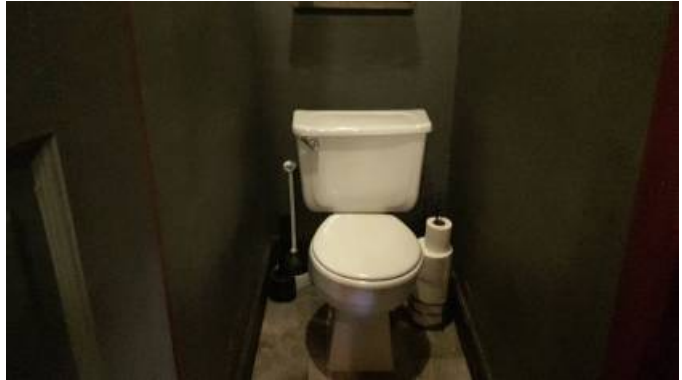
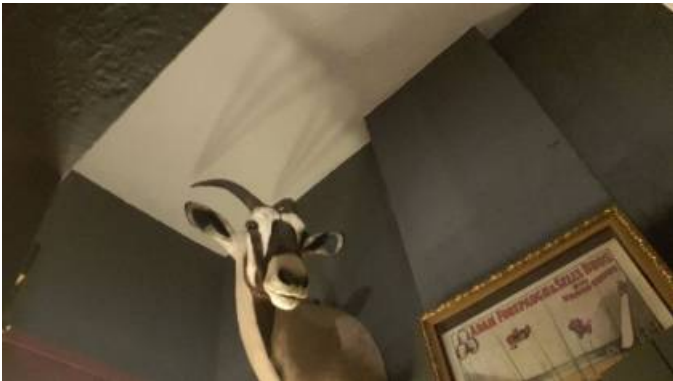
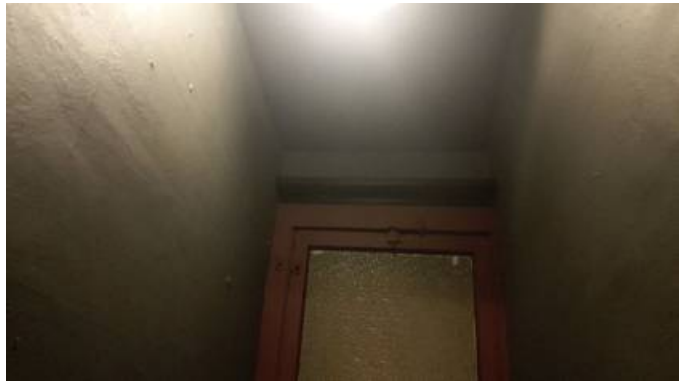
Bathroom #6:

Cleveland curiosity.

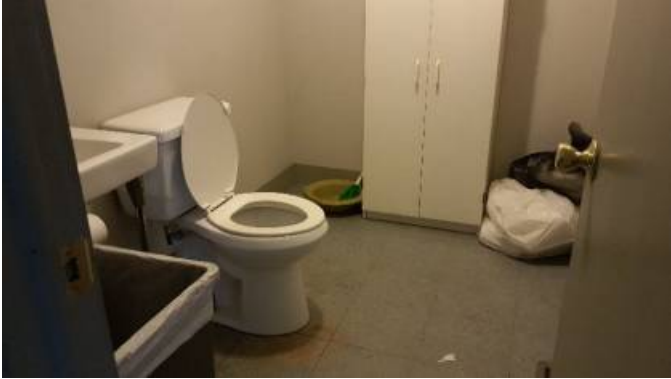
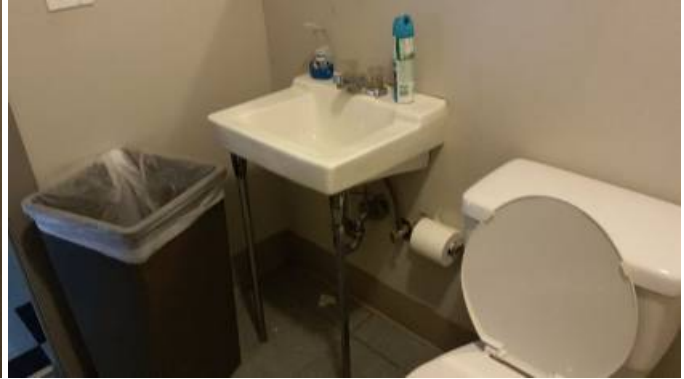
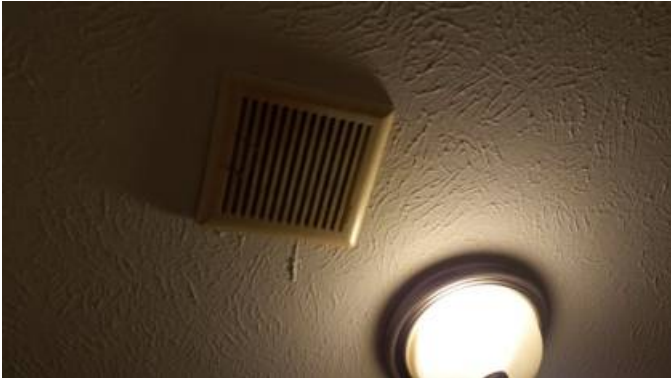
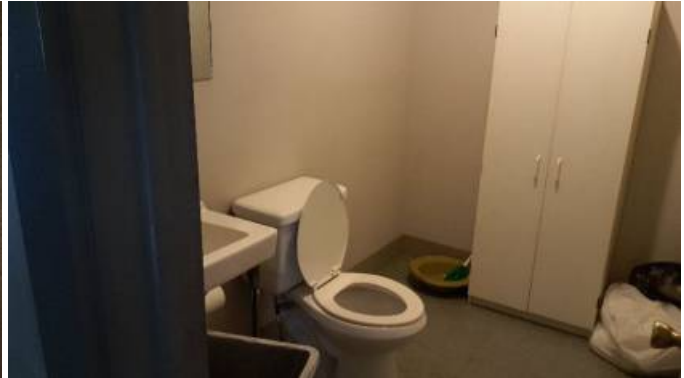
7.8 Location:

1st floor barber.

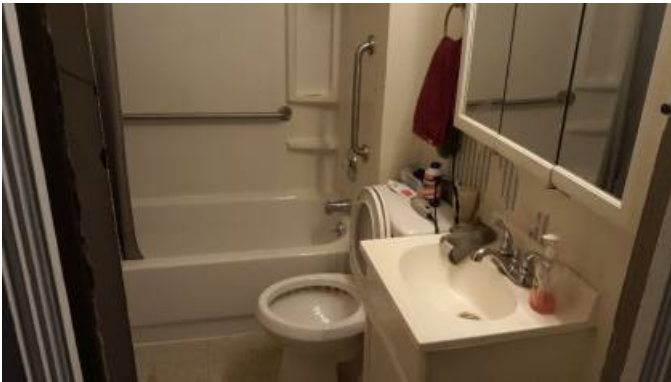
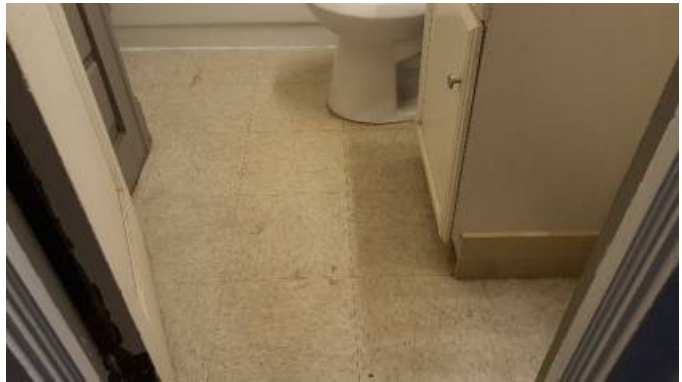
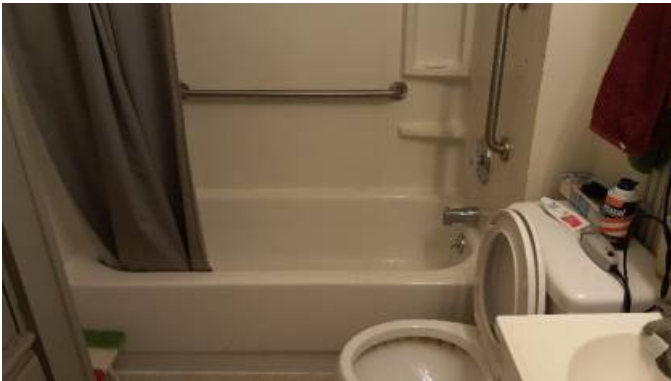
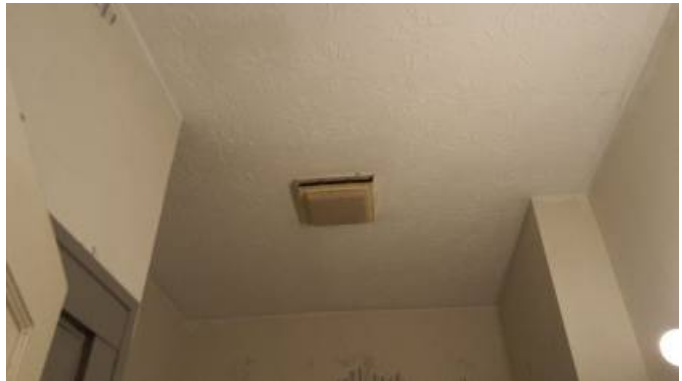
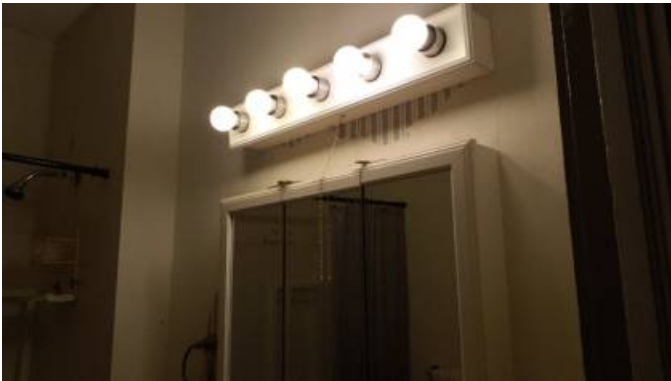
Bathroom #8:

Sam's unit.

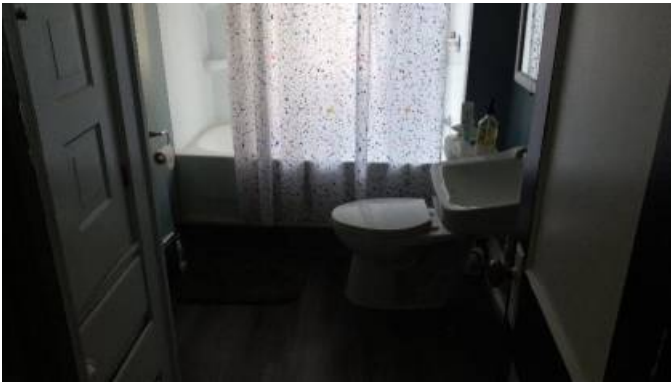
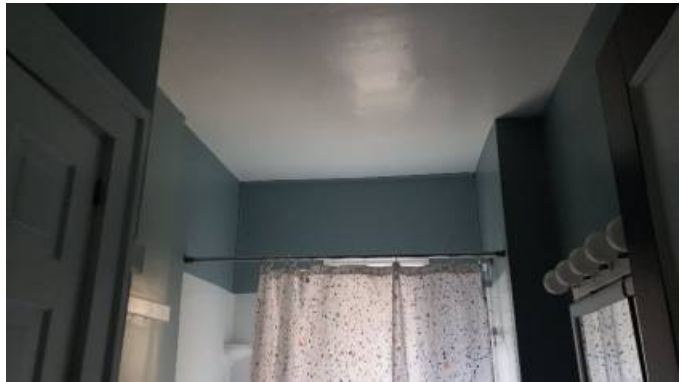
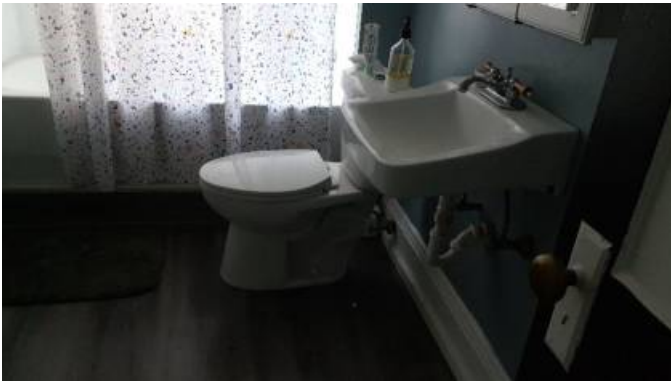
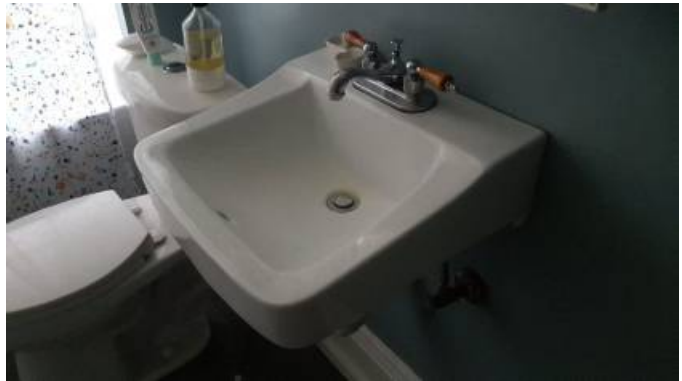
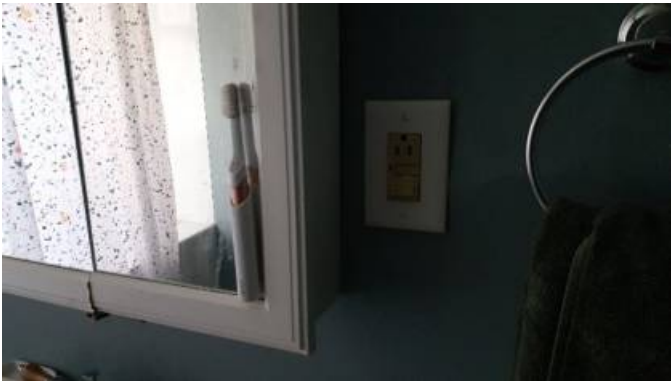
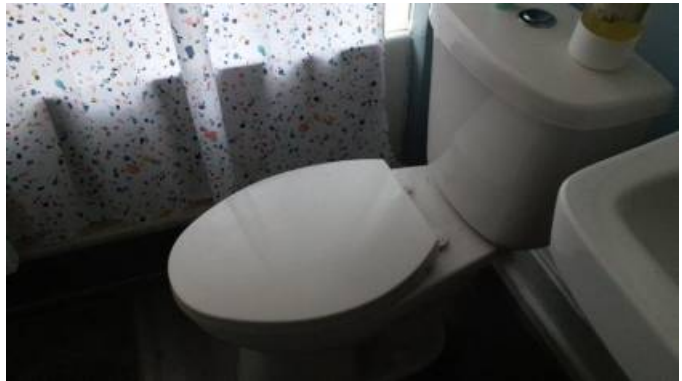
Bathroom #9:

Unit 2.

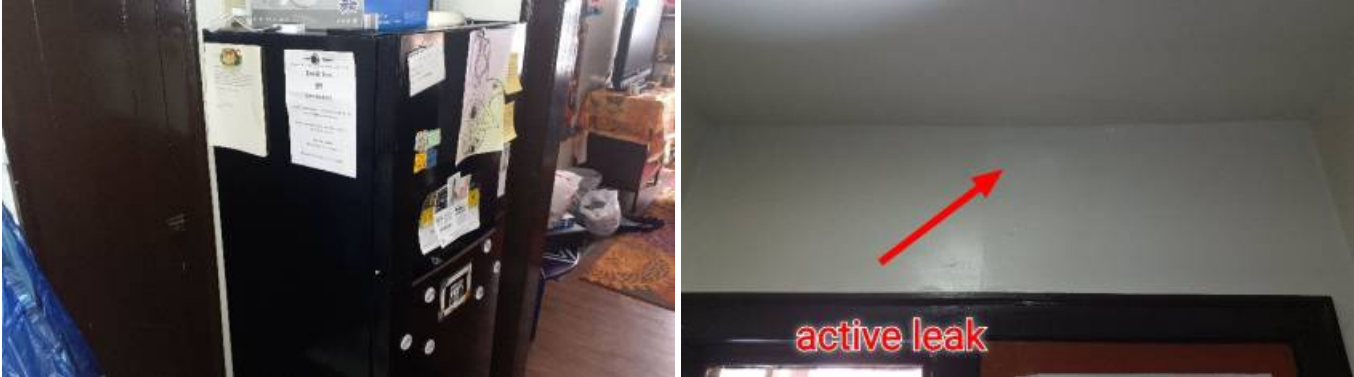
8.4 Ceiling:

Water stains, bulging walls, or other damage was observed that indicate leaks or possible concealed leaks. Client is advised to obtain further review by a qualified contractor prior to closing to determine extent of damage for repair or replacement as needed. Whenever there is water damage, there is the possibility of hidden mold growth and pest infestation. Because certain types of mold may be toxic and result in adverse health effects, or if you have concerns regarding mold, we suggest review by a qualified professional. Anytime there is a mold or mildew condition we suggest cleanup be performed per EPA guidelines to correct the condition and that corrective measures be taken to limit moisture in the home.

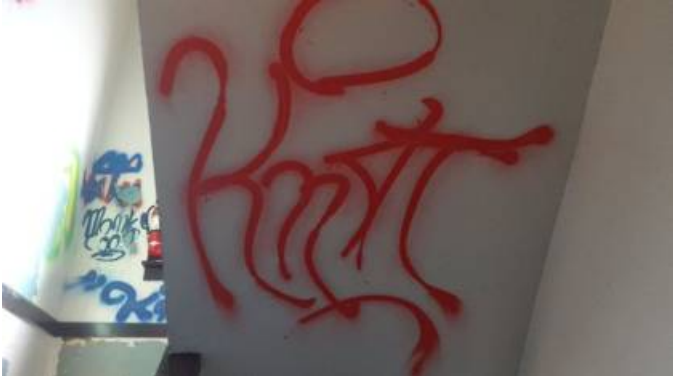
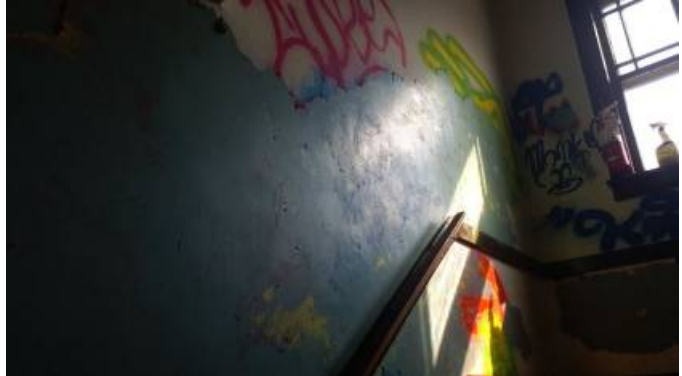
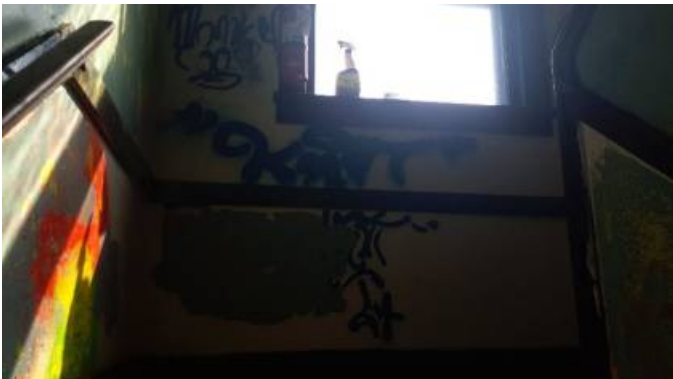
9.5 Stairs:

Peeling paint and graffiti observed in hall. Recommend repairs be made as needed.

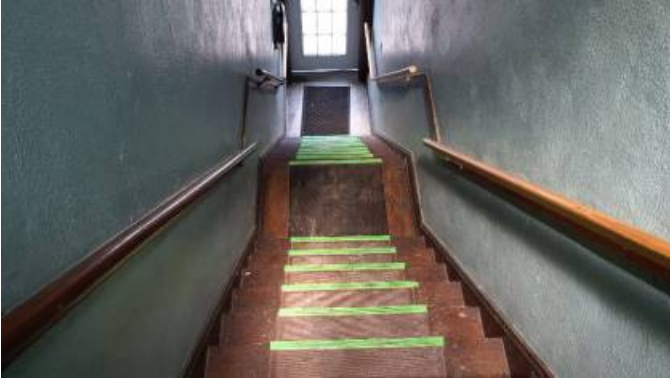
9.9 Stairs:

The main staircase appears to be installed correctly.

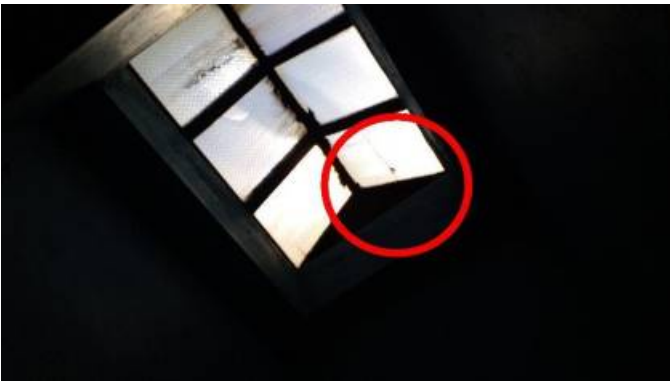
9.10 Windows:

Broken/cracked pane(s) observed. Recommend review for repair or replacement as needed.

Suggest windows and frames be kept caulked, sealed/painted to prevent moisture penetration. Failure to keep windows and frames sealed can cause deterioration and extensive moisture damage to the interior walls and surrounding sub-flooring. This damage is not always visible or accessible to the inspector at the time of inspection.

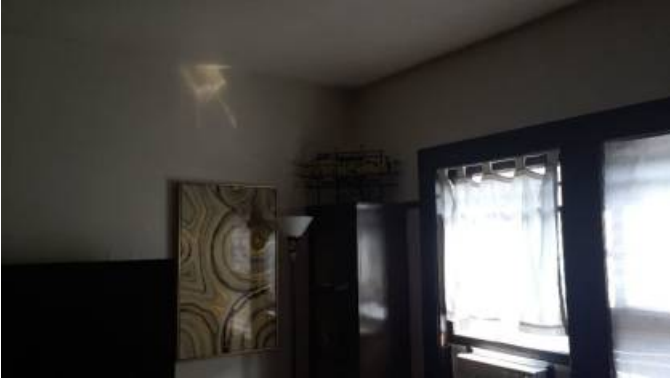
9.12 Closet Door:

Excessive settlement has been noted. This structural condition results in misalignment of the door to the door frame. Recommend review by a qualified contractor for repairs as needed.

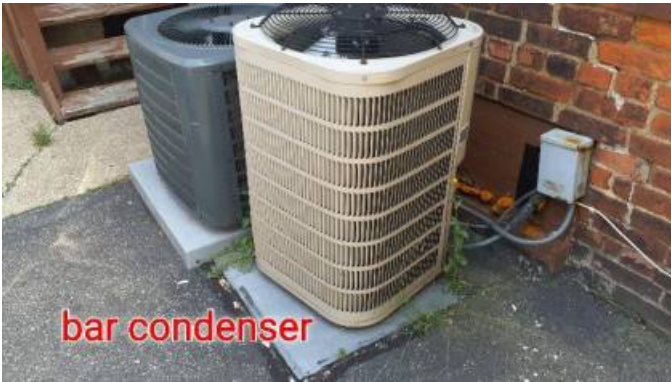
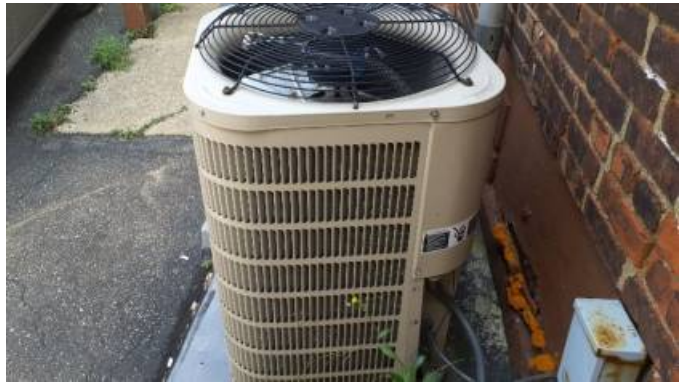
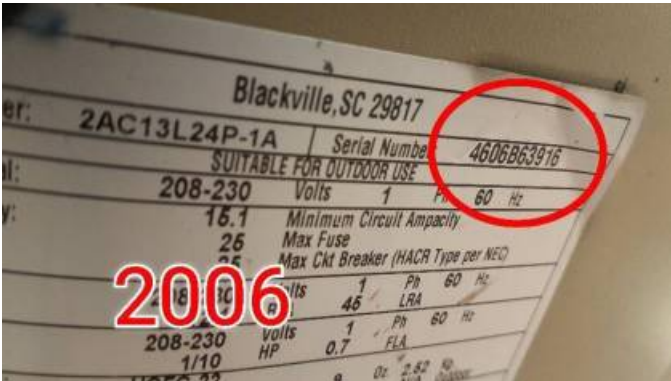
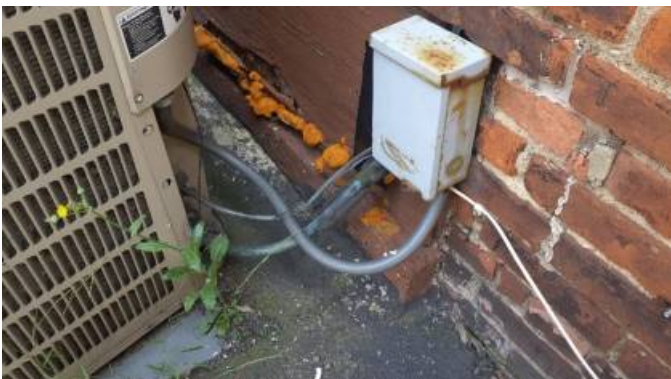
Bar Condenser

System is Carrier Brand. The unit is a 2006 and is 16 years old.

In the inspectors opinion the air conditioning unit has exceeded its designed life expectancies. Typical life cycle of an A/C unit is 15-20 years, however it can reach 20-25 years with good routine maintenance. We make no warranty, guarantee or estimation as to the remaining useful life of this unit.

Insulation missing or deteriorated on outside piping recommend review by a qualified contractor for repair as needed.

We recommend this equipment be cleaned and evaluated by a qualified HVAC contractor for repair or replacement prior to close.

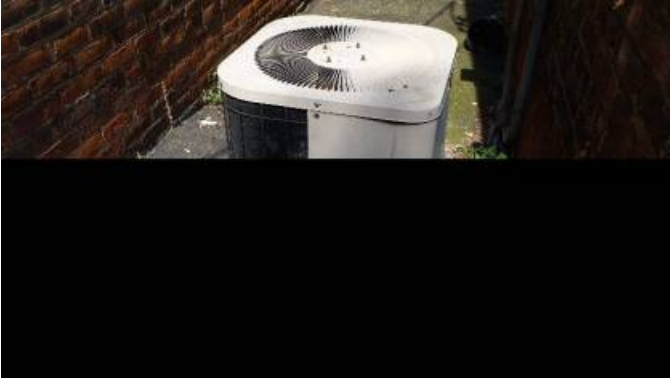
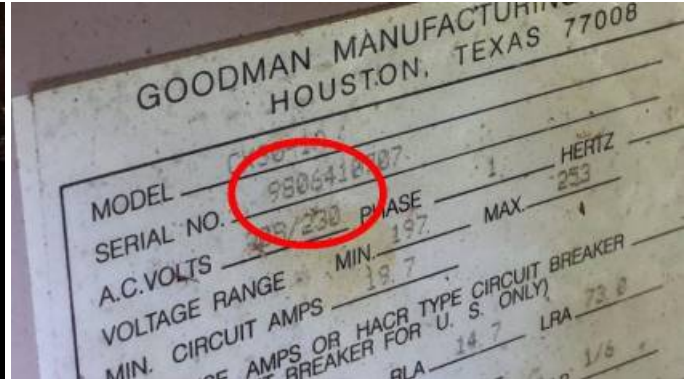
System is Goodman Manufacturing Brand. The unit is a 1998 and is 24 years old.

In the inspectors opinion the air conditioning unit has exceeded its designed life expectancies. Typical life cycle of an A/C unit is 15-20 years, however it can reach 20-25

Insulation missing or deteriorated on outside piping recommend review by a qualified contractor for repair as needed.

We recommend this equipment be cleaned and evaluated by a qualified HVAC contractor for repair or replacement prior to close.

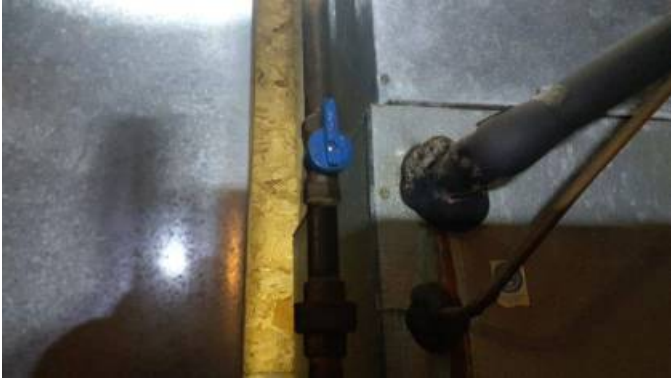
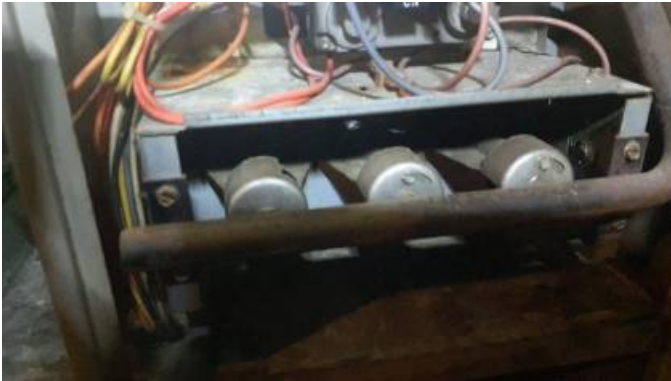
11.4 Burners Chamber:

Partially visible. Unable to inspect the entire heat exchanger without dismantling. If concerned recommend review by a qualified HVAC contractor prior to close.

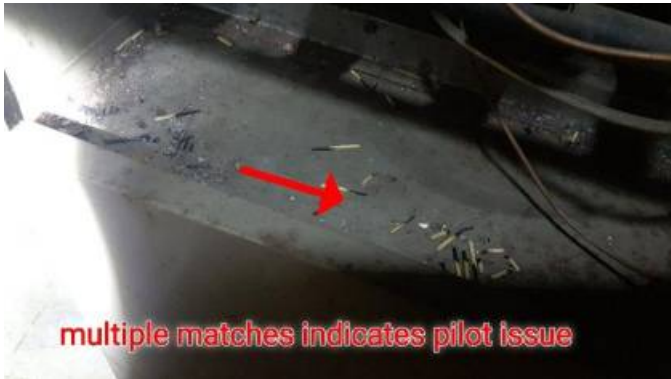
multiple matches indicates pilot issue
