**Mixed Use Store
Front/Apts
Sample Report**

13375 Madison
Lakewood OH 44107

September 16, 2022

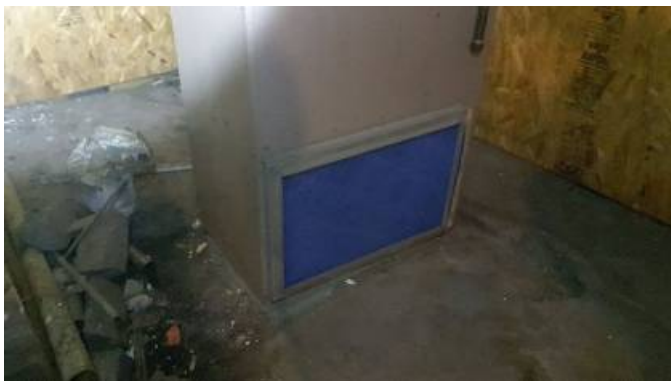
11.16 Distribution/Ducts Condition:

No cold air return observed near unit, which may result in backdrafting and mixing of combustion by-products with interior circulation air. This is common with older homes more than 50 years old. Recommend review by a qualified HVAC contractor for prior to close if concerned about this.

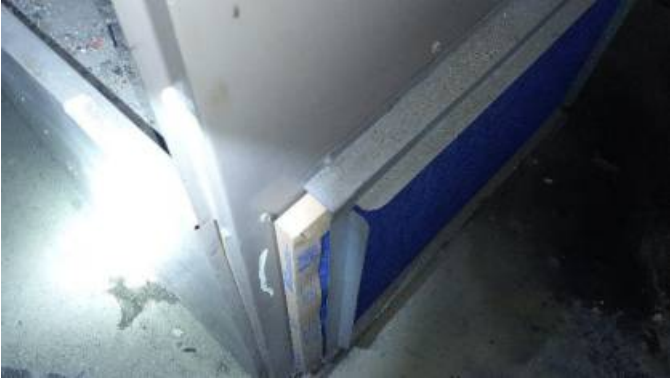
11.24 Distribution/Ducts Condition:

No cold air return observed near unit, which may result in backdrafting and mixing of combustion by-products with interior circulation air. This is common with older homes more than 50 years old. Recommend review by a qualified HVAC contractor for prior to close if concerned about this.

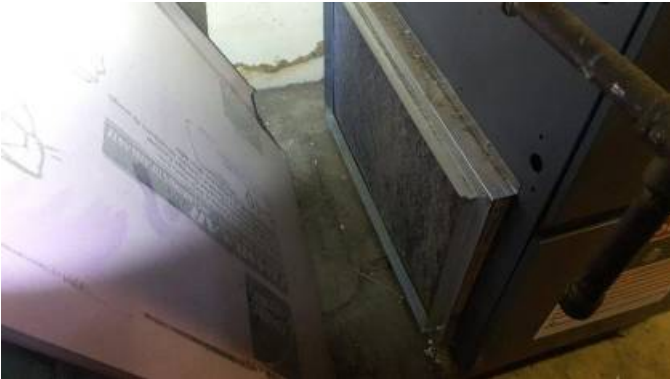
11.32 Distribution/Ducts Condition:

No cold air return observed near unit, which may result in backdrafting and mixing of combustion by-products with interior circulation air. This is common with older homes more than 50 years old. Recommend review by a qualified HVAC contractor for prior to close if concerned about this.

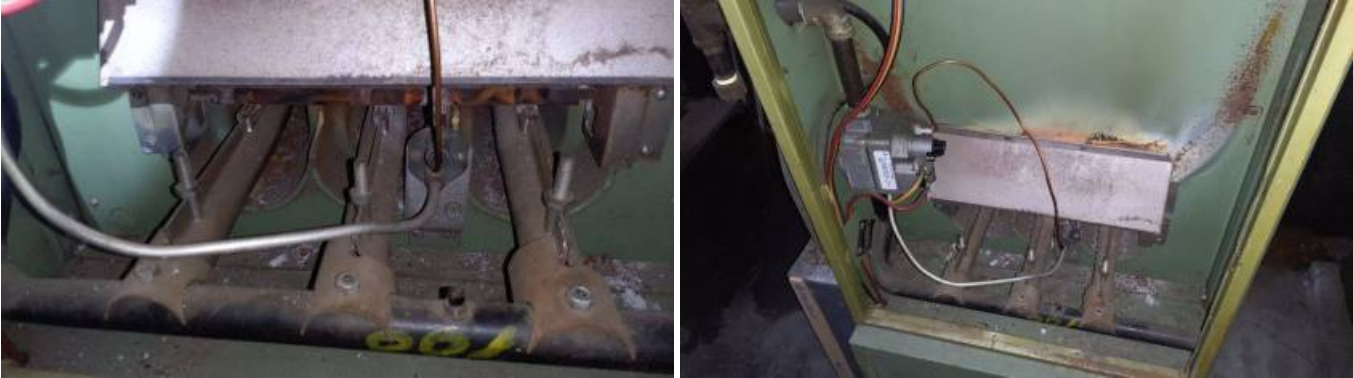
11.37 General Conditions:

The furnace did not ignite or operate during the inspection. Recommend review by a qualified HVAC contractor for repair or replacement as needed prior to close.

We recommend this equipment be cleaned and evaluated by a qualified HVAC contractor for repair or replacement prior to close.

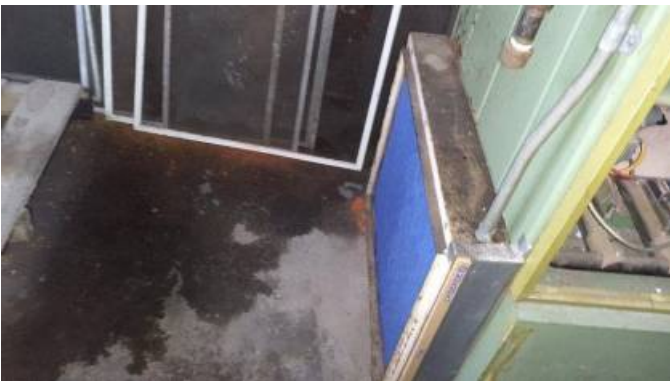
11.40 Distribution/Ducts Condition:

No cold air return observed near unit, which may result in backdrafting and mixing of combustion by-products with interior circulation air. This is common with older homes more than 50 years old. Recommend review by a qualified HVAC contractor for prior to close if concerned about this.

Possible asbestos materials observed at ducts/pipes. The materials appeared to be in serviceable condition at the time of inspection. Asbestos materials are considered safe by the EPA if they are not disturbed, torn, ripped, or damaged. No torn, ripped, or damaged materials were observed. If client has any concerns regarding asbestos materials, an asbestos testing lab should be consulted for further review to ensure safety.

Recommend encapsulating asbestos duct tape with furnace tape to prevent any fibers from entering duct work.

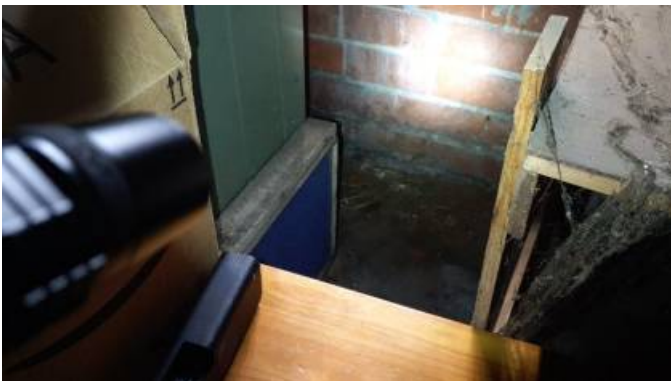
11.48 Distribution/Ducts Condition:

No cold air return observed near unit, which may result in backdrafting and mixing of combustion by-products with interior circulation air. This is common with older homes more than 50 years old. Recommend review by a qualified HVAC contractor for prior to close if concerned about this.

Possible asbestos materials observed at ducts/pipes. The materials appeared to be in serviceable condition at the time of inspection. Asbestos materials are considered safe by the EPA if they are not disturbed, torn, ripped, or damaged. No torn, ripped, or damaged materials were observed. If client has any concerns regarding asbestos materials, an asbestos testing lab should be consulted for further review to ensure safety.

Recommend encapsulating asbestos duct tape with furnace tape to prevent any fibers from entering duct work.

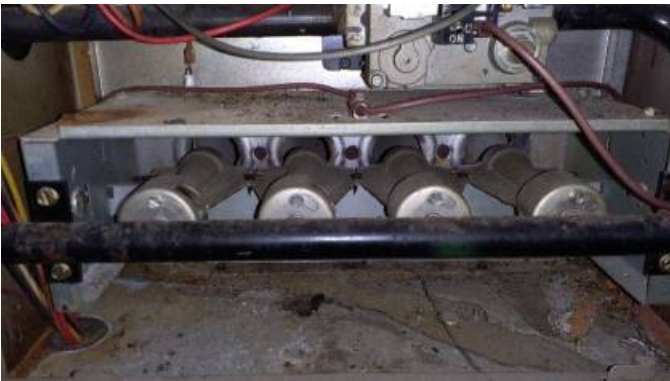
11.52 Burners Chamber:

Partially visible. Unable to inspect the entire heat exchanger without dismantling. If concerned recommend review by a qualified HVAC contractor prior to close.

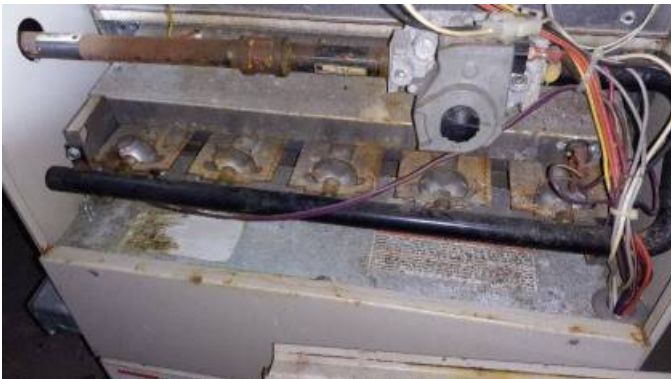
11.60 Burners Chamber:

Rust, scale, and some debris was observed in this appliance. Recommend review by a qualified HVAC contractor ensure proper and safe operation of this unit prior to close. Dismantling to inspect for holes and/or cracks in heat exchanger is not within the scope of this inspection.

Partially visible. Unable to inspect the entire heat exchanger without dismantling. If concerned recommend review by a qualified HVAC contractor prior to close.

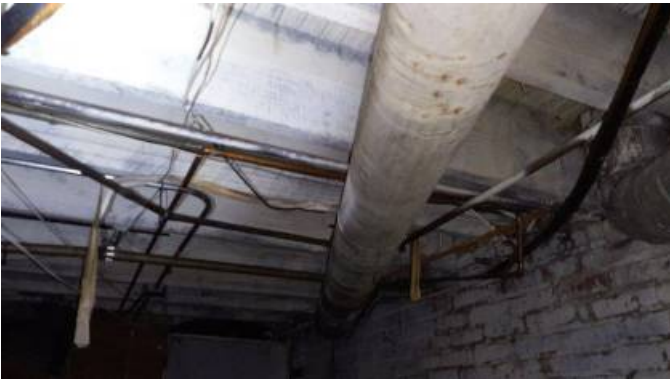
11.64 Distribution/Ducts Condition:

No cold air return observed near unit, which may result in backdrafting and mixing of combustion by-products with interior circulation air. This is common with older homes more than 50 years old. Recommend review by a qualified HVAC contractor for prior to

Possible asbestos materials observed at ducts/pipes. The materials appeared to be in serviceable condition at the time of inspection. Asbestos materials are considered safe by the EPA if they are not disturbed, torn, ripped, or damaged. No torn, ripped, or damaged materials were observed. If client has any concerns regarding asbestos materials, an asbestos testing lab should be consulted for further review to ensure safety.

Recommend encapsulating asbestos duct tape with furnace tape to prevent any fibers from entering duct work.

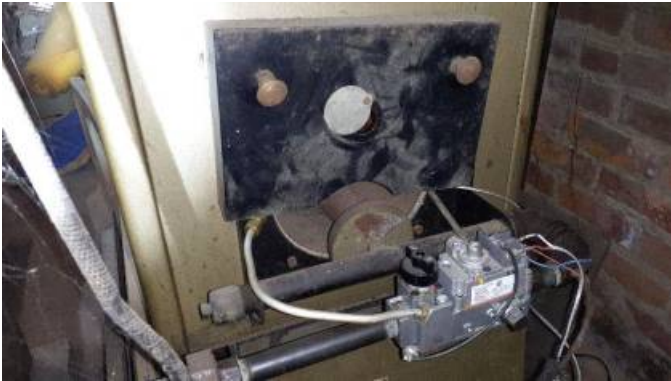
11.76 Burners Chamber:

Rust, scale, and some debris was observed in this appliance. Recommend review by a qualified HVAC contractor ensure proper and safe operation of this unit prior to close.

Dismantling to inspect for holes and/or cracks in heat exchanger is not within the scope of this inspection.

Closed System - Unable to inspect without dismantling. If concerned recommend review by a qualified HVAC contractor prior to close.

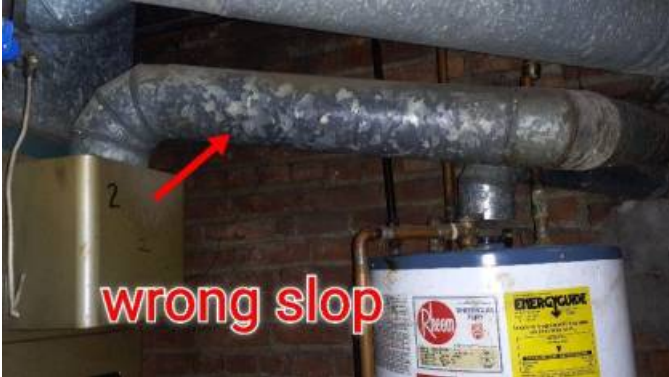
Improperly sloped vent pipes noted; pipe should slope upward from the unit. This can cause back drafting and could allow products of combustion to escape. The minimum allowable pitch is 1/4" per foot of vent run. This is a "Safety Hazard" requiring immediate attention by a qualified contractor for repairs or replacement prior to close.

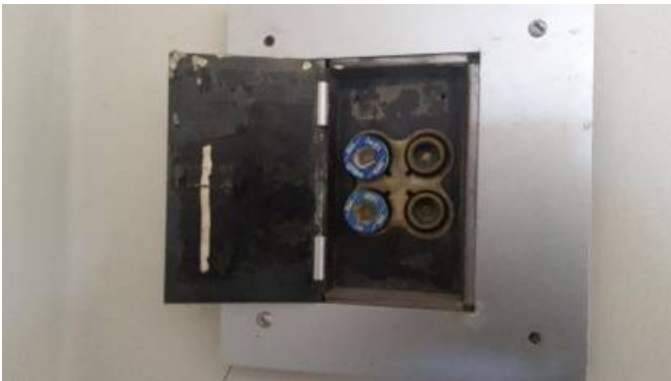
12.7 Sub Panel #1:

2nd floor unit 1.

The structure is equipped with a fuse type main power panel, usually a combination of pullout fuse blocks and screw type fuses. This was the standard for new construction until the 60's. Recommend review by a qualified electrician for safety enhancements as needed.

Open fuse positions observed. Recommend review by a qualified electrician for repair as needed for safety.

In the inspector's opinion, the electrical panel has exceeded its designed life expectancies. We make no warranty, guarantee or estimation as to the remaining useful life of this panel.

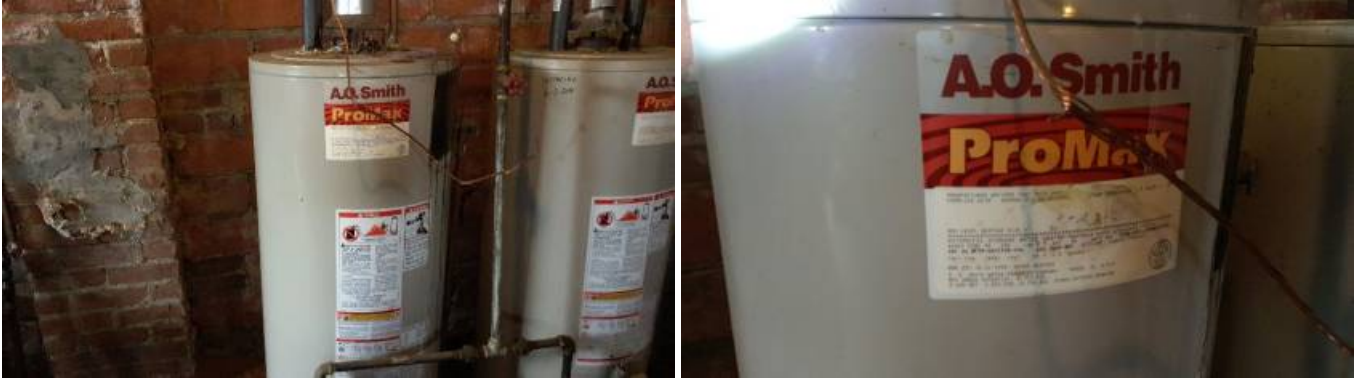
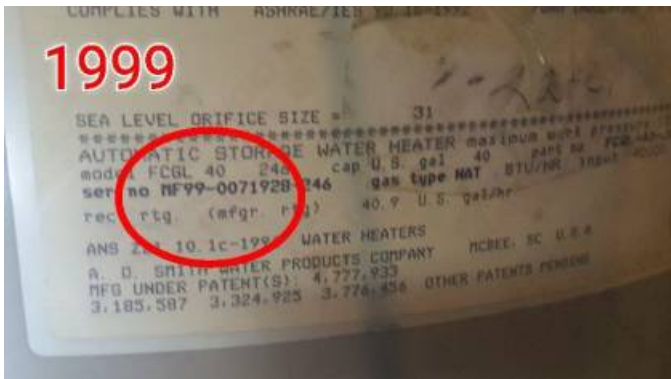
13.1 Brand:

Water heater is manufactured by A O Smith. The unit is a 1999 and is 23 years old.

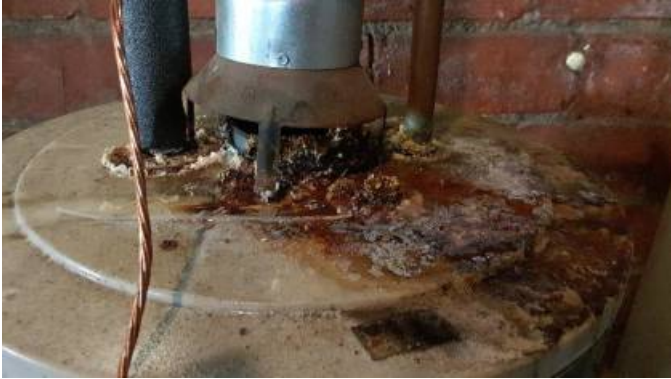
Leaks and rust or corrosion were observed on the supply lines. Recommend review by a qualified plumber for repair or replacement, as needed.

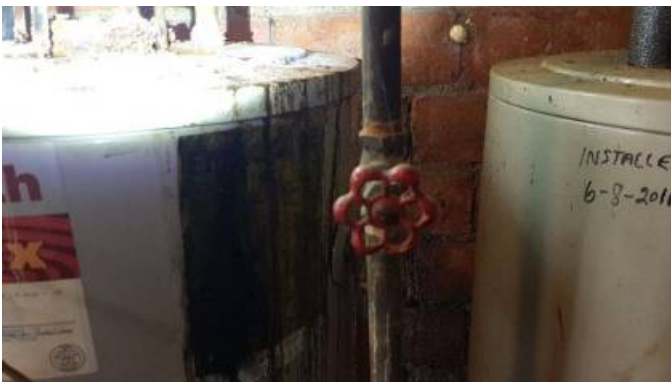
13.5 Energy Source:

Inspector observed a GATE gas valve was on one or more appliance in the house. These types of valves are prone to leak and may require maintenance. Recommend a qualified HVAC contractor update with a modern ball valve as needed or when updating appliance.

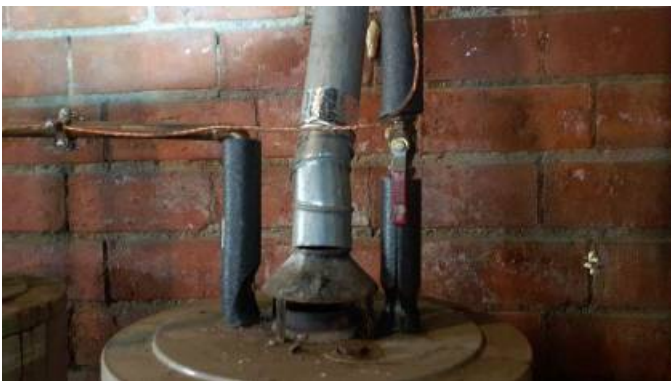
Ground jumper cable not observed between hot and cold water lines, recommend installing jumper cable to insure proper grounding and safety.

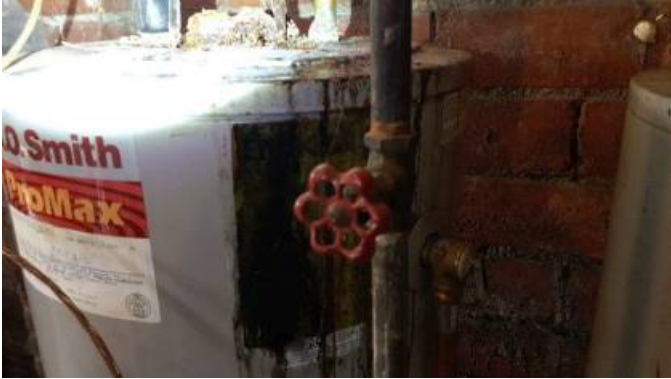
13.14 Energy Source:

Inspector observed a GATE gas valve was on one or more appliance in the house. These types of valves are prone to leak and may require maintenance. Recommend a qualified HVAC contractor update with a modern ball valve as needed or when updating appliance.

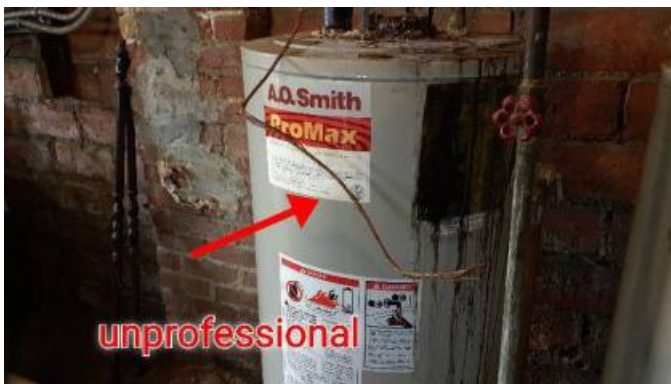
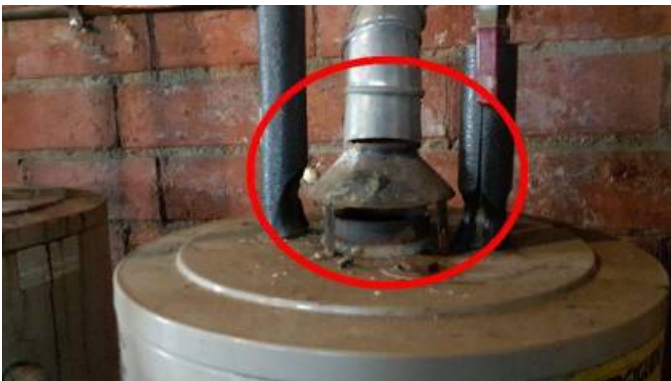
13.18 Flue Venting:

Disconnected vent pipes noted, this will allow products of combustion to escape. This is a "Safety Hazard" requiring attention by a qualified contractor for repairs/replacement as required to ensure safety.

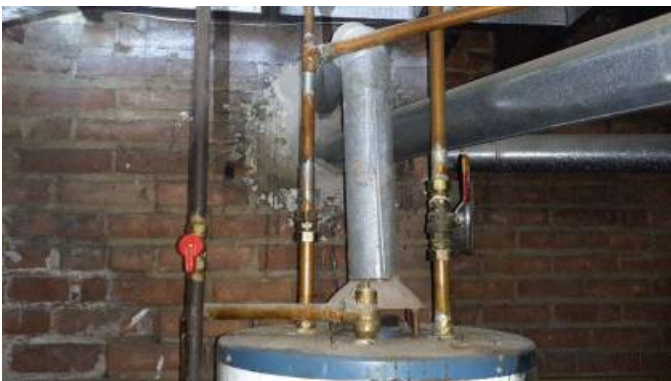
Ground jumper cable not observed between hot and cold water lines, recommend installing jumper cable to insure proper grounding and safety.

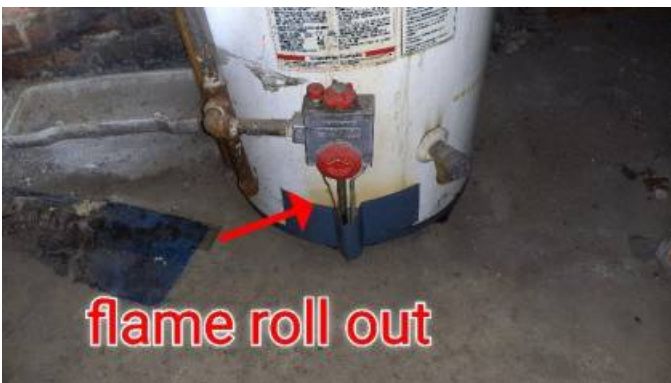
13.25 Burner:

Flame roll-out observed, this is a safety concern. Recommend review by a qualified heating contractor for repair or replacement, as needed, prior to close.

Limited visual inspection only. Unable to inspect burner chamber due to closed system.

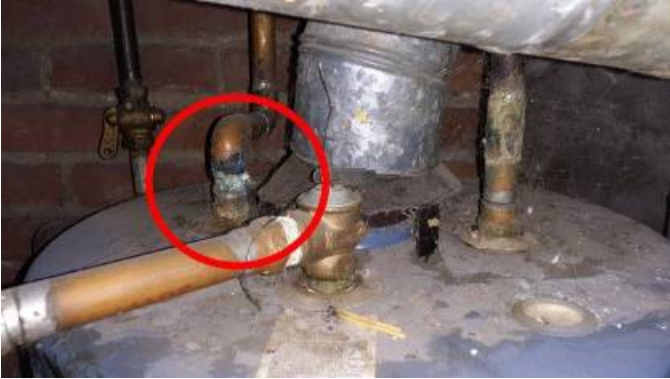
Corrosion observed; no leaks visible at time of inspection. Recommend review by a qualified plumber for repair or replacement as needed.

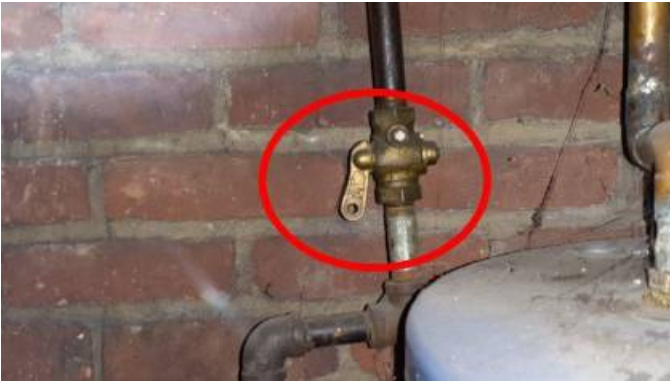
13.32 Energy Source:

Inspector observed a grease packed gas valve was on one or more appliance in the house. These types of valves are prone to leak and may require maintenance. Recommend a qualified HVAC contractor update with a modern ball valve as needed or when updating appliance.

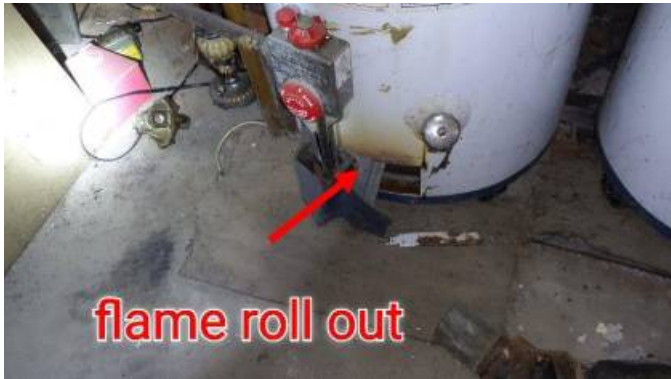
13.34 Burner:

Flame roll-out observed, this is a safety concern. Recommend review by a qualified

heating contractor for repair or replacement, as needed, prior to close.

Limited visual inspection only. Unable to inspect burner chamber due to closed system.

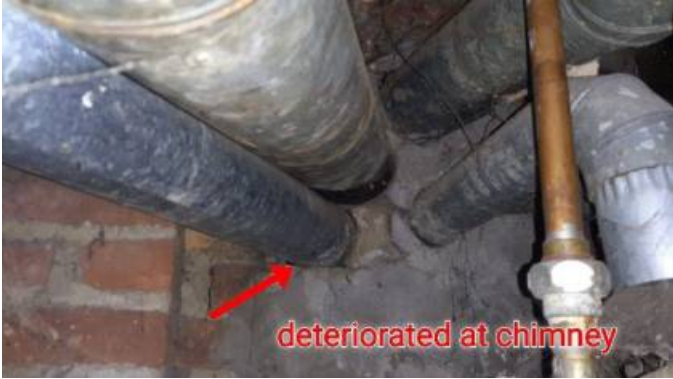
Deteriorated seal at chimney and should be resealed for safety. Recommend review by a qualified contractor for repair or replacement, as needed, prior to close.

deteriorated at chimney

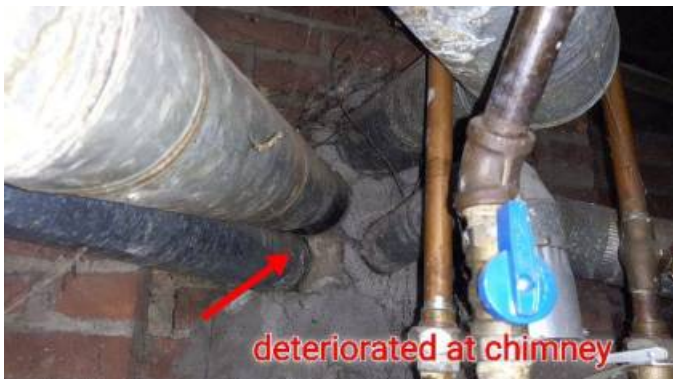
13.45 Flue Venting:

Deteriorated seal at chimney and should be resealed for safety. Recommend review by a qualified contractor for repair or replacement, as needed, prior to close.

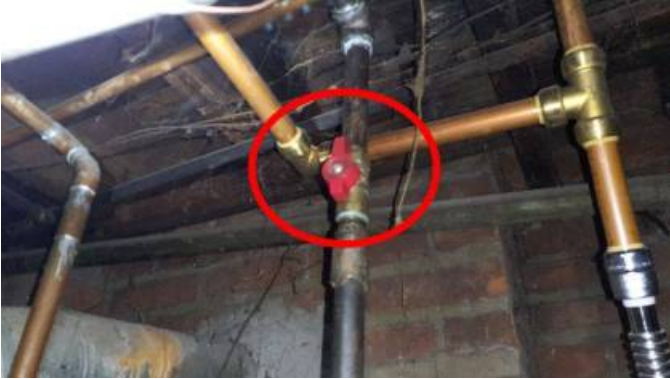
13.51 Temperature & Pressure Relief Valve:

Discharge pipe is missing on the temperature pressure relief valve. Suggest installing the required 3/4 inch discharge pipe on the temperature pressure relief valve to within six inches above the floor or to exterior of the building to ensure safety. If the valve were to activate while a person was nearby, that person could be badly scalded. The Inspector recommends that a properly-configured TPR discharge pipe be installed by a qualified plumbing contractor. **The TPR SHOULD NOT BE TESTED UNTIL A PROPER DISCHARGE PIPE HAS BEEN INSTALLED!**

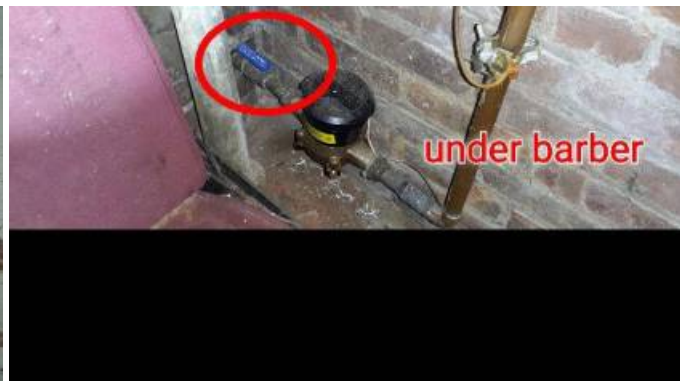
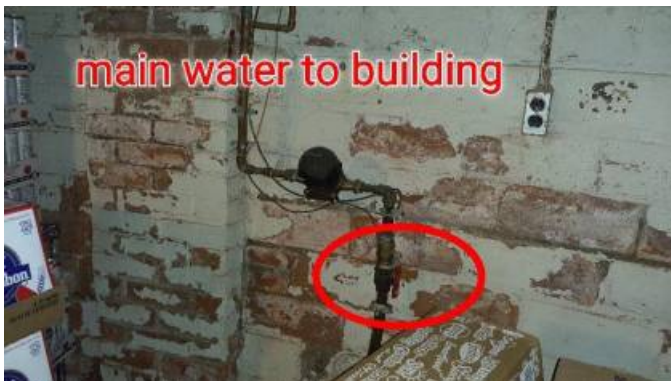
14.2 Supply Lines:

Galvanized. Galvanized water lines rust from the inside out and can become restricted over time. If low water flow is observed at plumbing fixtures, some restriction may have occurred. We suggest further review by a qualified plumber for repairs/replacement as needed to ensure proper water flow.

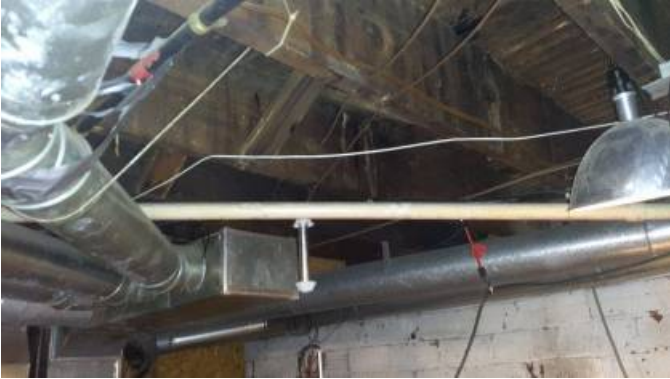
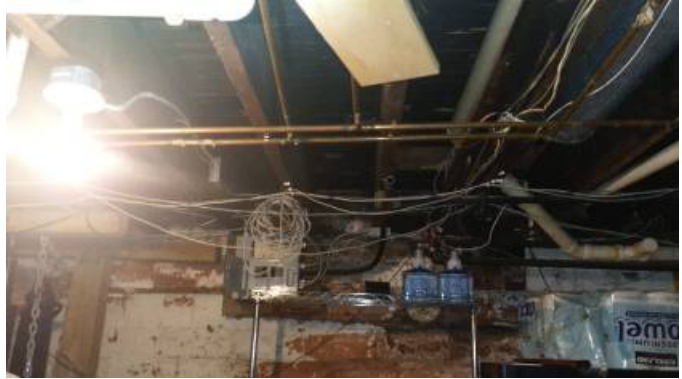
15.6 Supports

Supports added - Structural re-enforcements observed, unable to determine effectiveness of repairs, suggest consult sellers, qualified contractor or a structural engineer for additional information, prior to close.

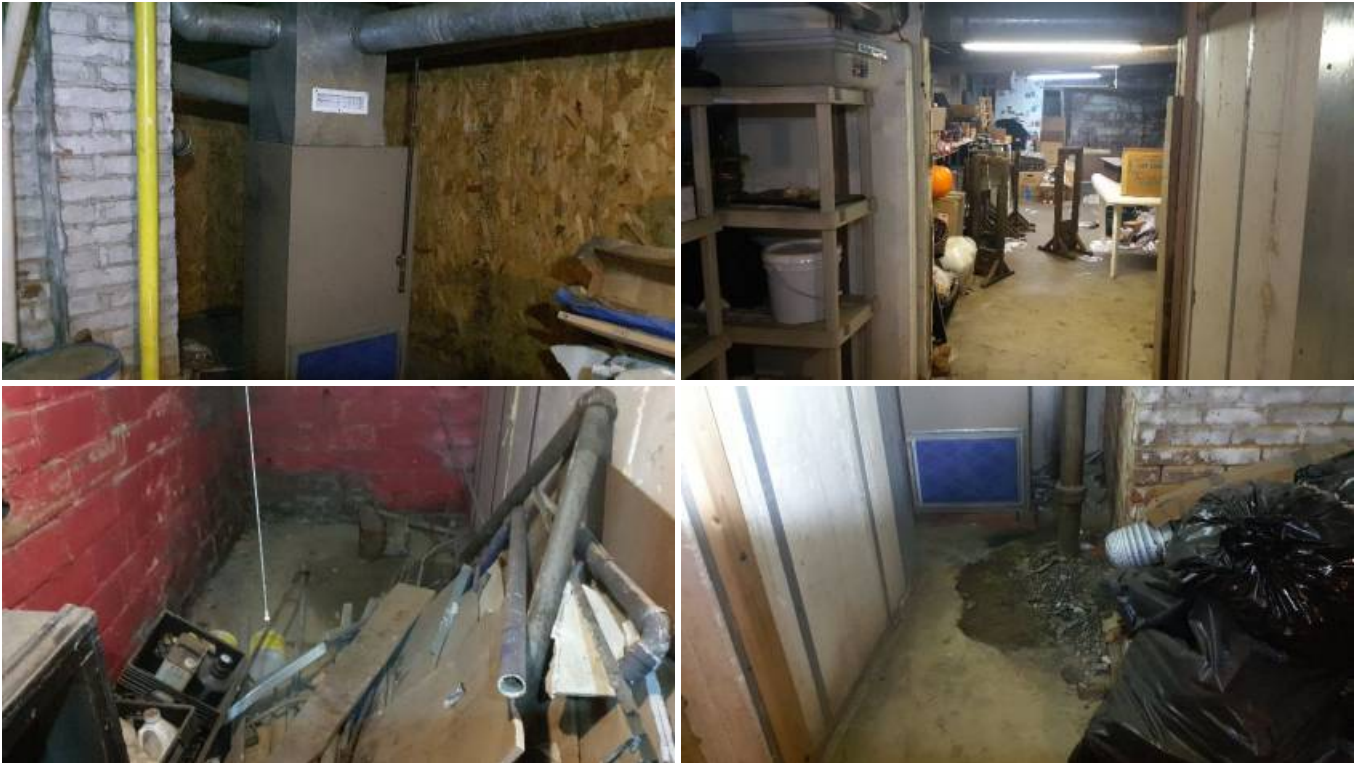
15.12 Floor:

Moisture present at the time of inspection. Recommend review by qualified professional for repair as needed.

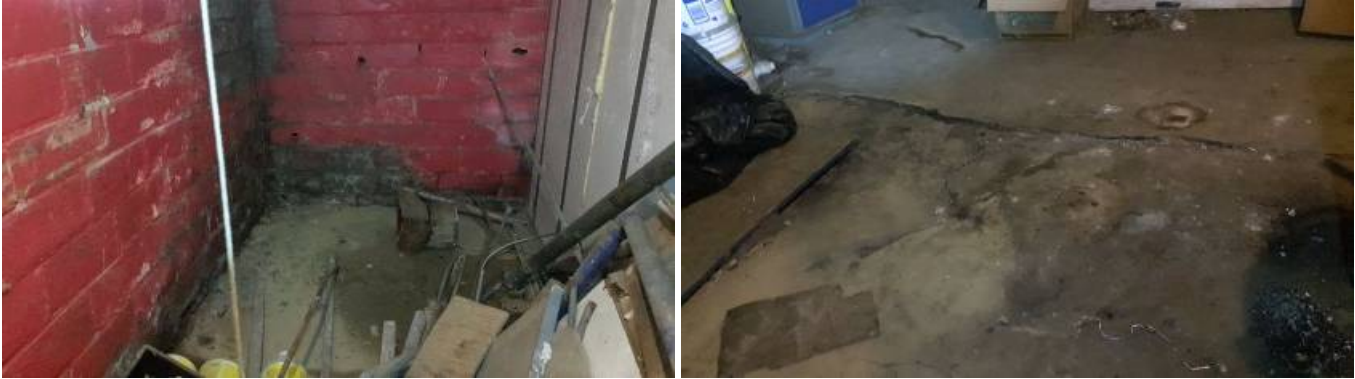
15.13 Walls:

Peeling paint observed, which is a possible sign of moisture. Recommend review of sellers disclosure statement or have reviewed prior to close.

Evidence of past water penetration observed. Recommend review sellers disclosure statement or have reviewed by qualified professional for repair as needed.

Moisture stains observed. An elevated level of moisture was detected using an electronic moisture meter. Whenever there is water damage, there is the possibility of hidden mold growth and pest infestation. Because certain types of mold may be toxic and result in adverse health effects, or if you have concerns regarding mold, we suggest review by a qualified professional. Anytime there is a mold or mildew condition we suggest clean up be performed per EPA guidelines to correct the condition and that corrective measures be taken to limit moisture in the home.

The basement walls exhibited discoloration that appeared to be microbial growth, possibly mold. Confirming the presence of mold would require laboratory analysis. To avoid potential damage to home materials or the development of unhealthy conditions related to mold, the Inspector recommends that the source of moisture be identified and the condition corrected.

Deteriorated mortar observed, suggest tuckpointing as needed to prevent further damage.

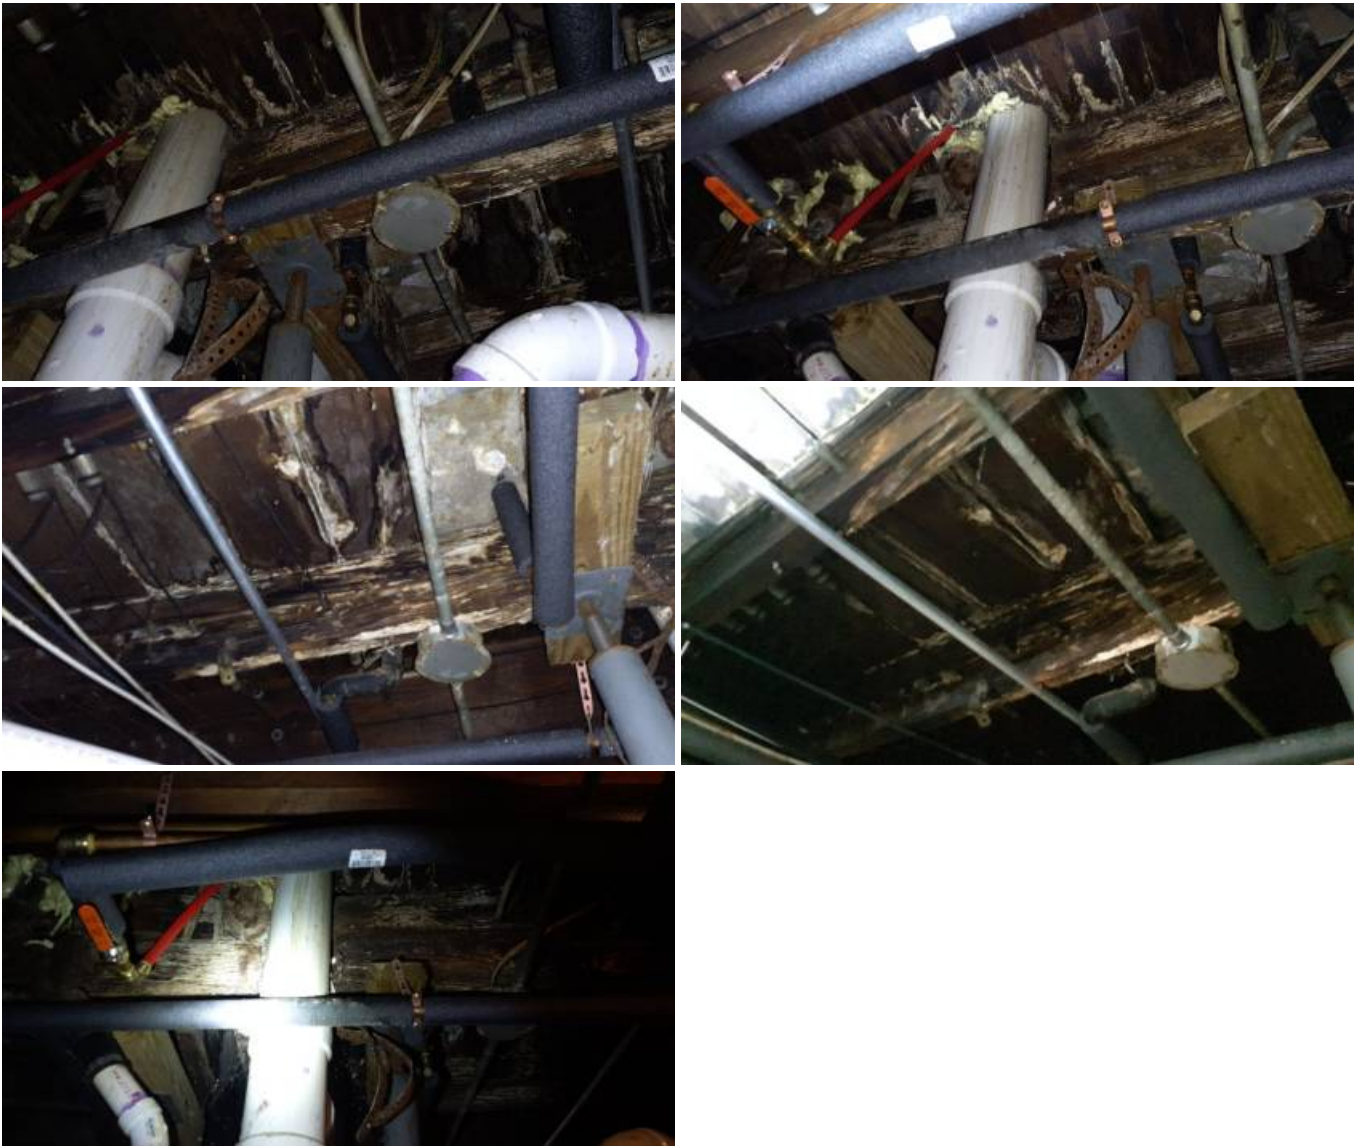
15.22 Supports

Serviceable, Metal Posts

Supports added - Structural re-enforcements observed, unable to determine effectiveness of repairs, suggest consult sellers, qualified contractor or a structural engineer for additional information, prior to close.

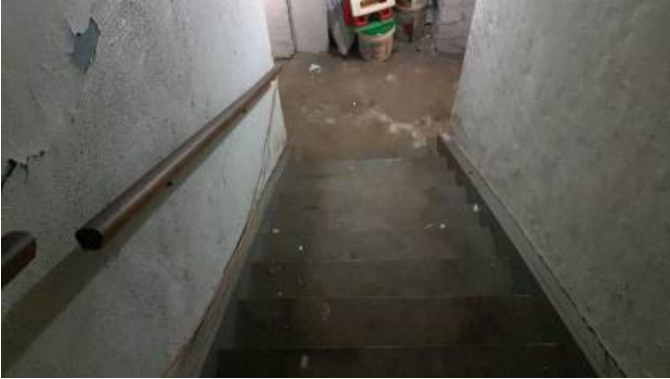
15.27 Floor:

Concrete

Underground drain observed. Underground drainage systems are not within the scope of this inspection and a functional water flow test is not performed.
