Warehouse Sample Report

Confidential Inspection Report

501 Clark St
Elyria OH 44035

November 11, 2019

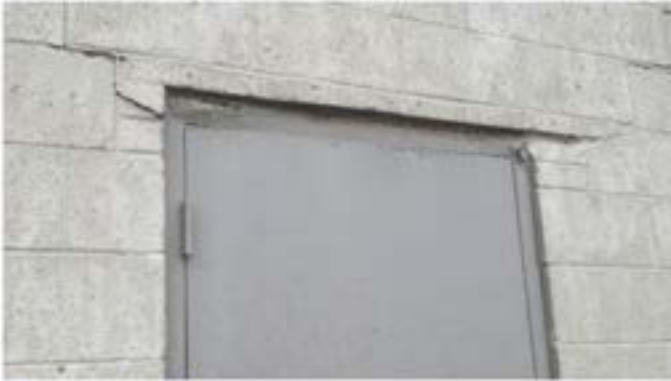
Deterioration observed. Suggest repairs/replacement as needed.

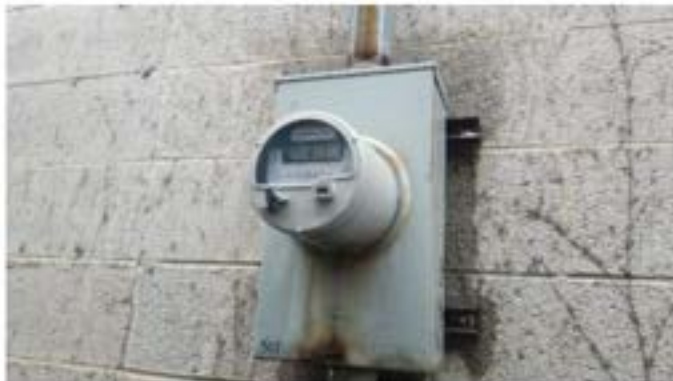
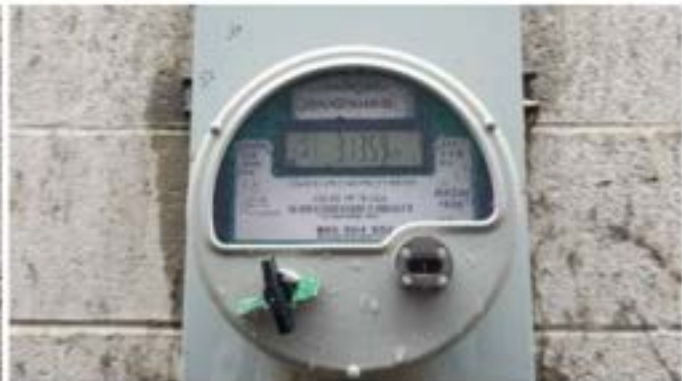
E029

Electric Meter Box:
Serviceable

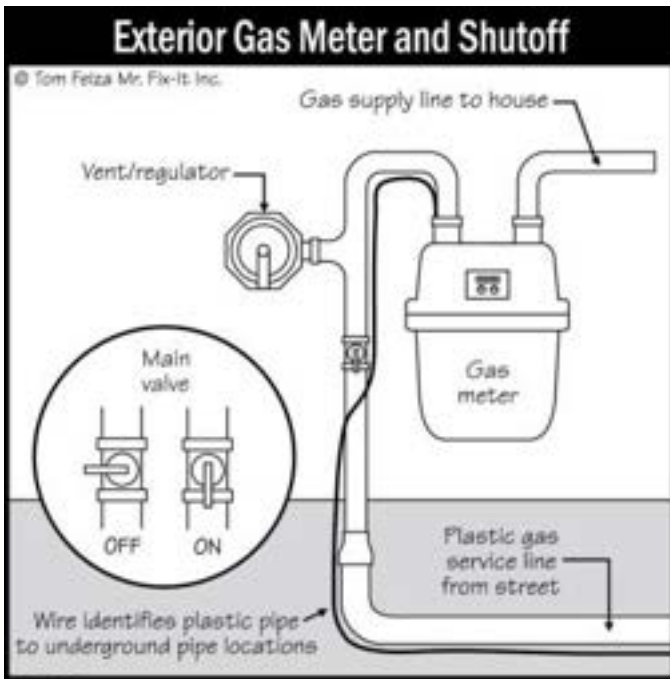
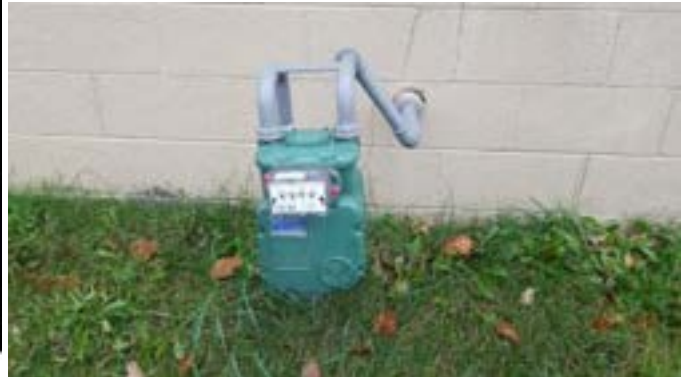
Gas meter and shut off located at front. Since shut-off valves are operated infrequently, it is not unusual for them to become frozen over time. They often leak or break when operated after a period of inactivity. For this reason shut-offs are not tested during a building inspection. We suggest caution when operating shut-offs that have not been turned for a long period of time. All shut-off valves and angle stops should be turned regularly to ensure free movement in case of emergency. Buried gas lines can leak, rust, corrode, and become unsafe without warning. Buried gas lines are not visible or accessible to the inspector and are beyond the scope of this inspection.

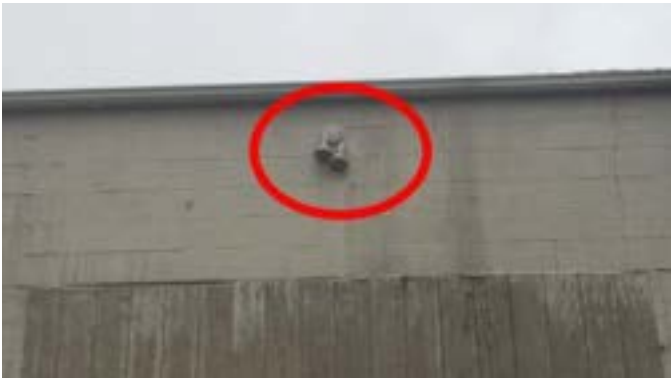
Damaged light fixture observed. Recommend review by a qualified electrician for review or repair as needed.

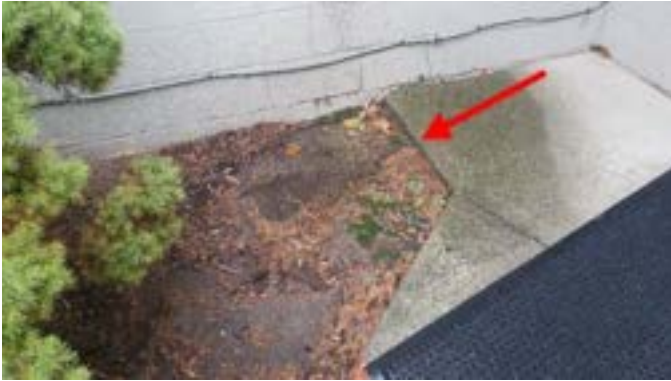
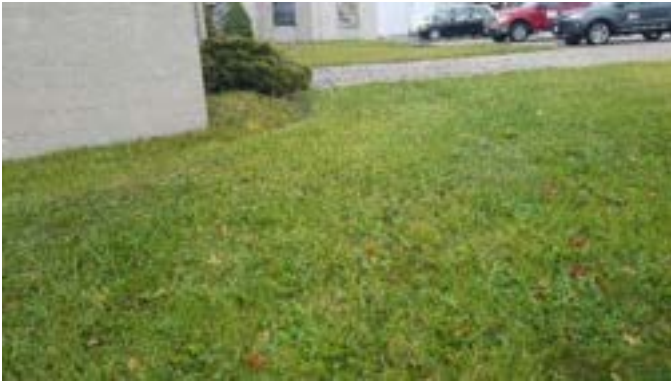
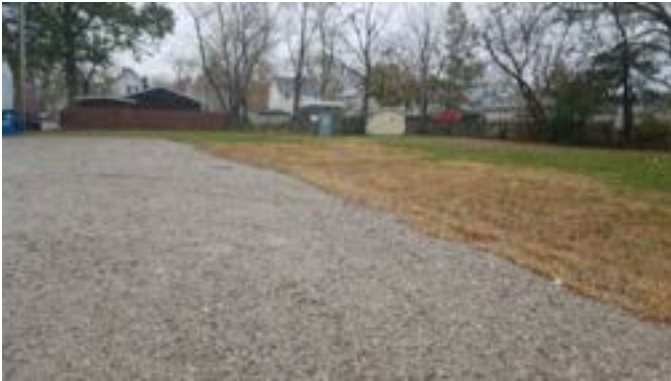
Evidence of ponding observed. Grade improvements, landscape alterations, or the installation of surface drains may be needed if water ponding is an ongoing concern. Ponding near foundation may result in basement/crawlspace seepage or foundation damage. This inspection does not include determining if the property is above the 100 year flood plain. For further information regarding elevation of the lot, check with your survey and appraiser.

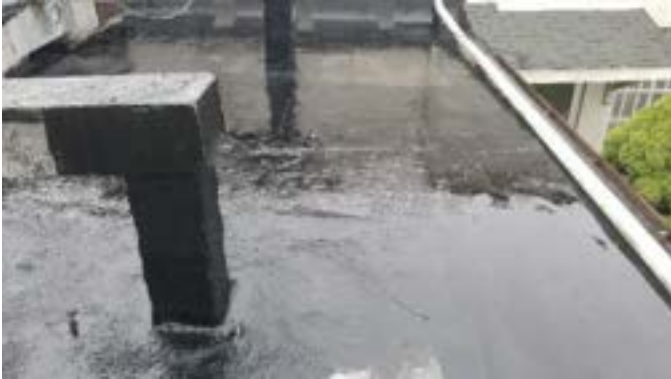
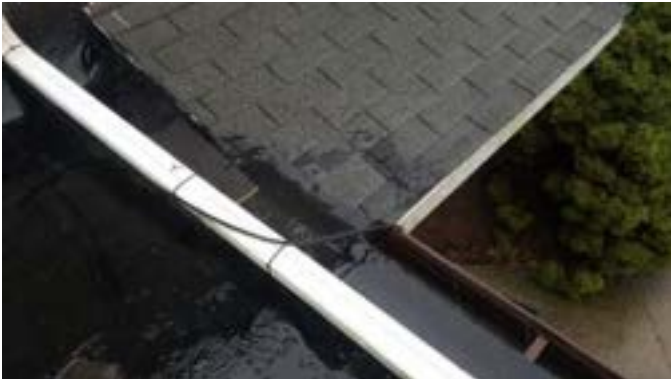
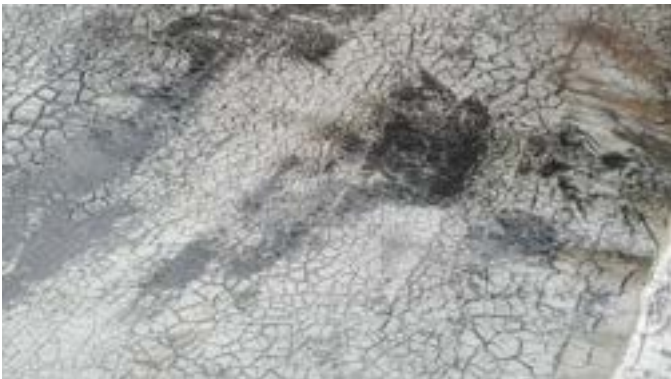
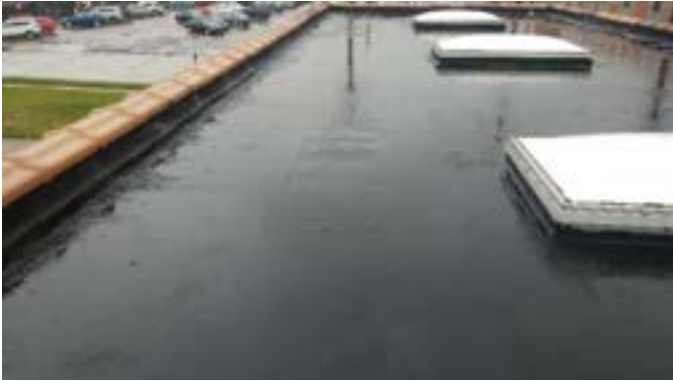
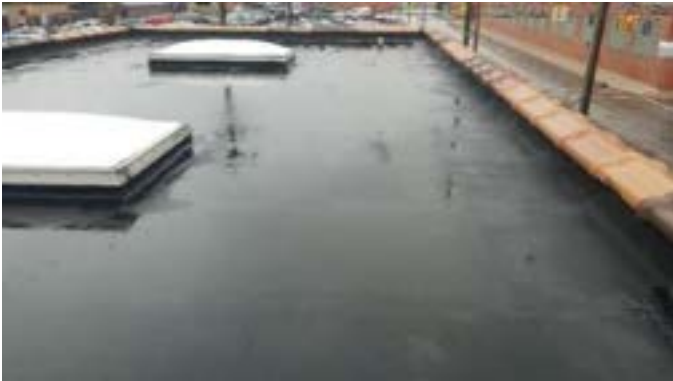
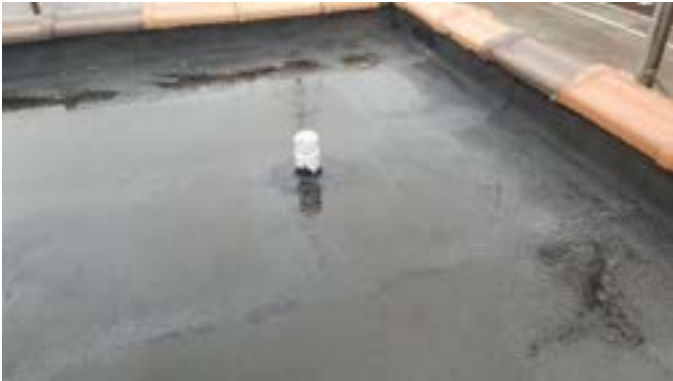
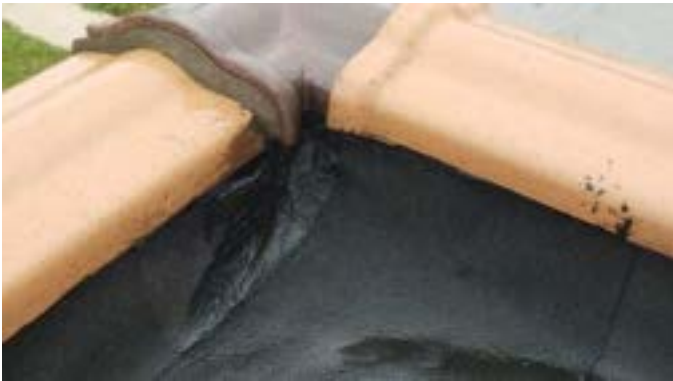
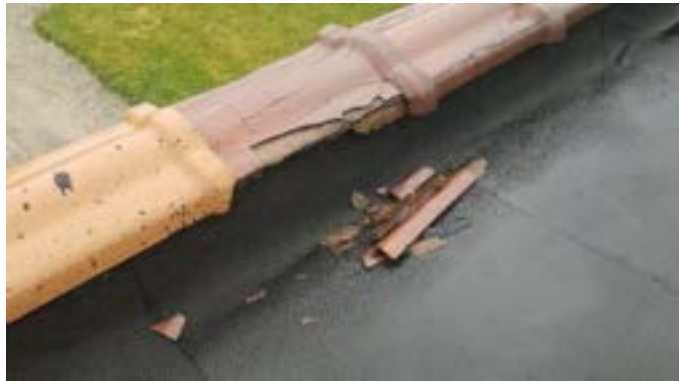
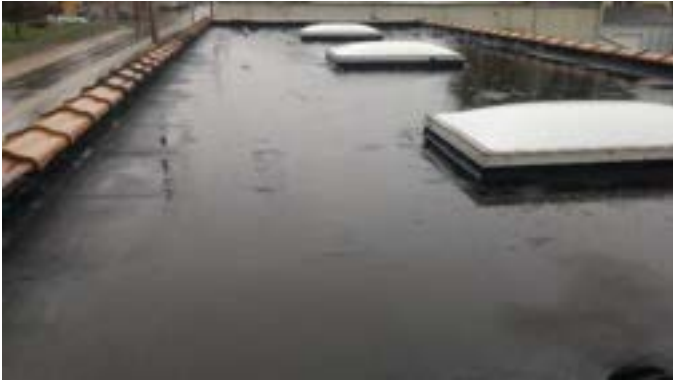
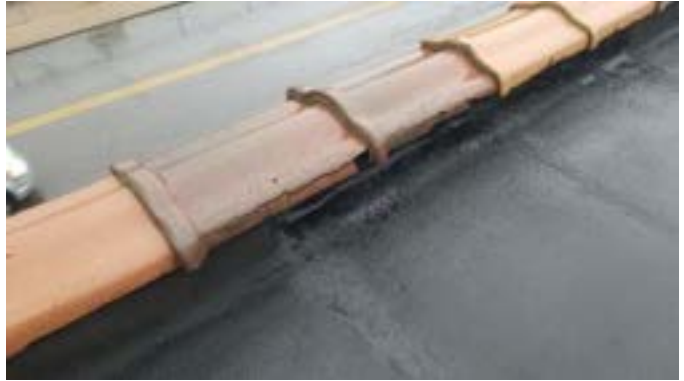
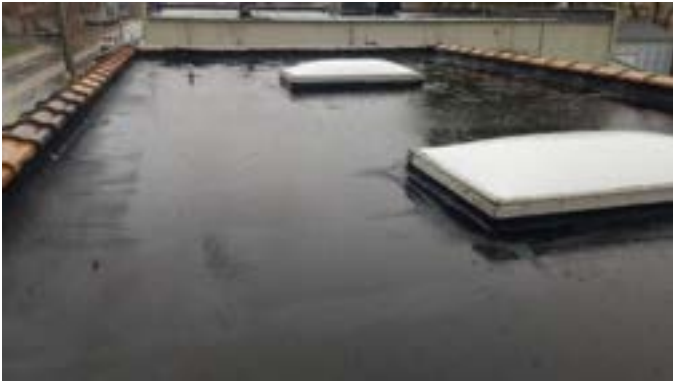
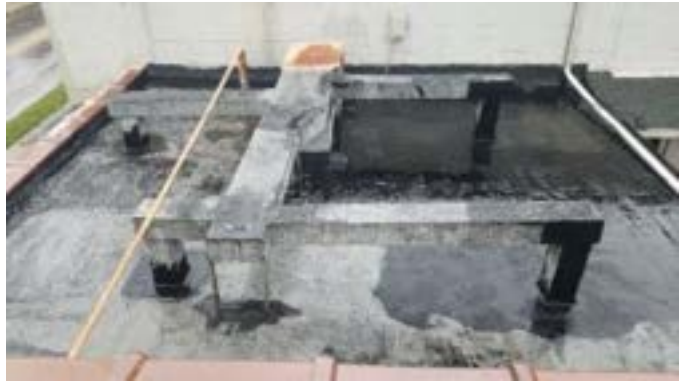
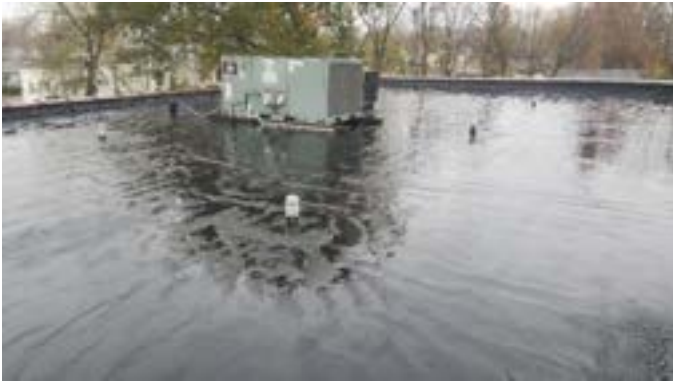
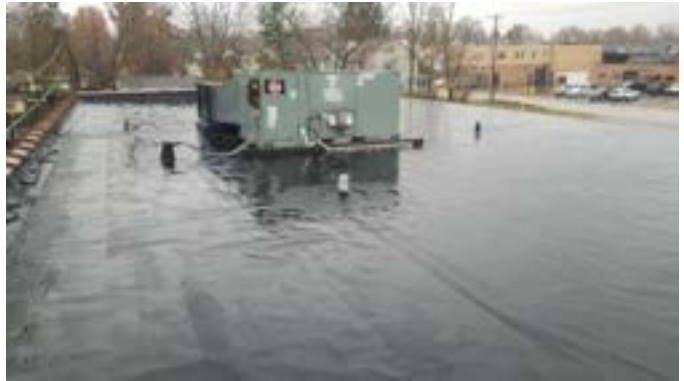
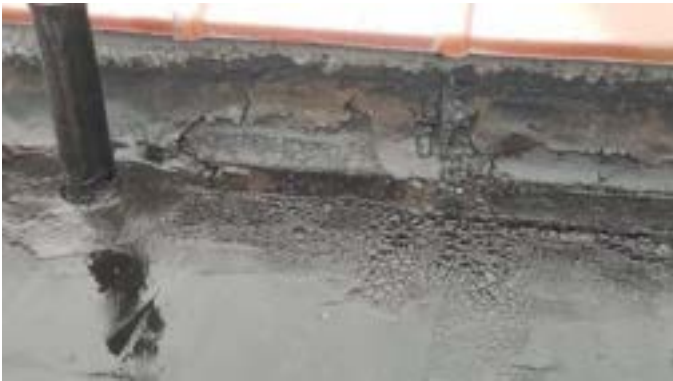
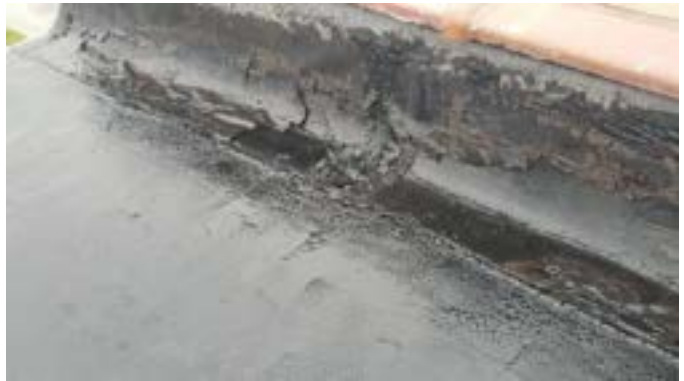
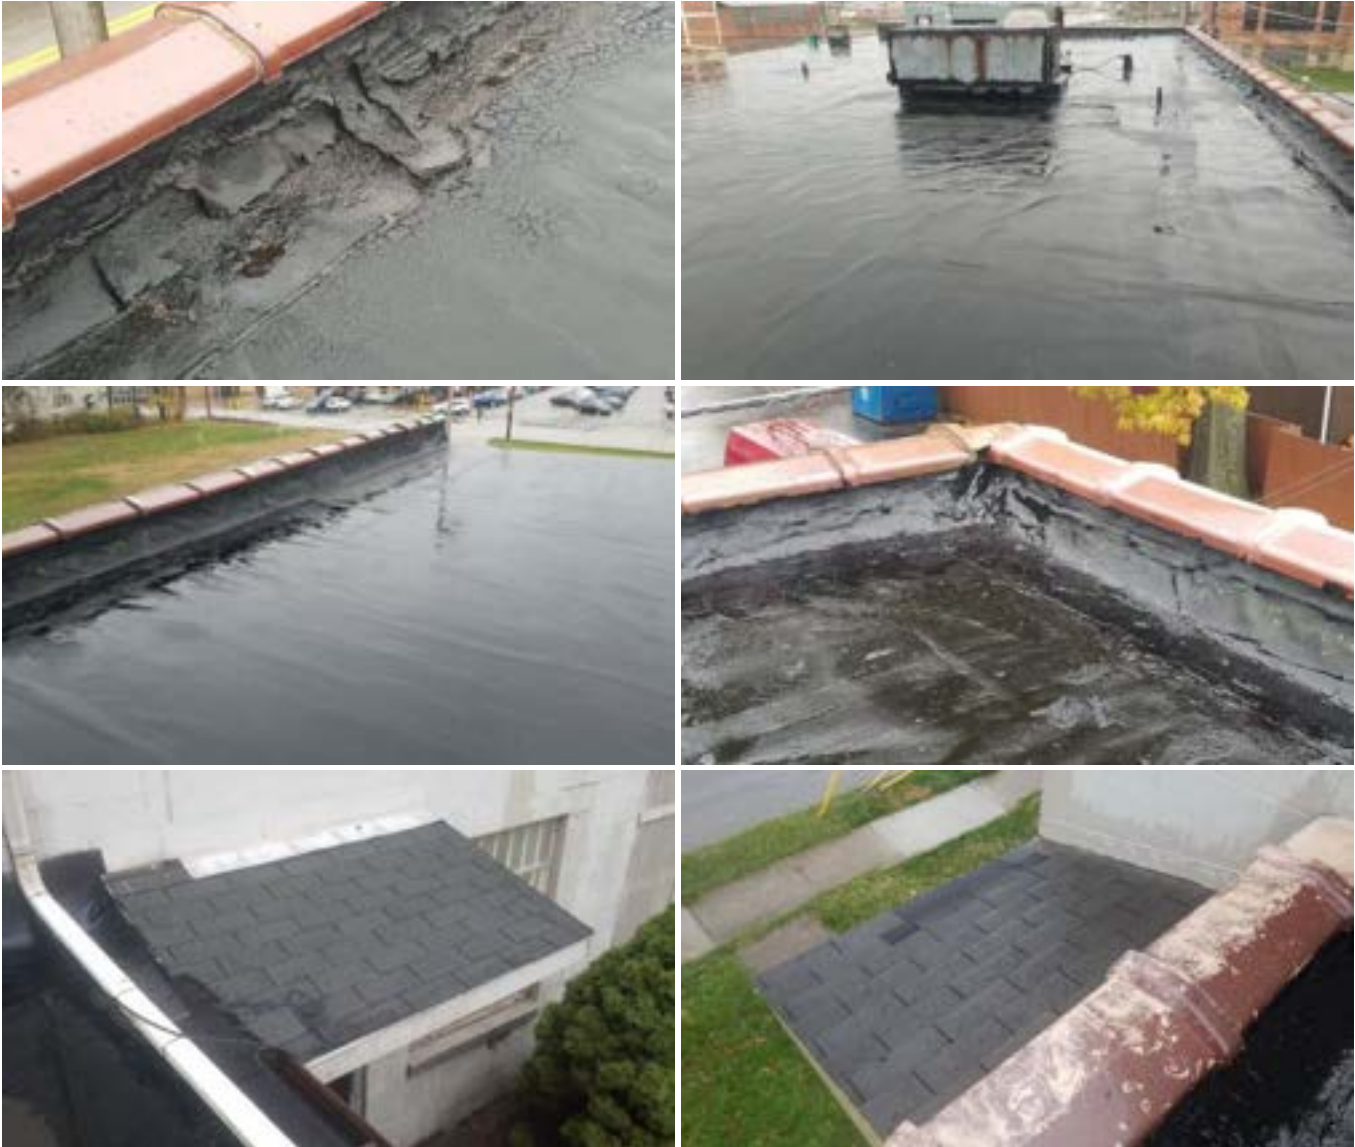
Alligator cracking observed. Recommend review by a qualified roofer for repair or replacement, as needed, prior to close.

Evidence of patching noted on the roof. Recommend review by a qualified roofer for additional information, repair or replacement as needed.

Minor cupping/curling shingles observed. This is cosmetic in nature. Recommend monitoring the roof for further/future damage or if concerned review by a qualified roofer for repair or replacement, as needed.

Deteriorated area of the roof should be replaced or repaired to prevent further deterioration or damage due to leakage. Recommend review by a qualified roofer for repair or replacement as needed.

Small leaks observed in main garage area. Recommend repair of roof leaks by qualified contractor.

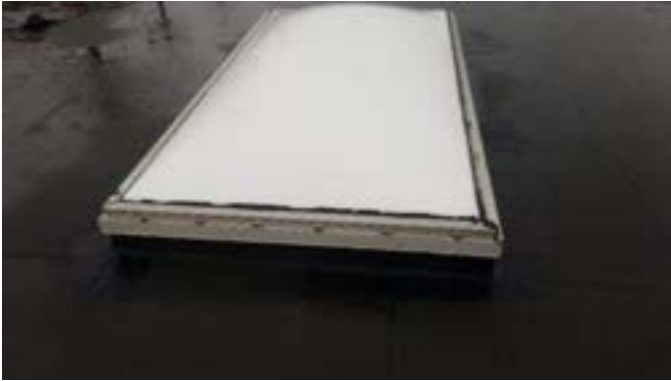
Flashings are covered with roofing cement, which may indicate previous water penetration into the structure at this location. Recommend review by a qualified roofer for repairs or replacement as needed.

Flashings are covered with roofing cement, which may indicate previous water penetration into the structure at this location. Suggest client consult with sellers for additional information or review by a qualified roofer for repair or replacement as needed.

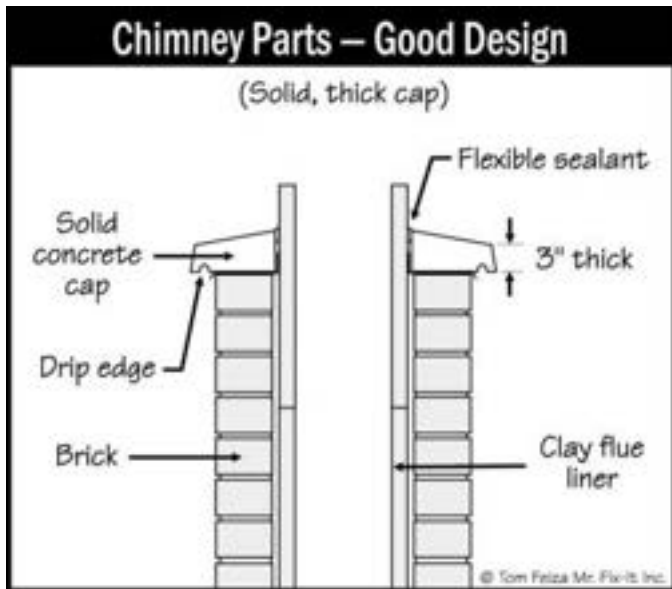
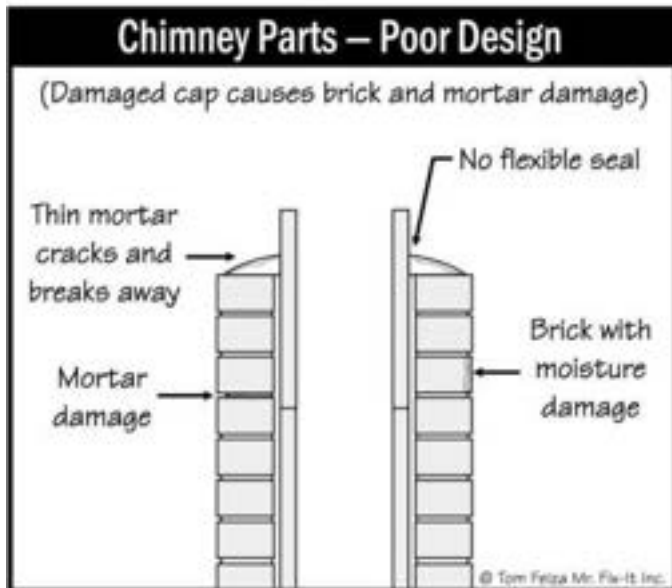
Crown and Flashing intact where visible.

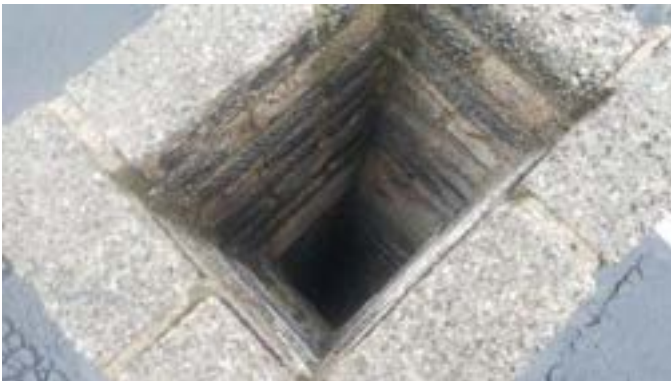
Serviceable where visible.

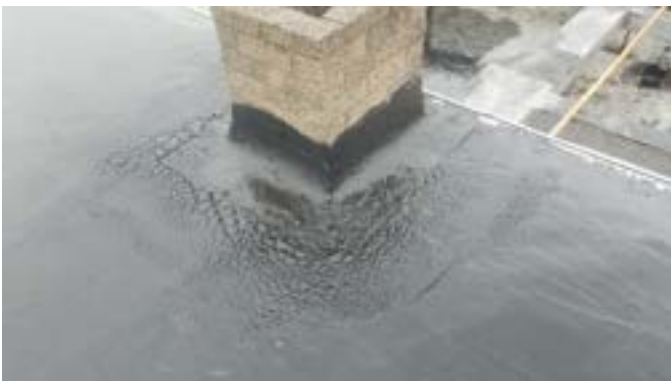
Flashings are covered with roofing cement, which may indicate previous water penetration into the structure at this location. Suggest client consult with sellers for additional information or review by qualified roofer for repair as needed.

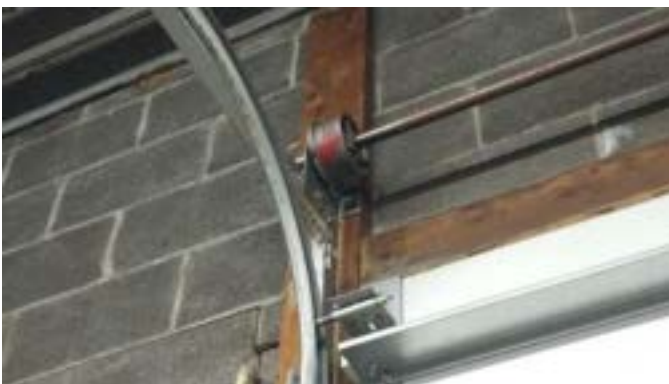
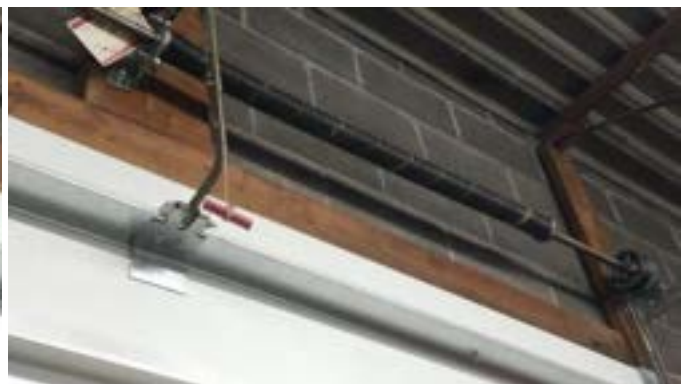
Door hardware for two of the functioning doors appears to be service.

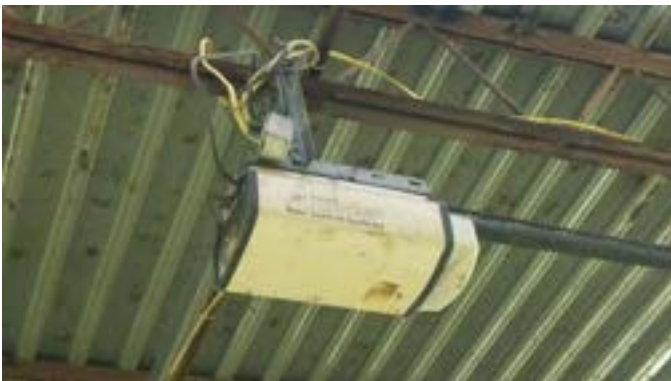
The overhead door opener appears to function appropriately.

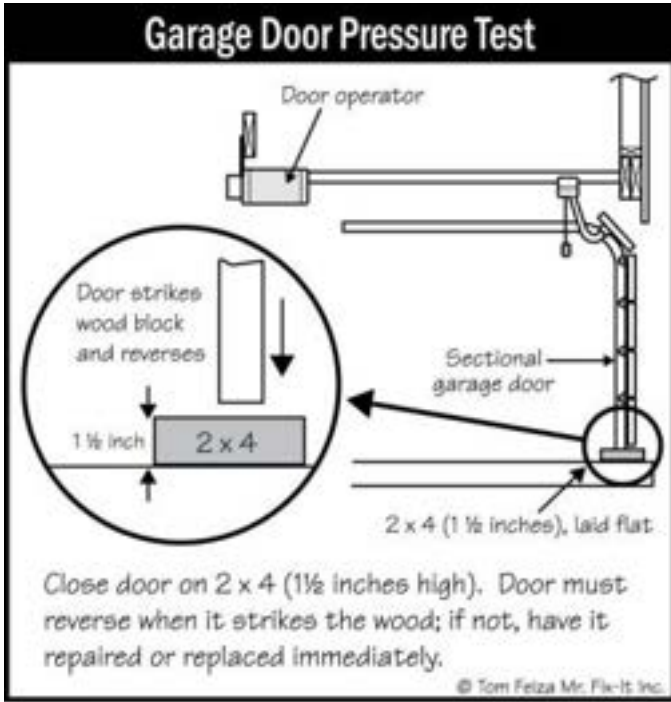
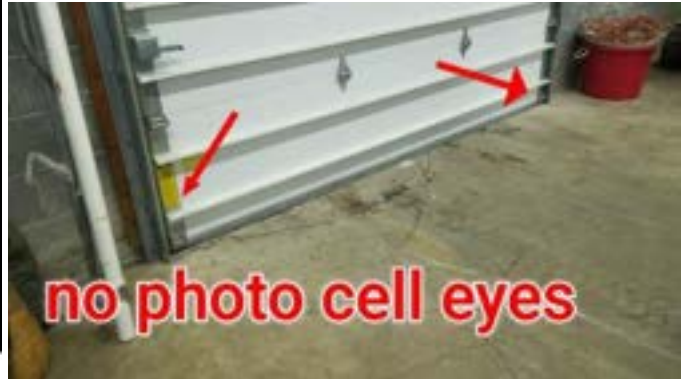
D012

No eyes present. Based on the age of the door opener, this may not have been required. Recommend installing photo eyes or replacing opener .

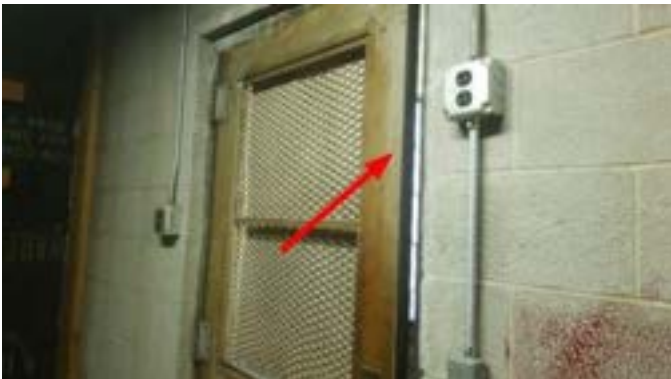
Door rubs jamb, sticks. Repair/adjustments are needed for proper operation.

Deterioration observed. Suggest repair or replacement as needed.

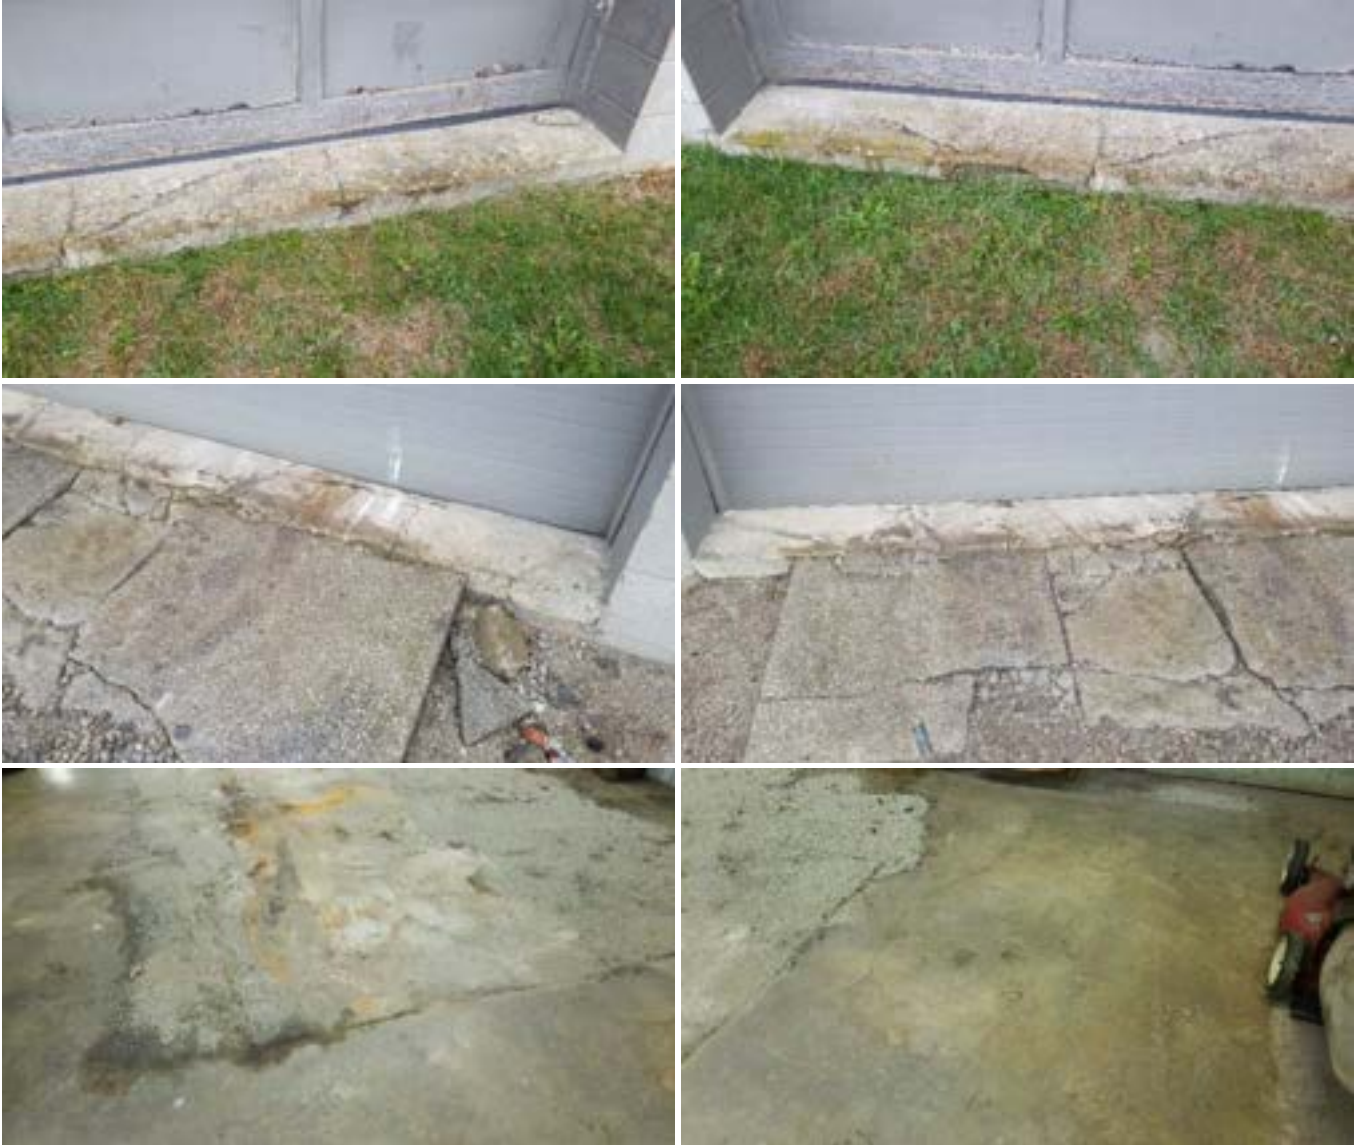
Garage floor shows an unusual amount of cracking. Due to conditions observed, floor may require some level of maintenance, repair or replacement in the foreseeable future. You should plan or budget for additional expenses on this component.

Common cracks observed; primarily a cosmetic concern. Suggest sealing all concrete slab joints as well as any cracks in concrete/asphalt/brick surfaces to prevent water

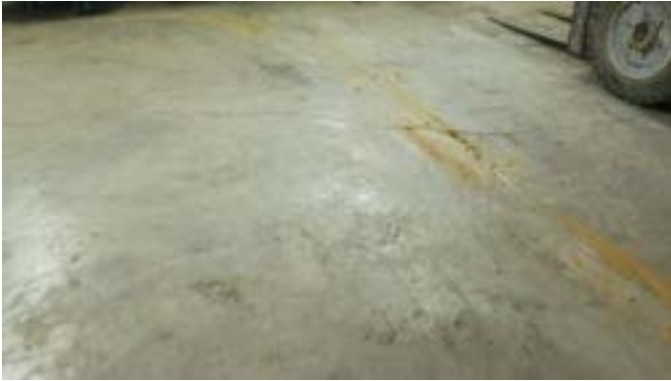
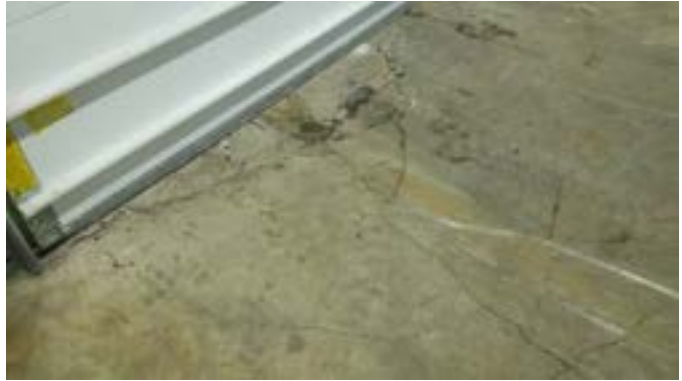
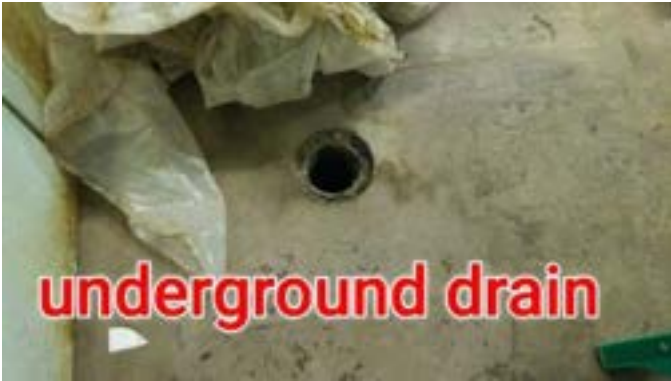
underground drain

Underground drains observed. Underground drainage systems are not within the scope of this inspection and a functional water flow test is not performed.

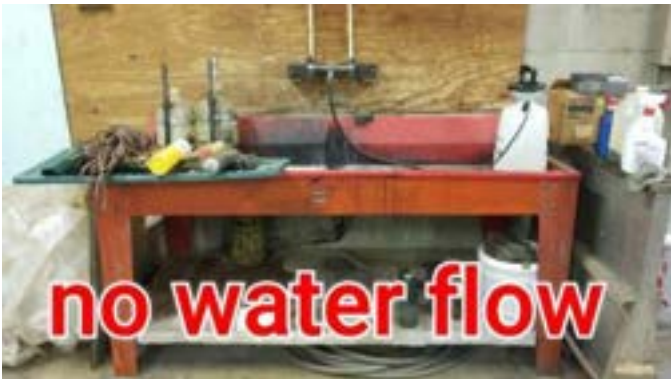
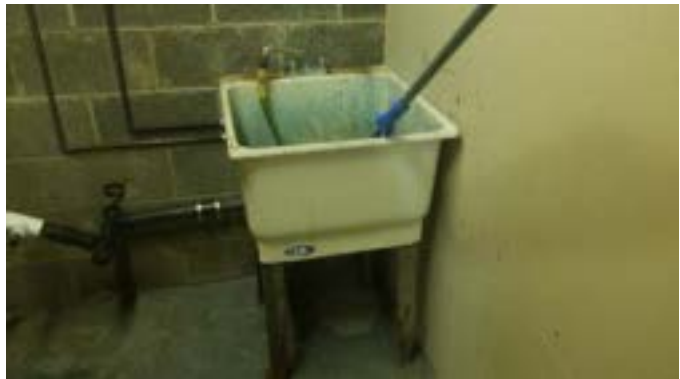
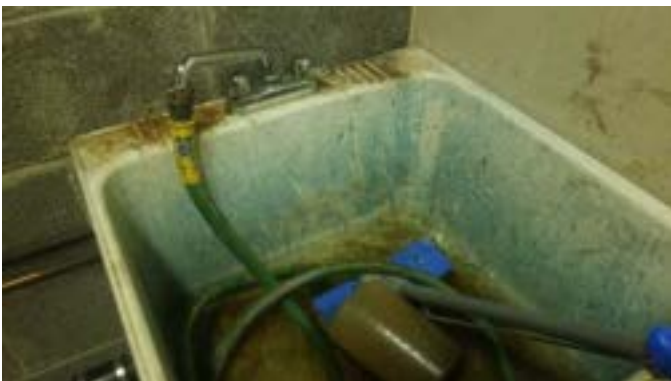
Faucet, **No water flow. Unable to determine the condition of the system and/or the function of plumbing fixtures. We recommend confirming proper operation of all plumbing appliances and fixtures prior to close.**

Drain, **No water flow. Unable to determine the condition of the system and/or the function of plumbing fixtures. We recommend confirming proper operation of all plumbing appliances and fixtures prior to close.**

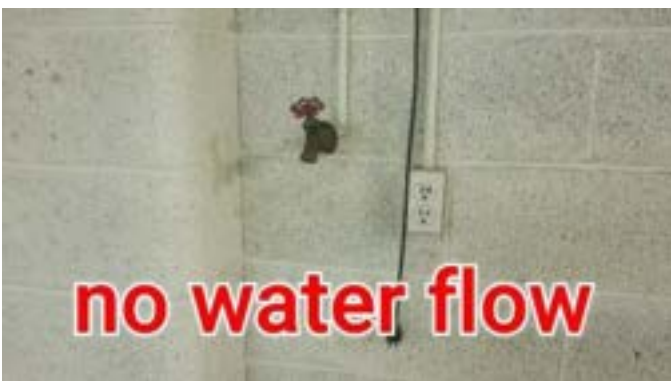
There was no water flow at this faucet at the time of the inspection and was not tested. Recommend consulting seller for additional information.

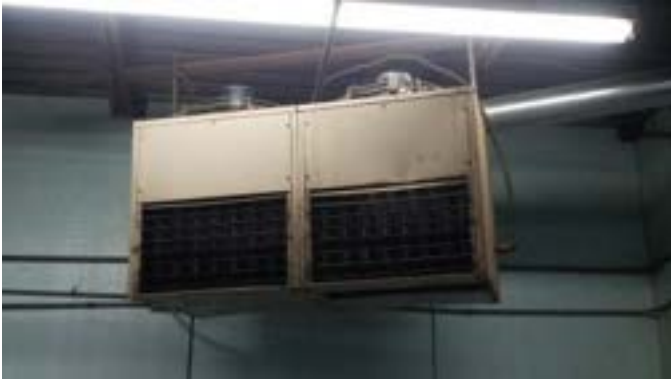
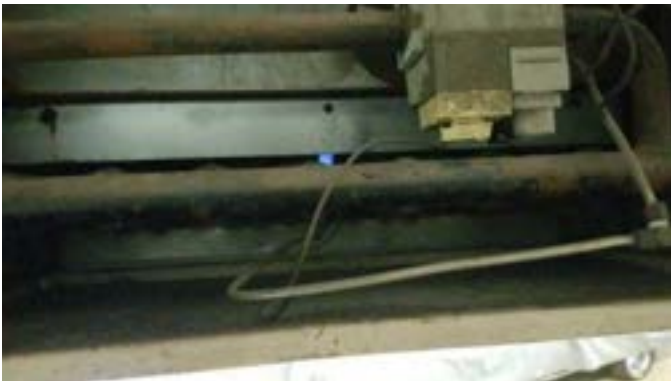
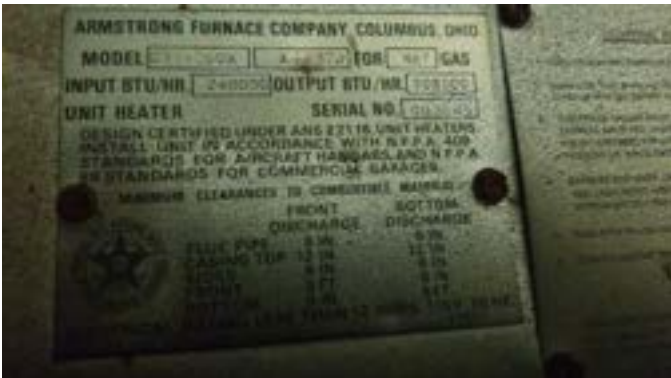
Overhead gas heater. Appears to be year 2000 and is 19 years old. Serviceable

Some of the ceiling heaters in main garage area do not appear to be connected and working properly. Recommend consulting sellers to find out more information.

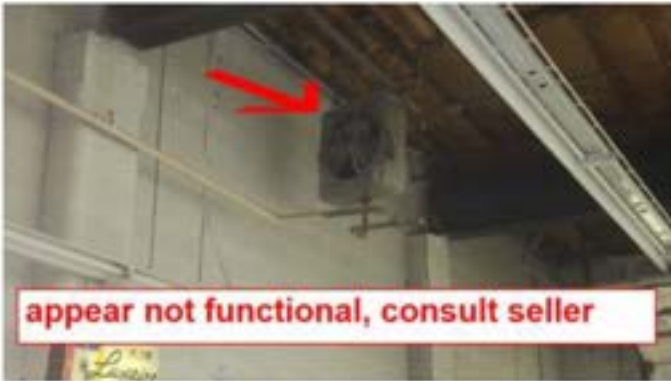
appear not functional, consult seller

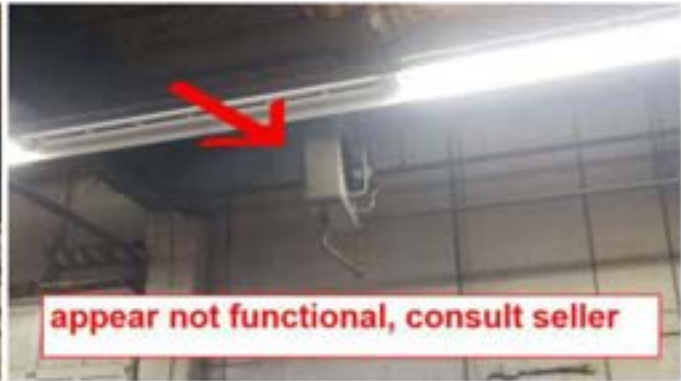
appear not functional, consult seller

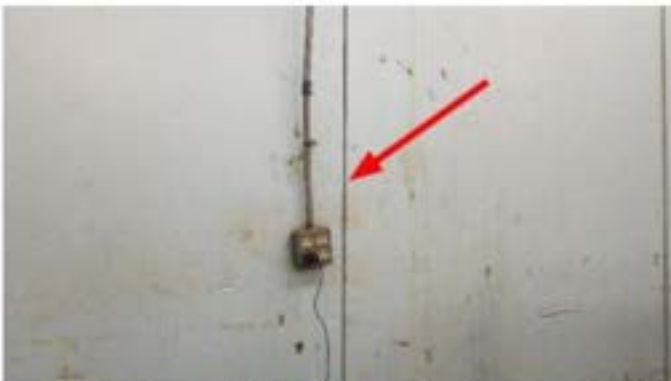
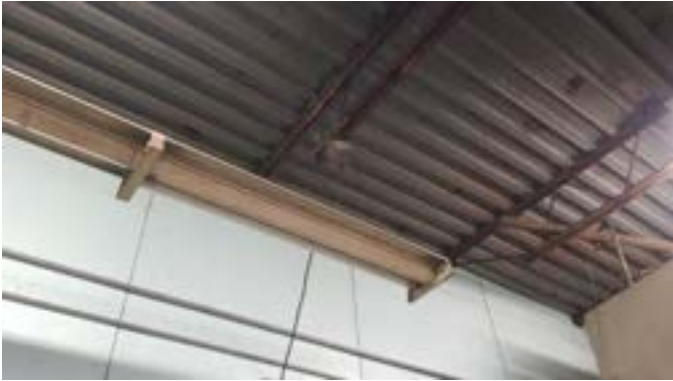
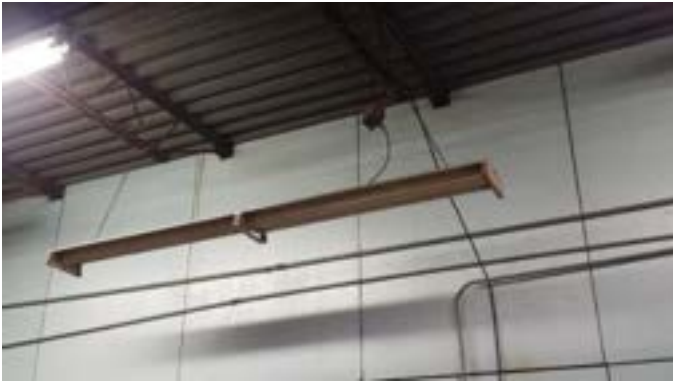
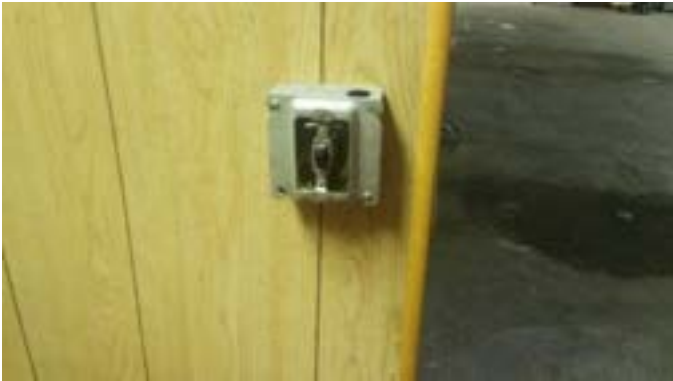
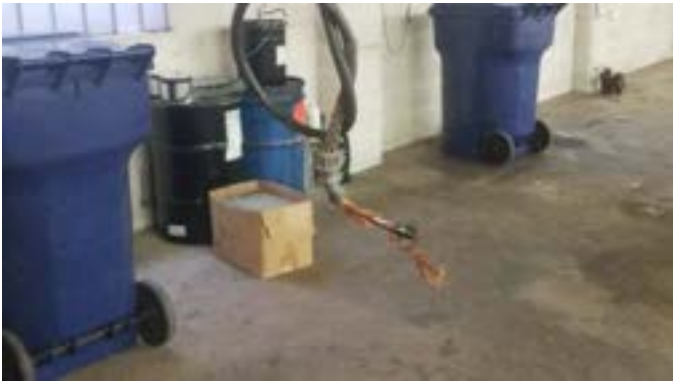
Loose outlets observed recommend securing outlet by a qualified electrician for safety.

Switch and/or receptacle covers are damaged/missing. Recommend review by a qualified electrician for repair or replacement as needed.

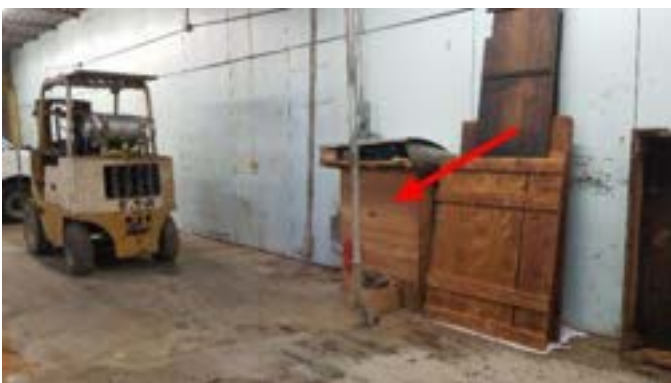
Loose wires observed throughout the garage and loose conduit pipe observed. Recommend securing these wires to ensure safety.

Exposed wiring was observed. Recommend review by a qualified electrician for repair or replacement as needed.

Open splices were observed. This is a "Safety Concern". Whenever an electric wire is cut and reconnected, the "splice" should be encased in a covered "junction box" to prevent shocks and separation of the splice. Recommend review by a qualified electrician for repair as needed for safety.

Visible wiring appeared to have some locations that need to be secured or rerouted for safety reasons. Recommend review by a qualified electrician for repair as needed.

Improperly terminated wiring was observed. Recommend review by a qualified electrician for repair or replacement as needed.

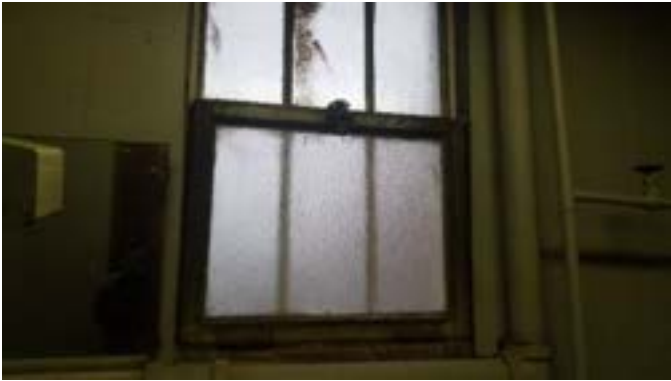
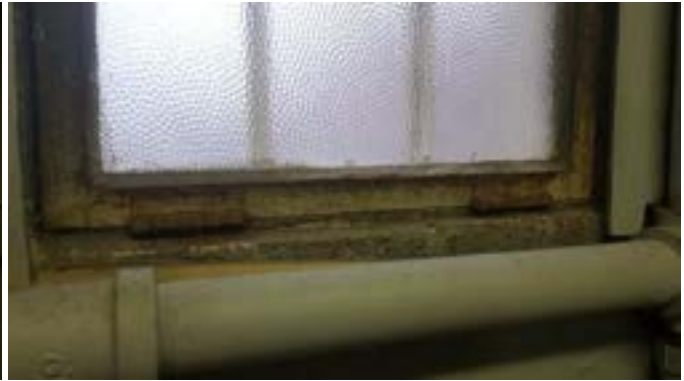
Moisture damaged trim and/or sill observed. The extent of damage could not be determined without destructive analysis. Maintenance and/or repairs should be performed. Whenever there is water damage, there is the possibility of hidden mold growth and pest

infestation.

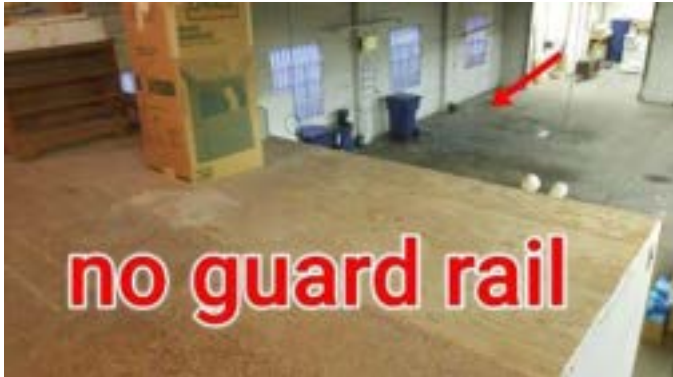
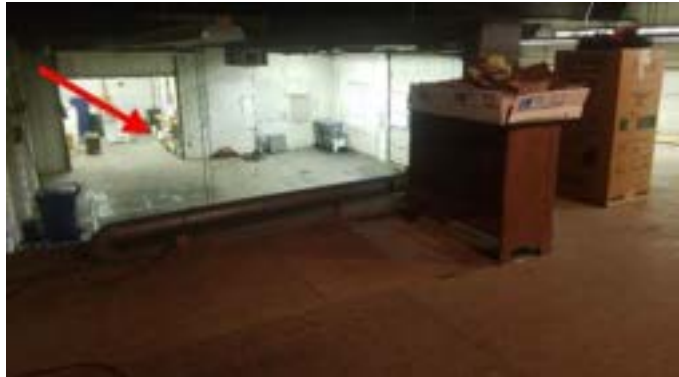
Recommend installing a handrail/guardrail for safety. Whenever a stairway is four or more risers high a handrail and/or guardrail is usually required for safety.

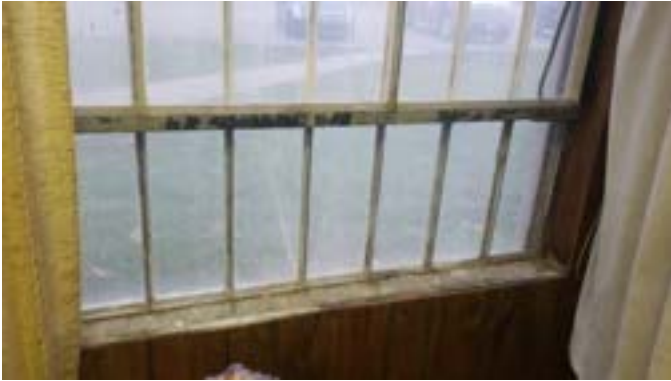
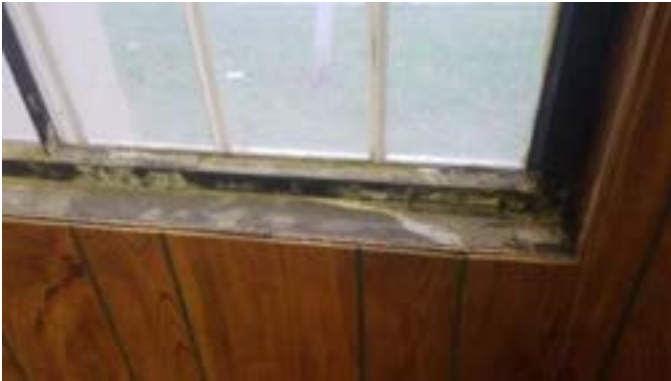
Peeling paint observed at various location, suggest scraping and painting as needed as part of normal maintenance.

Moisture damaged trim and/or sill observed. The extent of damage could not be determined without destructive analysis. Maintenance and/or repairs should be performed. Whenever there is water damage, there is the possibility of hidden mold growth and pest infestation.

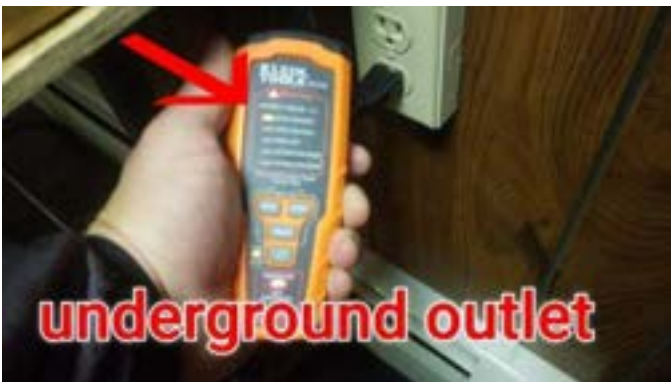
Switches/Fixtures/Outlets:

Ungrounded three prong receptacles observed. It is recommended that these types of receptacles be grounded, replaced with two prong receptacles, or protected on a GFCI circuits as applicable. Suggest review by qualified electrical contractor for repairs/replacements as needed to ensure safety.

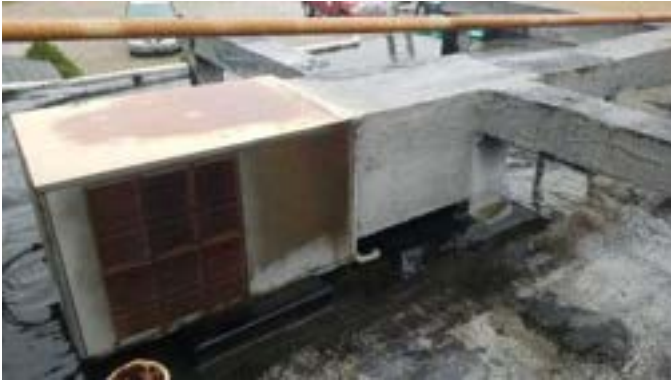
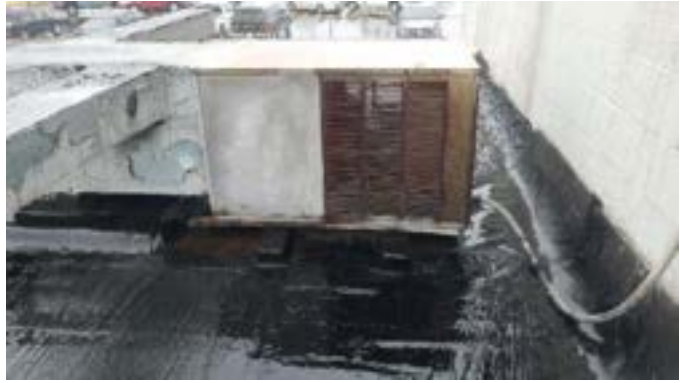
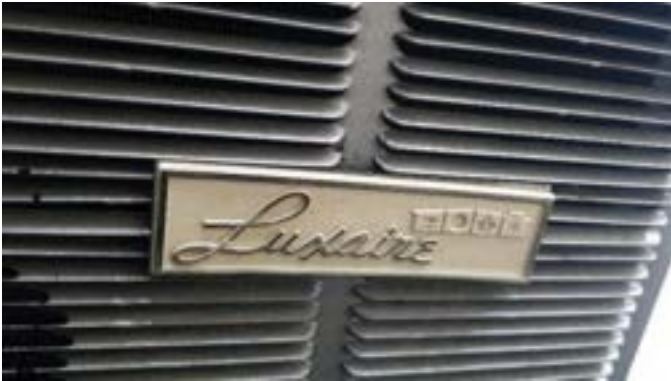
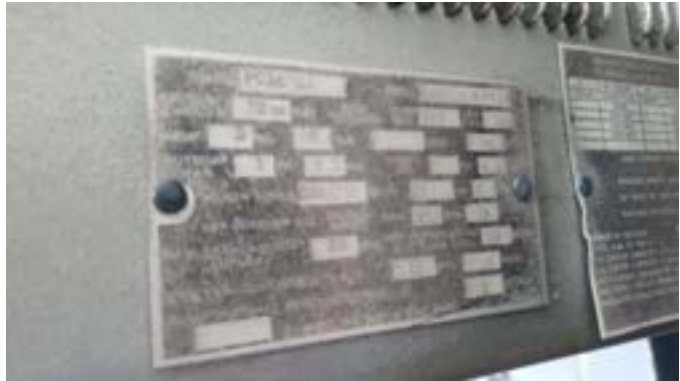
Air Conditioning & Heating #1:

System is Luxaire Brand. This is a combo heating and cooling unit. Unit is greater than 30 years old.

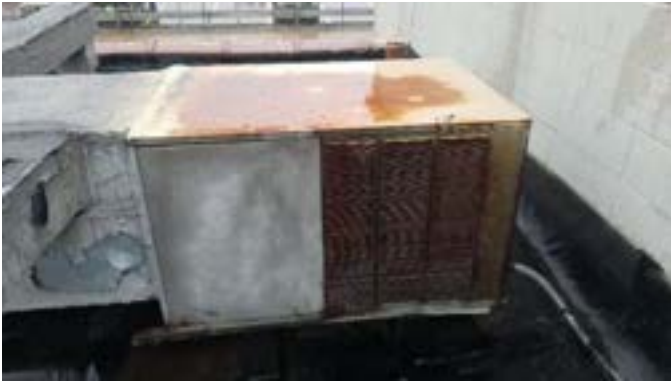
Unable to test the air conditioning unit at the time of the inspection due to cold temperature. The unit appears serviceable. If concerned recommend review by a qualified HVAC contractor for additional information prior to close.

In the inspectors opinion the air conditioning and heating unit has exceeded its designed life expectancies. We make no warranty, guarantee or estimation as to the remaining useful life of this unit.

The HCFC-22 or R-22 refrigerant used in the air conditioning system is being phased out. Effective 2020, no new R22 refrigerant will be produced or imported. This means any necessary repairs to the A/C system after that time that requires refrigerant to be added may not be available or may be more expensive to find. This may result in a replacement of the condenser/compressor unit, evaporator coil and possibly the refrigerant lines will be necessary.
