Warehouse Sample Report

Confidential Inspection Report

501 Clark St
Elyria OH 44035

November 11, 2019

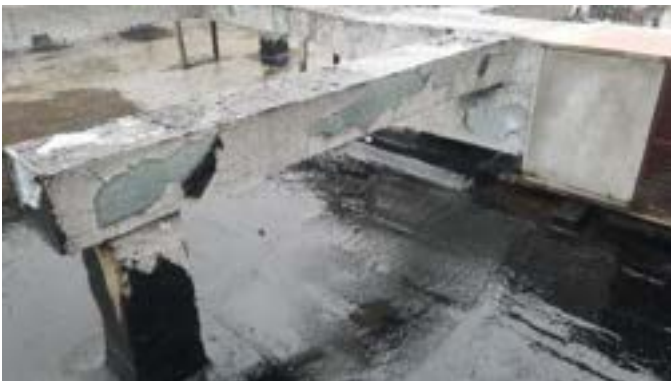
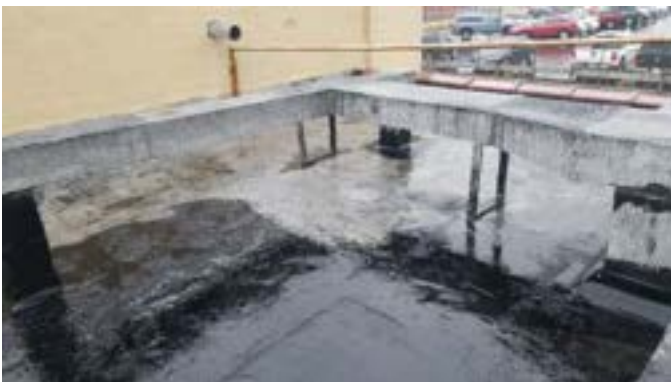
Distribution/Ducts Condition:

Ducts/Registers located on the roof top. Ducts are covered with roof cement and unable to determine condition. If concerned, recommend consulting qualified HVAC contractor.

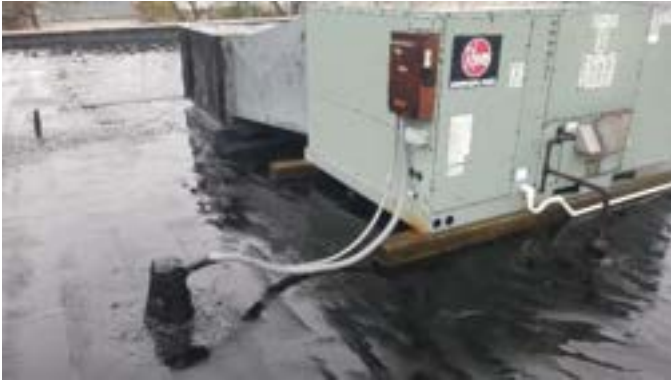
Inspector observed disconnect box was rusted, recommend review for replacement as needed by a qualified electrician.

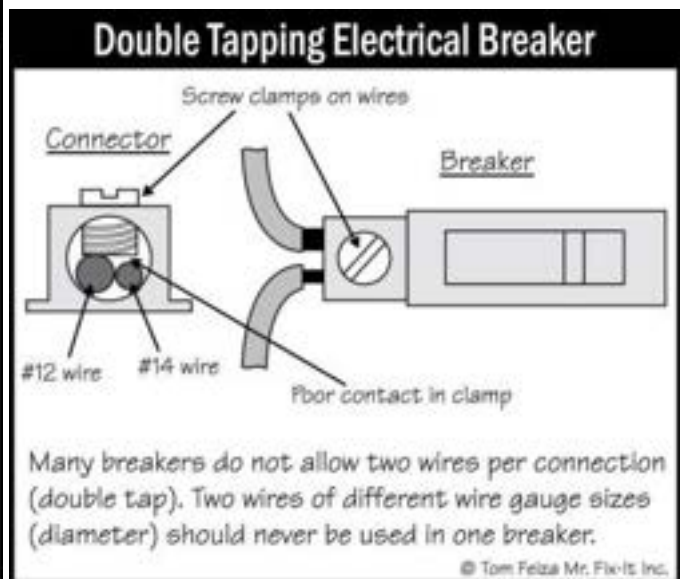
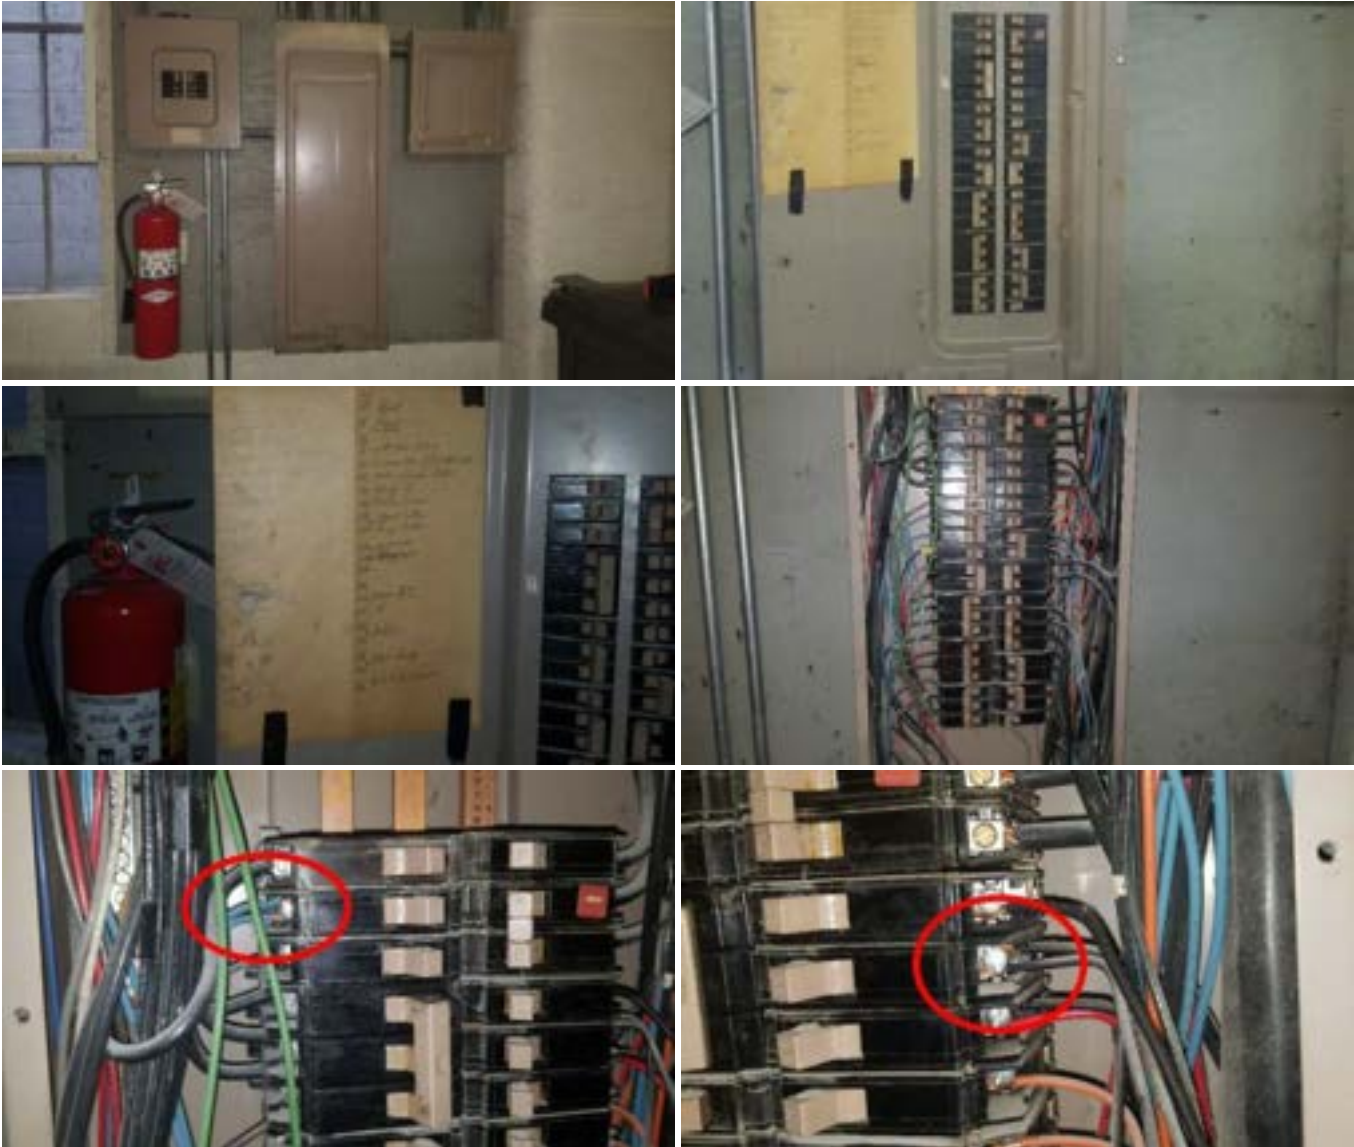
Double tapping observed in panel at breakers. Double tapping (i.e. 2 wires under a single screw), can cause possible overheating of the wire and is a safety concern unless the breaker is specifically designed to multiple wires. Recommend review by a qualified electrician for repair as needed.

Double tapping observed in panel at neutral bus bars. Double tapping (i.e. 2 wires under a single screw), can cause possible overheating of the wire and is a safety concern. Recommend review by a qualified electrician for repair as needed.

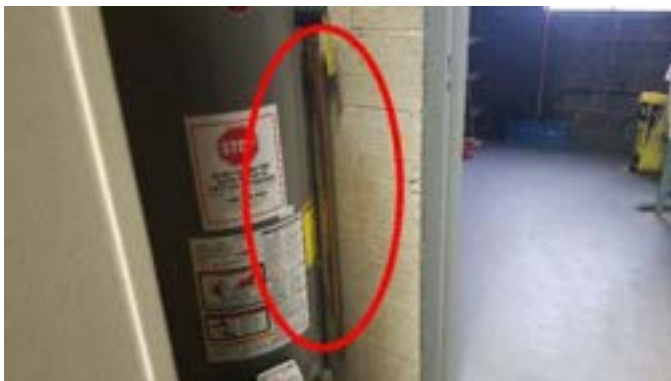
Temperature & Pressure Relief Valve:

Discharge pipe is short; recommend the discharge pipe be extended to six inches above the floor.

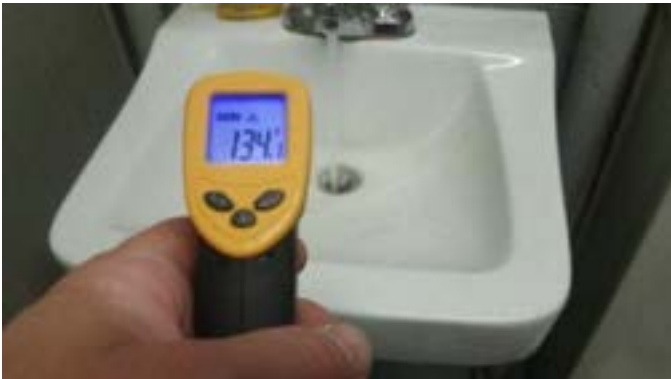
Water Temperature:

The water temperature at time of inspection was too hot. Recommend adjusting temperature to between 115 and 125 degrees for safety.

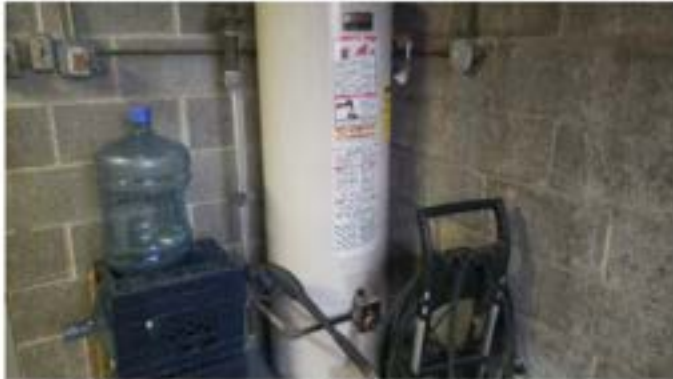
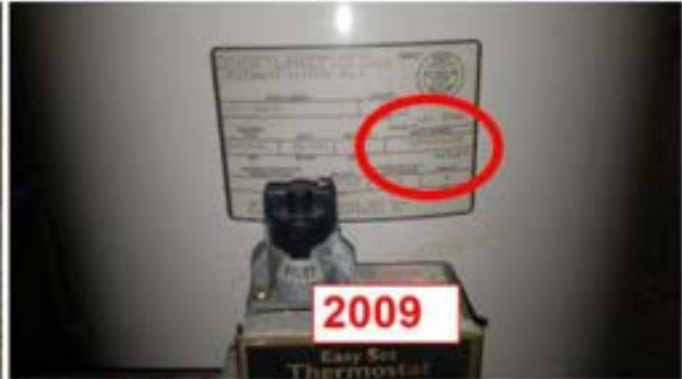
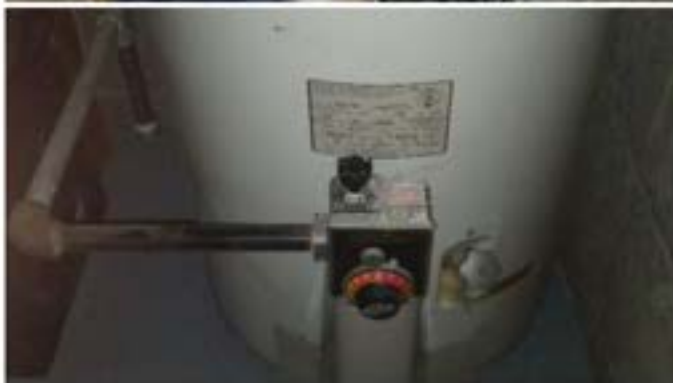
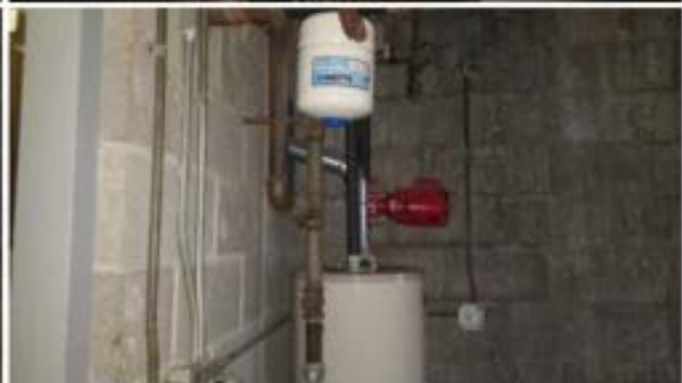
Brand:

Water heater is manufactured by Kenmore. Year is a 2009 and is 10 years old.

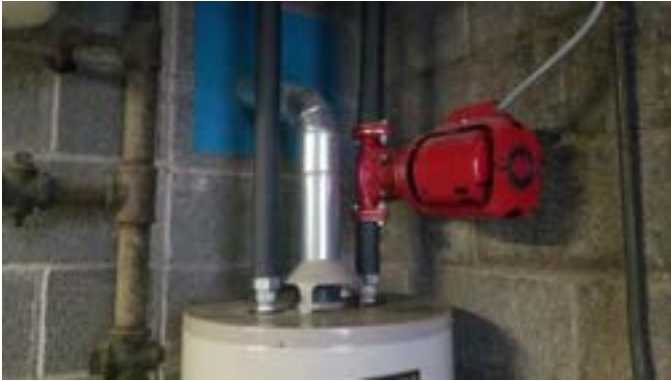
Ground jumper cable not observed between hot and cold water lines, recommend qualified electrician install jumper cable to insure proper grounding and safety.

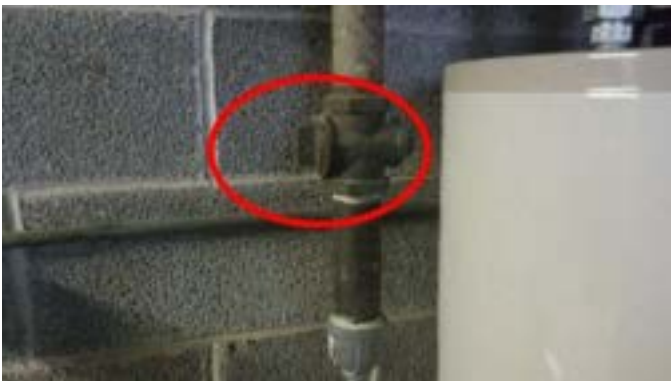
Energy Source:

Gas shut-off valve was observed near this appliance.

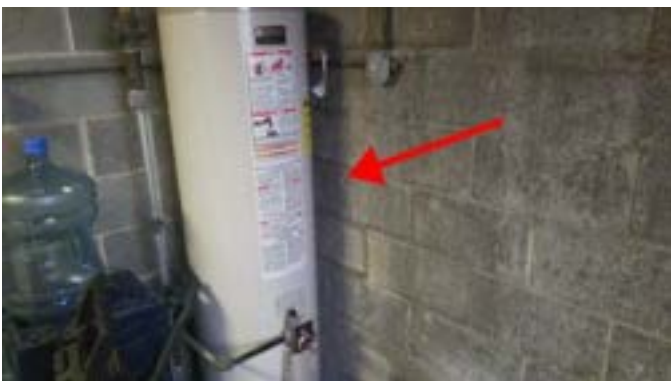
Temperature & Pressure Relief Valve:

Discharge pipe is missing on the temperature pressure relief valve. Suggest installing the required 3/4 inch discharge pipe on the temperature pressure relief valve to within six inches above the floor or to exterior of the building to ensure safety.

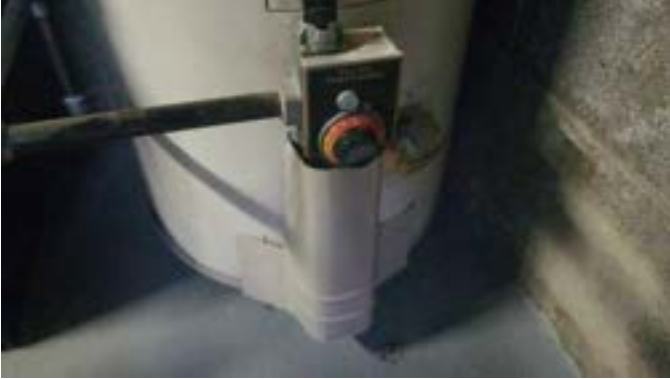
Burner:

Serviceable

Unable to inspect burner chamber due to closed system.

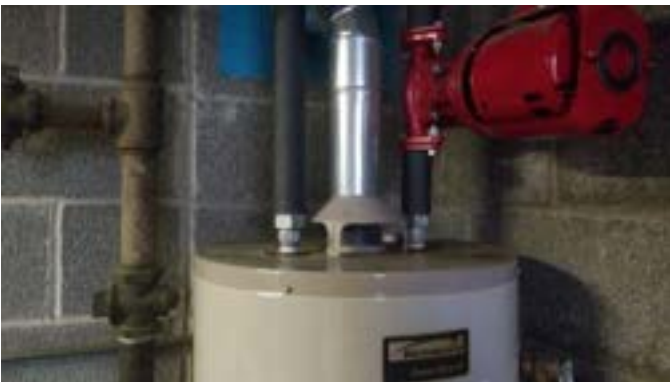
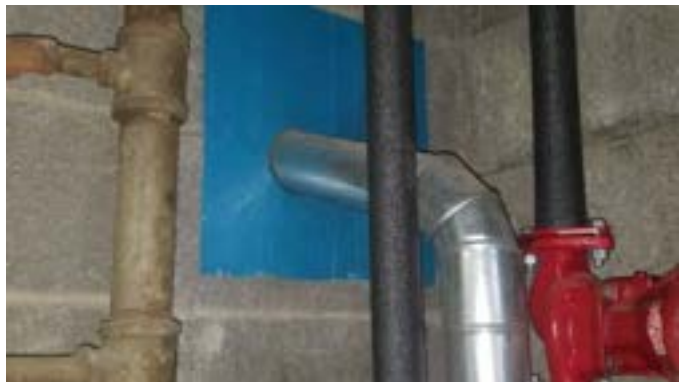
The visible portions of the flue/vent system appear to be installed correctly and appear to be serviceable.

The flue pipe is metal.

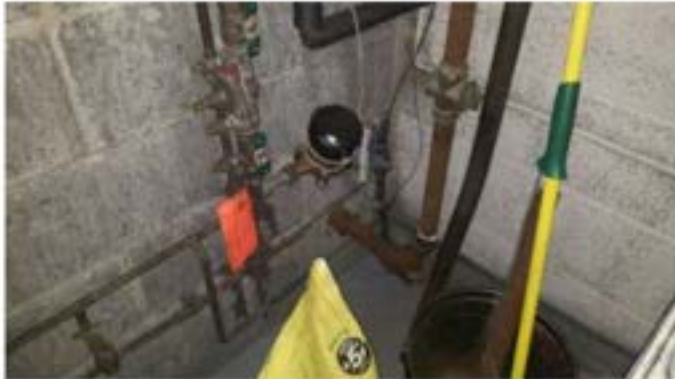
Shut Off Valve Location:

Main shut-off is located in garage utility area. Since main shut-off valves are operated infrequently, it is not unusual for them to become frozen over time. They often leak or break when operated after a period of inactivity. For this reason main shut-off valves are not tested during a building inspection. We suggest caution when operating shut-offs that have not been turned for a long period of time.
